**Florida Department of
Environmental Protection
Hazardous Waste Inspection Report**

Facility Name: Cliff Berry Inc - Tampa

Routine Inspection for Used Oil Processor Facility

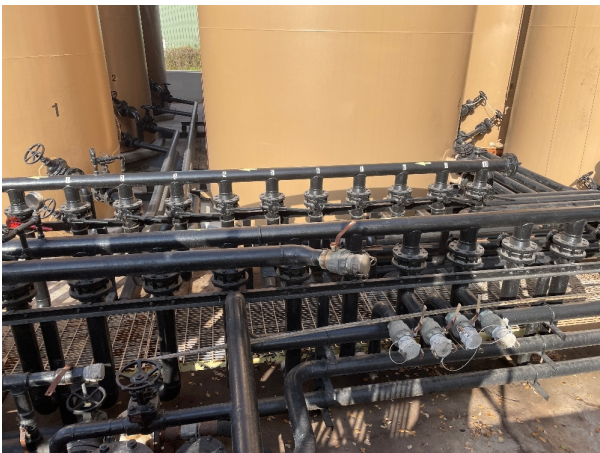
The tank farm consisted of ten aboveground storage tanks (ASTs) located within a concrete secondary containment structure. Tank 10 contains PCW, with tanks 1-9 used to contain used oil as needed. The tank sizes range from 15,000 to 30,000 gallons. Liquid waste is off-loaded through a valve-controlled pipeline to a "vac box" that contains filters to provide gross solids removal prior to entering the piping and tanks within the containment structure. The "vac box" is double lined. The concrete secondary containment unit was observed to be clean and dry, with no cracks or damage observed. All tanks were labeled with their appropriate contents and appeared to be in good condition.

tank farm and control valves

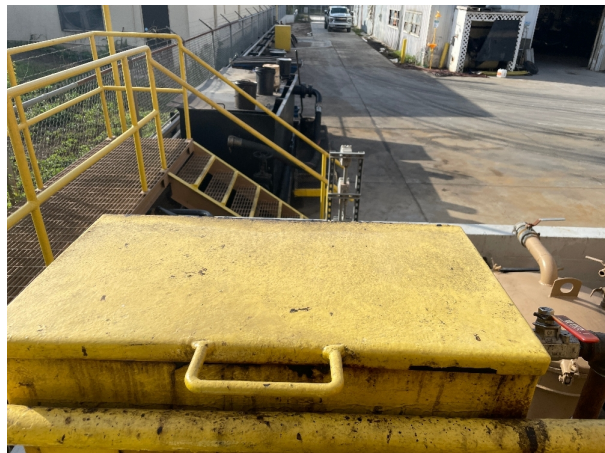
PCW filtration box

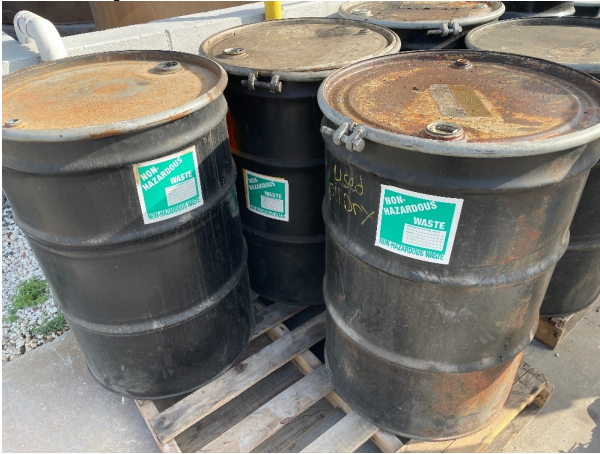
The tank farm had eleven 55-gallon metal drums near the tank farm. Mr. Tellier stated that this is not typically where drums are kept, typically these drums are stored on the trailers near the pole barn. Four of the eleven drums were empty.

- One 55-gallon metal drum of dry used oil, labeled with the words "Used Oil."
- Six 55-gallon drums of used oil filters, labeled with the words "Used Oil Filters."

Drums by tank farm

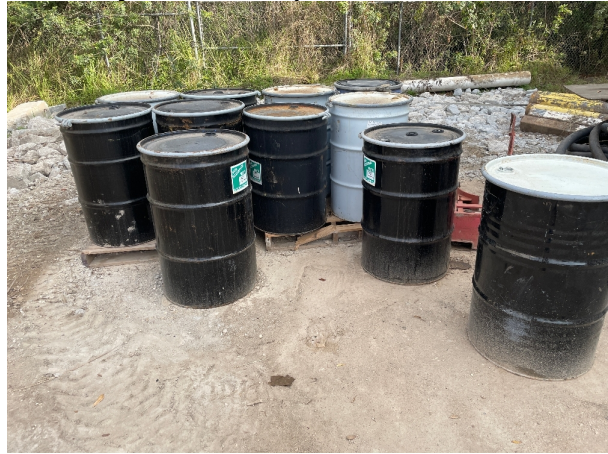
This area also had drums with waste stored outside of the trailers. Mr. Tellier informed staff that all drums were from the solid waste pit and are scheduled to be moved onto the nearby trailers for transportation later that day.

- Two 55-gallon metal drums of oily absorbents, labeled "Oily Absorbents."
- Three 55-gallon metal drums of oily dirt, labeled "Oily Dirt."
- Two 55-gallon metal drums of oily debris, labeled "Oily Debris."
- Four unlabeled 55-gallon metal drums containing a mixture of oily absorbents, dirt, and debris.

Drums by solid waste pit

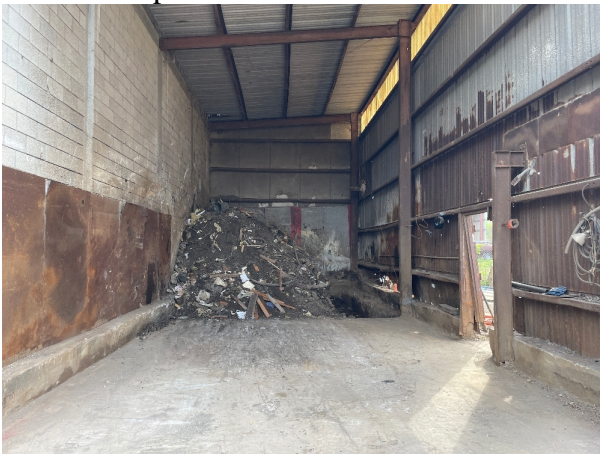
The pole barn behind the trailers houses a solid waste pit where oily solids are combined with dirt before being containerized and sent for disposal.

solid waste pit

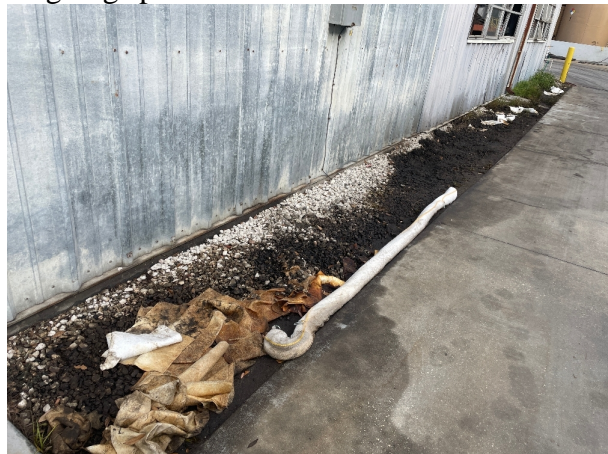
On February 14, 2025, the Department received notification from CBI that an unplanned discharge of petroleum contact water (PCW) occurred from the vac box used to off-load truck to the tanks in the tank farm. PCW overfilled vac box due to valves being left open overnight. The spill was reported by the first morning driver and a discharge report form was filed with the Department. The discharge moved south of the vac box along the east side of the on-site warehouse and pooled in the driveway. The discharge appears to have remained on-site and does not appear to have affected surface waters. Remedial action was in progress at the time of inspection. According to facility personnel, all potentially impacted soil will be screened and removed in accordance with FAC 62-780.500. All liquids had been removed from surfaces with absorbent materials and a vacuum truck. The Depart requests that the final Source Removal Report for this incident be submitted to both the Southwest District Hazardous Waste Section and the Hillsborough County Environmental Protection Commission Storage Tank Compliance Section.

Ongoing spill remediation
