Re: Mobile Impact Services Facility ID Number: FLR000203158 Sarasota County

Hazardous Waste Inspection Report

Inspection Date: 02/13/2020

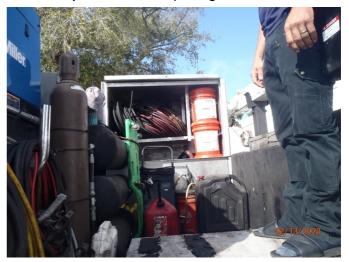
Large hydraulic lifts are serviced in the field. Used hydraulic oil is drained, collected in closed/labeled 5-gallon plastic containers and transported back to the facility. Containers holding used oil are stored inside a metal 'job box' inside the bed of the truck, capable of containing releases (see photo). A log is maintained reflecting the facility always transports <55-gallons of used oil at one time; and <500-gallons of used oil annually over public highways and is therefore not subject to the Certification Program under Rule 62-710.600 Florida Administrative Code.

Truck and job box for transporting used oil

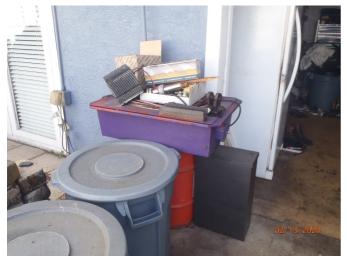
A sink top parts washer with a 16-gallon drum base was noted outside (see photo). Mr. Baxter indicated the drum contains approximately 5-gallons of mineral spirits, is rarely used and he has not disposed of any spent solvent to date. It was recommended to maintain the parts washer inside the shed, protected from weather in the event of a release. It was discussed that a small volume of spent mineral spirits may be added to the used oil for disposal as long as it does not cause the used oil to be considered ignitable and the used oil transporter is notified and approves. Spent mineral spirits may also be disposed thru the Sarasota County Project Green Sweep program. Information about the program was provided to Mr. Baxter at the time of the inspection, along with used oil labels and stencils.

parts washer
