**Florida Department of  
Environmental Protection  
Hazardous Waste Inspection Report**

**Facility Name:** FPL Port West Properties  
**On-Site Inspection Start Date:** 11/22/2022 **On-Site Inspection End Date:** 11/22/2022  
**ME ID#:** 9966 **EPA ID#:** FLD000807792  
**Facility Street Address:** 2455 Port West Blvd , Riviera Beach, Florida 33407-1214  
**Contact Mailing Address:** 2455 Port West Blvd, Riviera Beach, Florida 33407-1214  
**County Name:** Palm Beach **Contact Phone:** (561) 845-4973

Routine Inspection for LQG (>1000 kg/month) Facility

Inspection Date: 11/22/2022

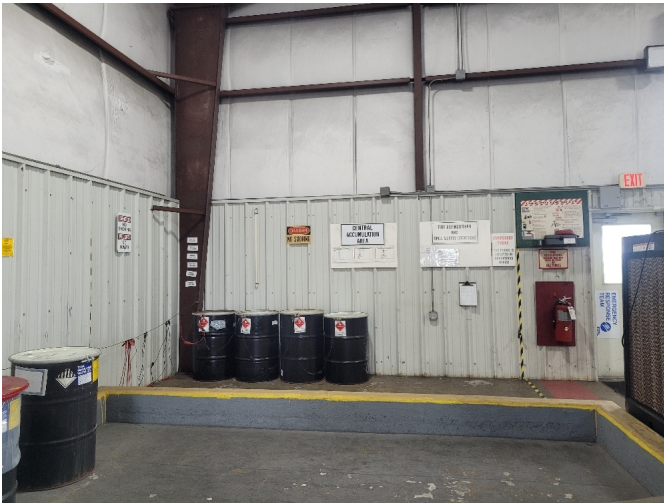
Hazardous Waste CAA

- In the "Central Accumulation Area", the inspectors observed four 55-gallon drums of aerosol cans, closed, labeled, marked with an accumulation start date and with indication of hazard.

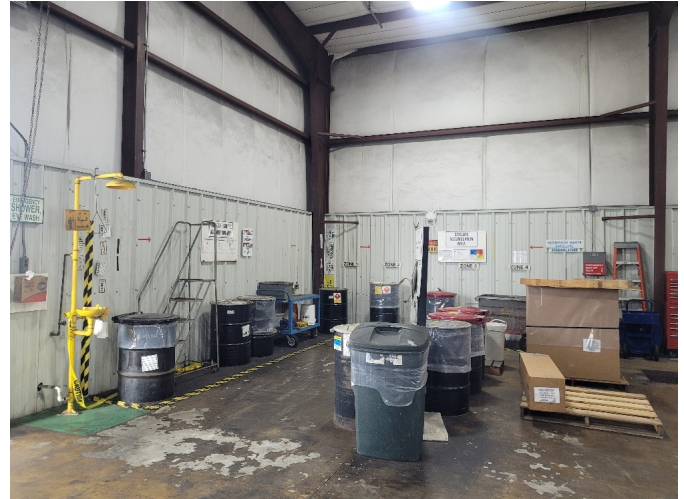
## Satellite Area

- In the "Satellite Accumulation Area", the inspectors observed one 55-gallon drum of spent aerosol cans and one 55-gallon of waste paint related material. Both containers were labeled, with an accumulation date and indication of hazards.

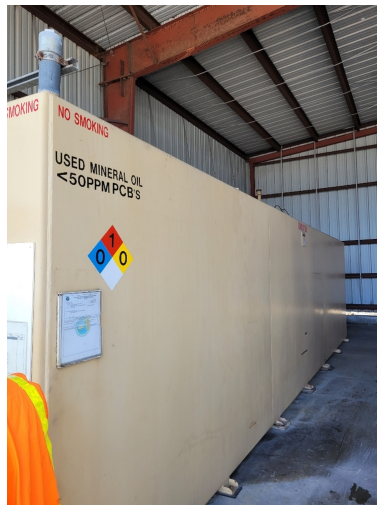
Used Mineral Oil Tank

The inspectors observed a 10,000 gallon tank of used mineral oil <50 PPM PCB's, labeled, and indicating the combustible hazard. The used mineral oil is collected from other FPL locations, stored at the Riviera Beach location, then sold to recycling company.
