**Florida Department of
Environmental Protection
Hazardous Waste Inspection Report**

Facility Name: Cliff Berry Inc - Jacksonville

On-Site Inspection Start Date: 08/24/2023

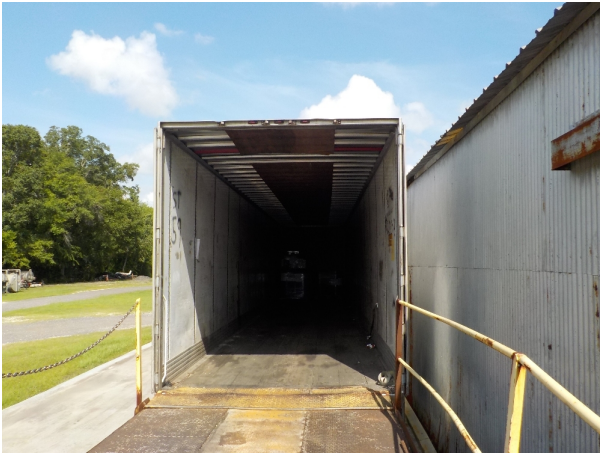
Photo 1

The Waste Storage Area consists of a sealed, secondary containment pad where one semitrailer containing non-hazardous waste, universal waste, used oil and used oil filters is parked (Photo 1). The secondary containment area is 111' long by 25' wide by 4" deep and is calculated to hold 6,850 gallons. The facility maintains a log of the date, manifest number, customer, quantity of drums and content of the drums that are loaded into the trailer. At the time of inspection, there were three boxes of universal waste lamps and one 5-gallon container of universal waste batteries, in addition to the non-hazardous and empty drums accumulating in the trailer. All inspected containers were closed, in good condition and properly labeled.

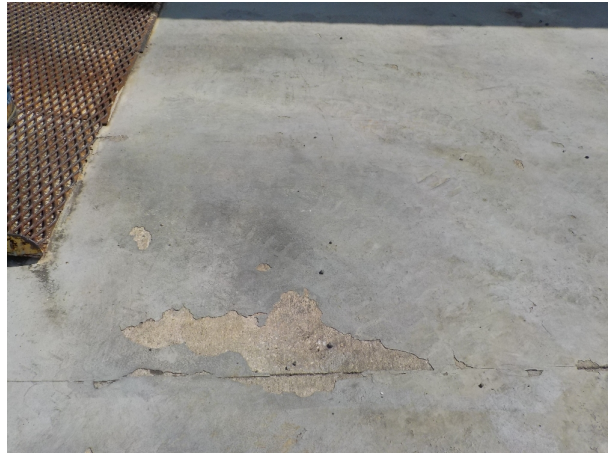
Photo 2

The facility is reminded that the secondary containment coating should be oil-impermeable when used oil or used oil filters are stored in this area. There was some peeling of the coating surface in the vicinity of the loading rack (Photo 2).

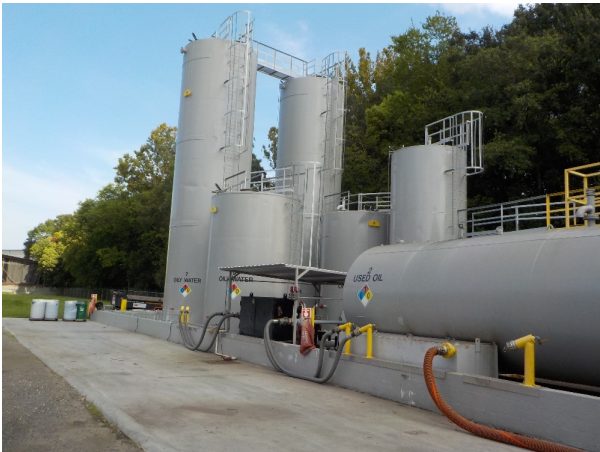
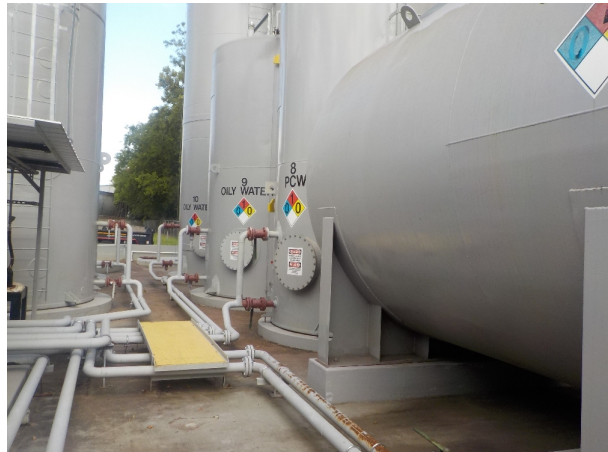
The AST Area is located northwest of the Storage Warehouse (Photos 3 and 4). There is one double-walled tank and six single-walled tanks installed and operating within a walled secondary containment area. There is a curbed, secondary containment pad for use during truck loading and unloading.

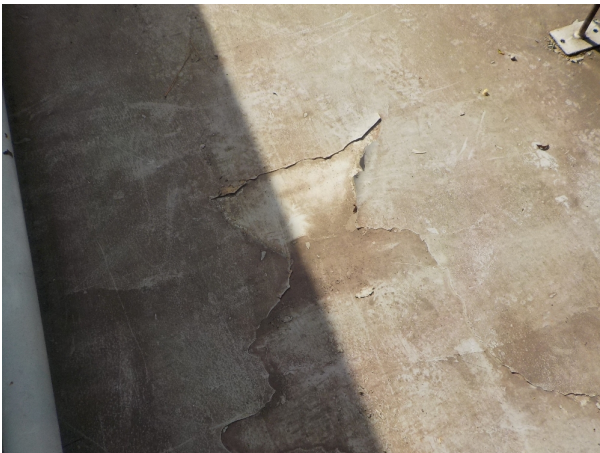
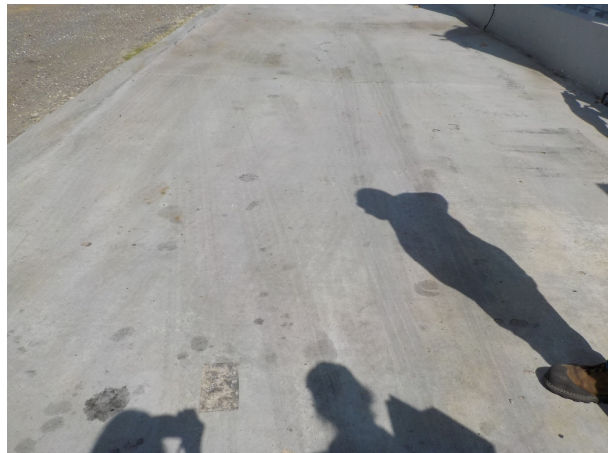
Tanks 1-5 were closed, in good condition and labeled as "Used Oil." There was some minor cracking and peeling of the secondary containment area around the tank farm, as well as the truck secondary containment pad (Photos 5 and 6), however, the secondary containment appeared to be sealed under the cracking. The facility is reminded that the secondary containment should be properly sealed and remain oil-impermeable.

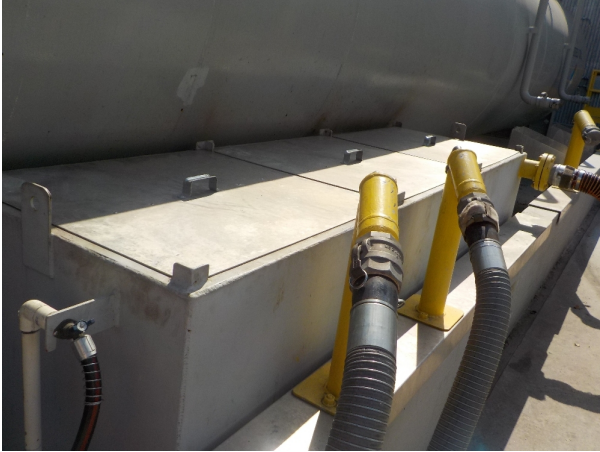
Photo 7

Used oil, PCW and oily water picked up from transportation activities are first offloaded into a separator (Photo 7). The separator has three compartments with screens. Once the liquid goes through the compartments, the liquid goes through canister filters before being routed to the proper tank. The canister filters are cleaned out approximately 8 times per year. The waste from cleaning the filters is managed as non-hazardous waste and accumulated in the used absorbent containers, described below, but the facility has not conducted a complete hazardous waste determination to support this action [40 CFR 262.11]. Solids are cleaned out of the separator approximately 2-3 times per year. Solids are managed as non-hazardous waste and accumulated in the used absorbent containers, described below, but the facility has not conducted a complete hazardous waste determination to support this action [40 CFR 262.11].

Type: Violation
Rule: 262.11
Explanation: The facility has not conducted a complete hazardous waste determination on the following wastestreams:
1. AST Area: waste from cleaning out the canister filters
2. AST Area: waste from cleaning out the solids from the separator trough
Corrective Action: In order to return to compliance, prior to the next routine disposal or within four months, the facility should conduct and fully document a hazardous waste determination by having a representative sample of the wastestreams analyzed separately by a certified Florida laboratory for the following:

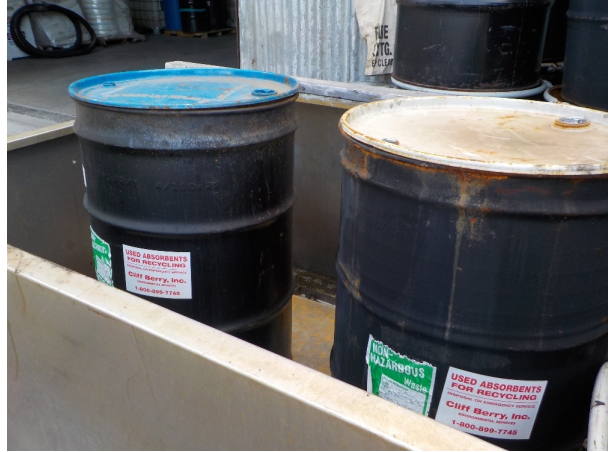
Photo 8

On one end of the truck secondary containment pad, there were two 55-gallon containers of used absorbents accumulating (Photo 8). Both drums were closed, in good condition and stored within a secondary containment

area. When full, the drums are transported to the CBI Miami facility for processing. Used absorbents are managed as non-hazardous waste based on previous analysis.

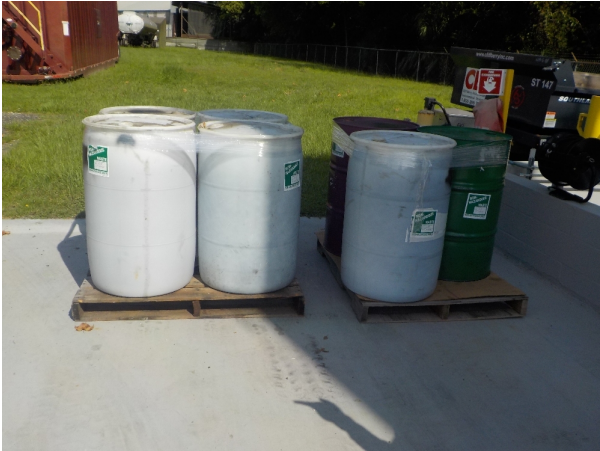
Photo 9

On the other end of the truck secondary containment pad, there were seven 55-gallon containers of oily water accumulating (Photo 9). This oily water had been picked up from a customer on the day of the inspection and was going to be off-loaded into one of the oily water tanks.

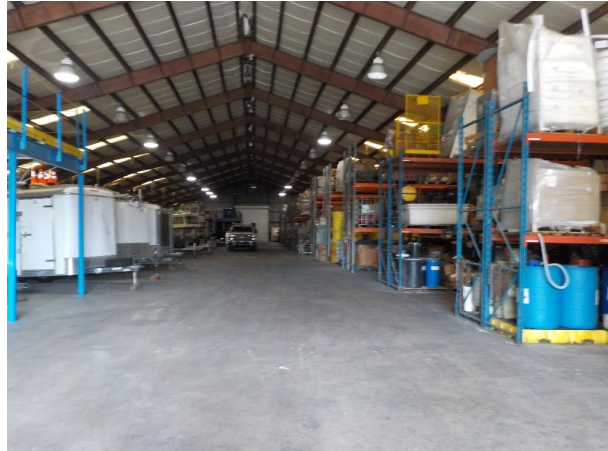
Photo 10

The Storage Warehouse is used to store emergency response equipment and materials used in clean-up efforts (Photo 10). The facility performs maintenance on some of its own equipment. Paints were stored in the Warehouse for maintenance operations. The facility is reminded to conduct a hazardous waste determination on any wastes generated from these materials prior to disposal. The facility uses Mansize as a degreaser for its industrial tank cleaning operations conducted off-site. Manfire degreaser (pH: 13-14) may also be used on occasion. Non-empty containers of Manfire would generate a D002 hazardous waste if disposed of. The facility representative stated that the liquid generated by tank cleaning operations is disposed of based on the contents of the tank that was cleaned. The facility is reminded to conduct a complete hazardous waste determination on any tank cleaning wastewaters prior to disposal. If a hazardous wastewater is generated, it is either directly transported to US Ecology for disposal or accumulated at the facility for less than 24-hours before being transported for disposal.
