RE: Warning Letter WL23-216 (Significant Non-Complier)
Cliff Berry Inc. - Jacksonville
EPA/DEP ID: FLR 000 119 784
Duval County – Hazardous Waste

**Florida Department of
Environmental Protection
Hazardous Waste Inspection Report**

Facility Name: Cliff Berry Inc - Jacksonville

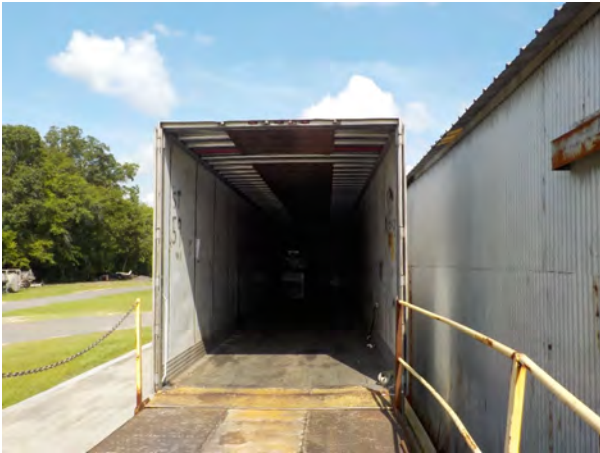
Photo 1

The Waste Storage Area consists of a sealed, secondary containment pad where one semitrailer containing non-hazardous waste, universal waste, used oil and used oil filters is parked (Photo 1). The secondary containment area is 111' long by 25' wide by 4" deep and is calculated to hold 6,850 gallons. The facility maintains a log of the date, manifest number, customer, quantity of drums and content of the drums that are loaded into the trailer. At the time of inspection, there were three boxes of universal waste lamps and one 5-gallon container of universal waste batteries, in addition to the non-hazardous and empty drums accumulating in the trailer. All inspected containers were closed, in good condition and properly labeled.

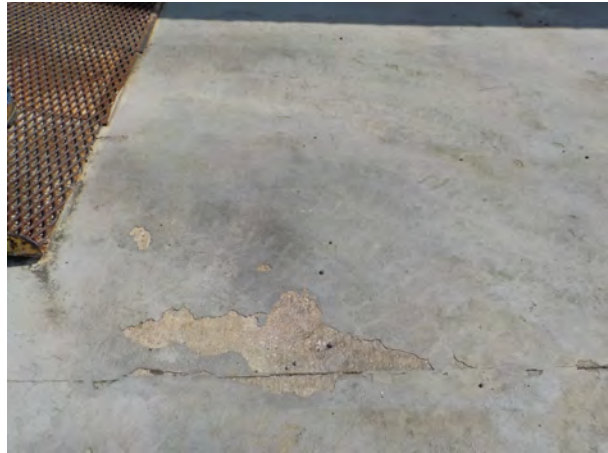
Photo 2

The facility is reminded that the secondary containment coating should be oil-impermeable when used oil or used oil filters are stored in this area. There was some peeling of the coating surface in the vicinity of the loading rack (Photo 2).

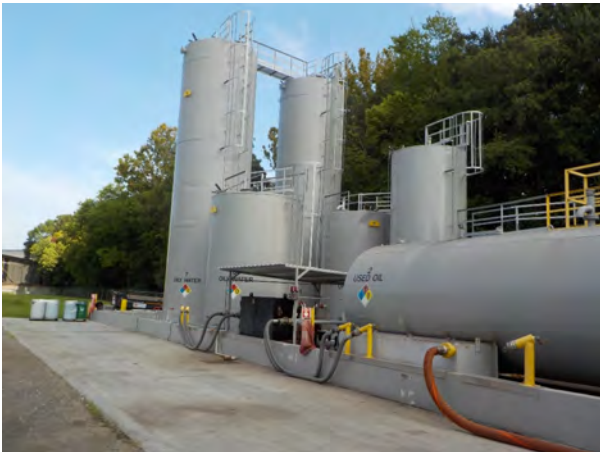
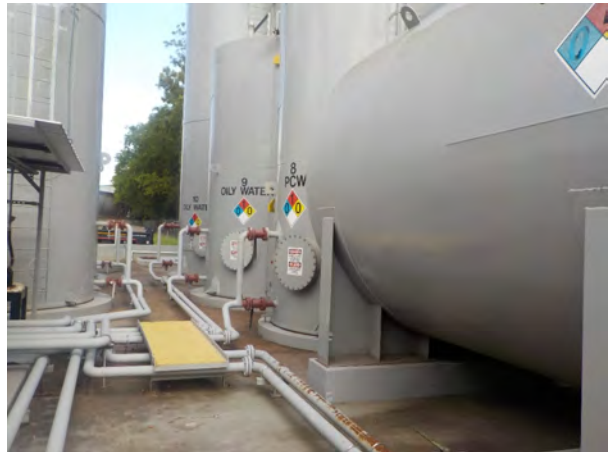
The AST Area is located northwest of the Storage Warehouse (Photos 3 and 4). There is one double-walled tank and six single-walled tanks installed and operating within a walled secondary containment area. There is a curbed, secondary containment pad for use during truck loading and unloading.

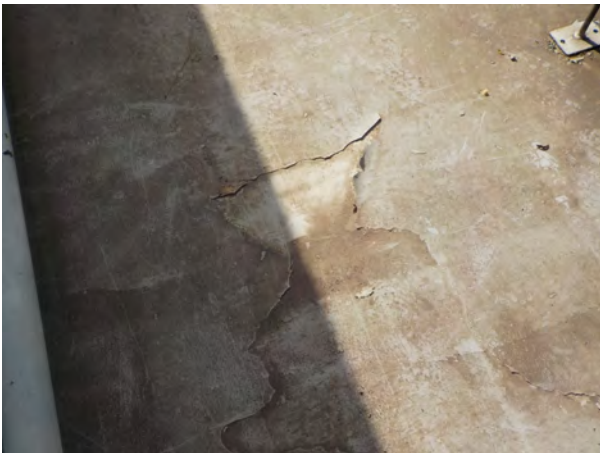
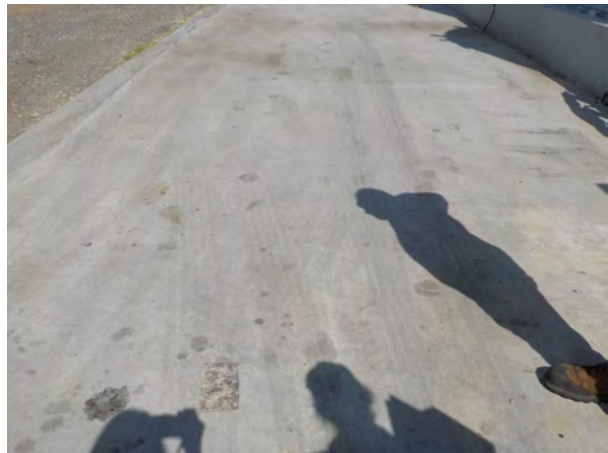
Tanks 1-5 were closed, in good condition and labeled as "Used Oil." There was some minor cracking and peeling of the secondary containment area around the tank farm, as well as the truck secondary containment pad (Photos 5 and 6), however, the secondary containment appeared to be sealed under the cracking. The facility is reminded that the secondary containment should be properly sealed and remain oil-impermeable.

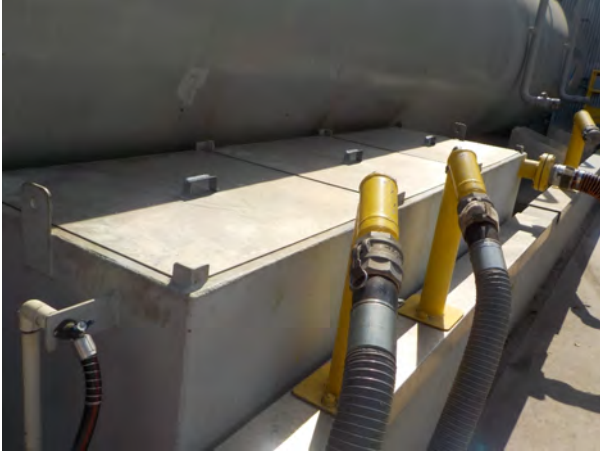
Photo 7

Used oil, PCW and oily water picked up from transportation activities are first offloaded into a separator (Photo 7). The separator has three compartments with screens. Once the liquid goes through the compartments, the liquid goes through canister filters before being routed to the proper tank. The canister filters are cleaned out approximately 8 times per year. The waste from cleaning the filters is managed as non-hazardous waste and accumulated in the used absorbent containers, described below, but the facility has not conducted a complete hazardous waste determination to support this action [40 CFR 262.11]. Solids are cleaned out of the separator approximately 2-3 times per year. Solids are managed as non-hazardous waste and accumulated in the used absorbent containers, described below, but the facility has not conducted a complete hazardous waste determination to support this action [40 CFR 262.11].

Type: Violation 1
Rule: 262.11
Explanation: The facility has not conducted a complete hazardous waste determination on the following wastestreams:
1. AST Area: waste from cleaning out the canister filters
2. AST Area: waste from cleaning out the solids from the separator trough
Corrective Action: In order to return to compliance, prior to the next routine disposal or within four months, the facility should conduct and fully document a hazardous waste determination by having a representative sample of the wastestreams analyzed separately by a certified Florida laboratory for the following:

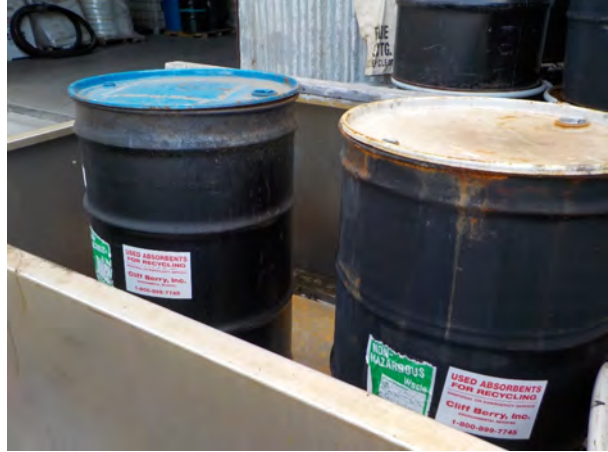
Photo 8

On one end of the truck secondary containment pad, there were two 55-gallon containers of used absorbents accumulating (Photo 8). Both drums were closed, in good condition and stored within a secondary containment

area. When full, the drums are transported to the CBI Miami facility for processing. Used absorbents are managed as non-hazardous waste based on previous analysis.

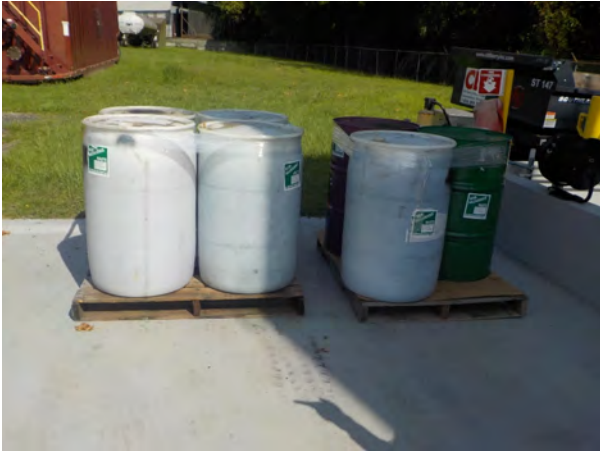
Photo 9

On the other end of the truck secondary containment pad, there were seven 55-gallon containers of oily water accumulating (Photo 9). This oily water had been picked up from a customer on the day of the inspection and was going to be off-loaded into one of the oily water tanks.

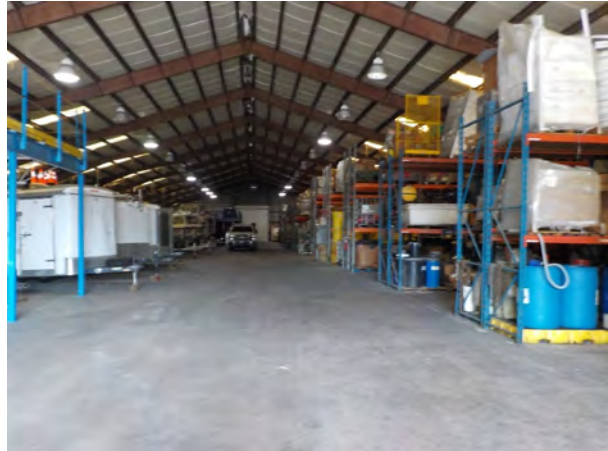
Photo 10

The Storage Warehouse is used to store emergency response equipment and materials used in clean-up efforts (Photo 10). The facility performs maintenance on some of its own equipment. Paints were stored in the Warehouse for maintenance operations. The facility is reminded to conduct a hazardous waste determination on any wastes generated from these materials prior to disposal. The facility uses Mansize as a degreaser for its industrial tank cleaning operations conducted off-site. Manfire degreaser (pH: 13-14) may also be used on occasion. Non-empty containers of Manfire would generate a D002 hazardous waste if disposed of. The facility representative stated that the liquid generated by tank cleaning operations is disposed of based on the contents of the tank that was cleaned. The facility is reminded to conduct a complete hazardous waste determination on any tank cleaning wastewaters prior to disposal. If a hazardous wastewater is generated, it is either directly transported to US Ecology for disposal or accumulated at the facility for less than 24-hours before being transported for disposal.
