**Florida Department of
Environmental Protection
Hazardous Waste Inspection Report**

Facility Name: Atlantic Marine Cleaning LLC

Routine Inspection for Used Oil Transporter Facility

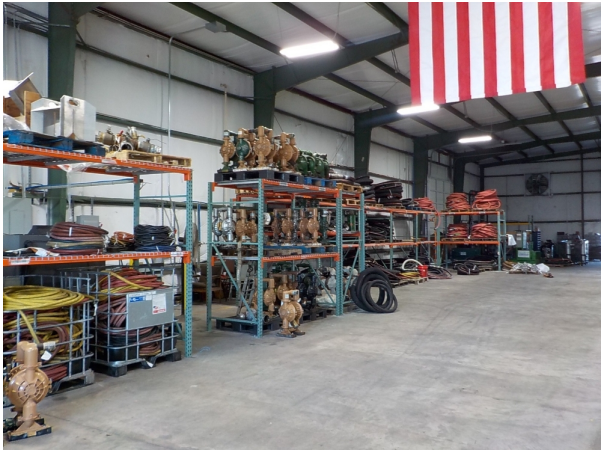
Photo 1

The main building on the property includes office and training spaces along the southeastern portion of the building, materials and equipment storage in the southwestern portion, a small maintenance area is located in the northwestern portion, and supplies and out of service equipment are stored in the northeastern portion of the building (Photo 1).

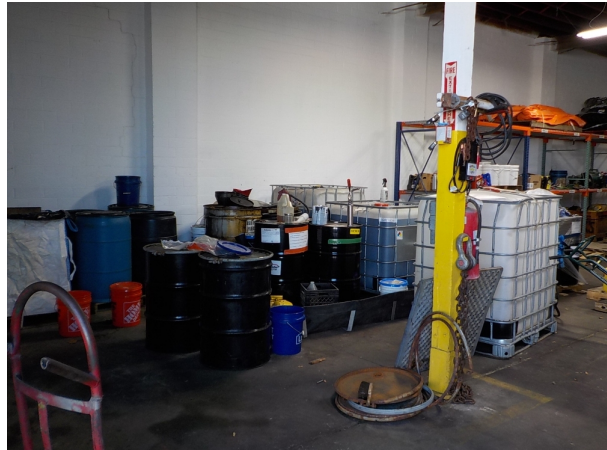
Photo 2

General maintenance is performed on AMC's vehicles and equipment, including oil and oil filter changes, in the maintenance area. Used oil and filters are accumulated in the adjacent building's Storage Area described below (Photo 2). Oily shop rags are collected in a lined fiberboard tri-wall in the Storage Area and managed as non-hazardous waste and disposed through WRI (Photo 3). Various cleaning products are used by technicians depending upon the type of equipment being repaired and maintained. Products observed in flammable storage lockers in this area included: Rustoleum aerosol paints in several colors (no RCRA metals; flashpoint: 106°F) that are used for touch-up painting; Klean Strip Paint Thinner (flashpoint: >100°F) that is used for paint clean-up; aerosol CRC Brakleen Brake Parts Cleaner (90-100% tetrachloroethylene; DOT compressed gas) and aerosol CRC Lectra-Motive Electric Parts Cleaner (90-100% tetrachloroethylene; DOT compressed gas) that are used to clean parts and motors; Oatey Medium Blue PVC Cement (5-15% MEK; flashpoint 14°-23°F) and Oatey Purple Primer (15-30% MEK; flashpoint 14°-23°F) that are used for PVC pipe assembly. Klean Strip when used on a rag would generate a non-hazardous solid waste. Excess Klean Strip would generate a D001 hazardous waste liquid. The CRC products when used on a rag would generate an F005, and potentially a D035, hazardous waste solid. The Oatey products when used on a rag would potentially generate a D035 hazardous waste solid. Excess Oatey products would potentially generate a D035 hazardous waste liquid. The facility had not made an accurate hazardous waste determination on its shop rags [40 CFR 262.11].

Type: Violation
Rule: 262.11
Explanation: The facility failed to make an accurate hazardous waste determination on its disposable shop rags.
Corrective Action: In order to return to compliance, the facility should make an accurate hazardous waste determination on its shop rags by having a representative sample of the rags from each maintenance process analyzed for the following:
- Toxicity Characteristic Leaching Procedure (TCLP) for volatiles, pursuant to 40 CFR 261.24, via method 8260.

Alternatively, the facility could manage its disposable shop rags as Excluded Solvent-Contaminated Wipes (ESCW) in accordance with 40 CFR 261.4(b)(18).

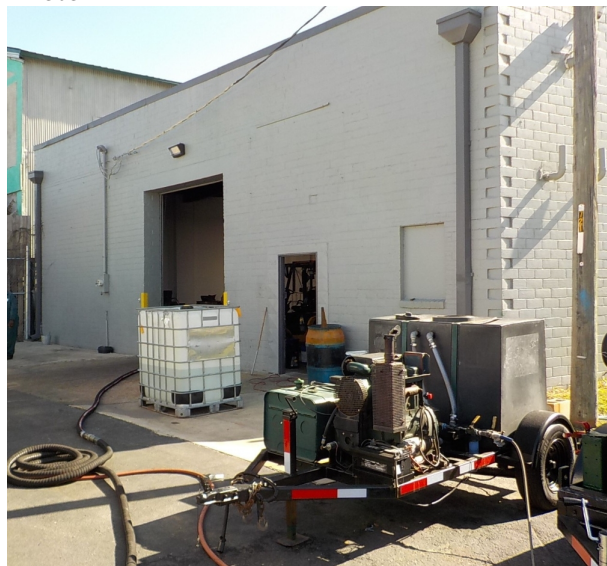
Photo 4

The second building on the property is located to the southeast of the main building (Photo 4). The majority of the building space is used for equipment storage. The used oil, used oil filter, and shop rags accumulation containers, and the aerosol can puncturer, are located in the northwest corner of the building to the left of the roll-up door. At the time of the inspection, there was one 55-gallon drum of used oil and one 55-gallon drum of used oil filters accumulating (See Photo 2). Both containers were properly labeled, and located within adequate secondary containment. There were product oil drums and a tote also located in this area. The drum of aerosol can liquid was closed. The punctured cans are recycled as scrap metal. No liquid waste has been disposed yet, but the facility is reminded that an accurate hazardous waste determination will be required prior to disposal.

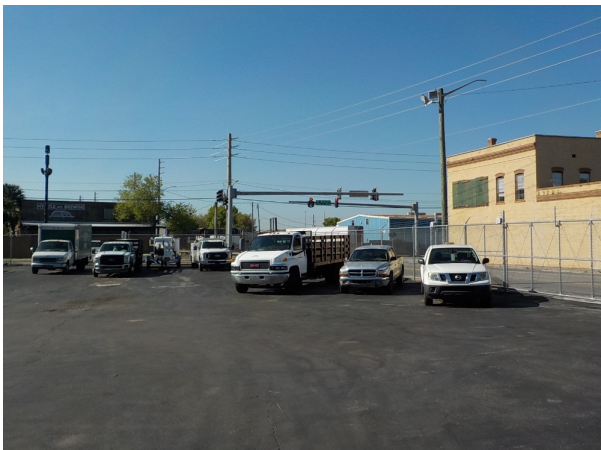
Photo 5

South of the main building is a parking lot for AMC's trucks, trailers and tankers (Photo 5). There was one vehicle in the area that is used to transport used oil. The vehicle had the appropriate transporter registration and insurance certificates in the cab.

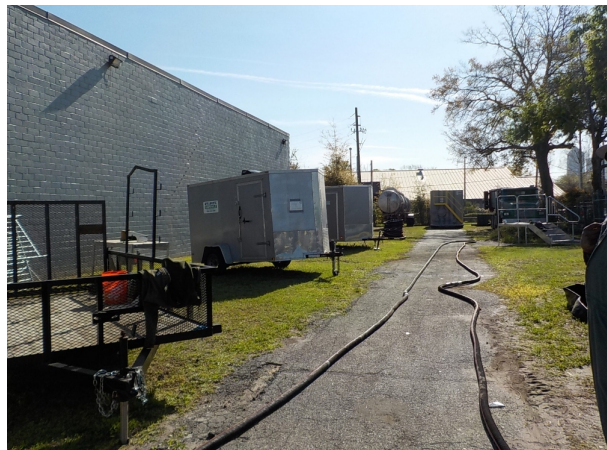
Photo 6

Immediately south of the second building and to the east of the vehicle parking area was a long, narrow section of the property that was partially grassed (Photo 6). The area is used to stage equipment, trailers, and hoses. The hoses are washed in a paved portion of the parking area adjacent to the second building using Zep Concentrate All-In-One Premium Pressure Wash (pH: 11.5-12.5) and Dawn Professional Dish Detergent. AMC uses detachable hoses to pump-out vessel bilges and tanks. The hoses are washed with Dawn or a 1:20

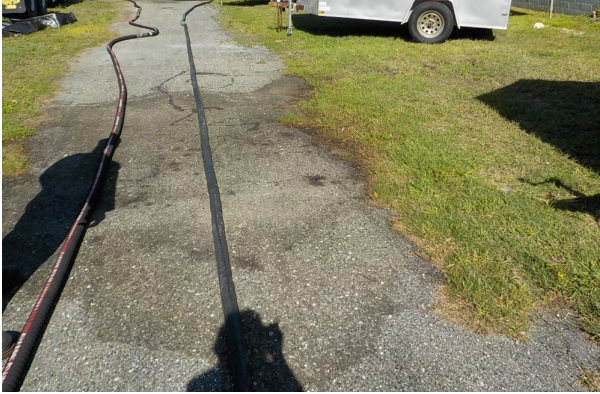
Photo 7

dilution of Zep and water and the washwater is discharged into a tote or tank. The washwater solution is circulated through the hoses until personnel determine they are clean. After washing, the hoses are drained into the tote or tank, and are then placed along the asphalt path to air-dry. In one area along the path, the asphalt was stained and the grass/dirt adjacent to the stained area was discolored (Photo 7) [40 CFR 279.22(d)].

Type: Violation
Rule: 279.22(d)(3)
Explanation: The facility failed to respond to and cleanup a release of used oil/oily water in the Outdoor Equipment Laydown Area.
Corrective Action: No further action is required. The facility returned to compliance via an email on May 1, 2024.
