**Re: Atlantic Marine Cleaning, LLC**  
**Facility ID No.: FLR000258301**  
**Duval – Hazardous Waste Program**

**Florida Department of  
Environmental Protection  
Hazardous Waste Inspection Report**

**Facility Name:** Atlantic Marine Cleaning LLC

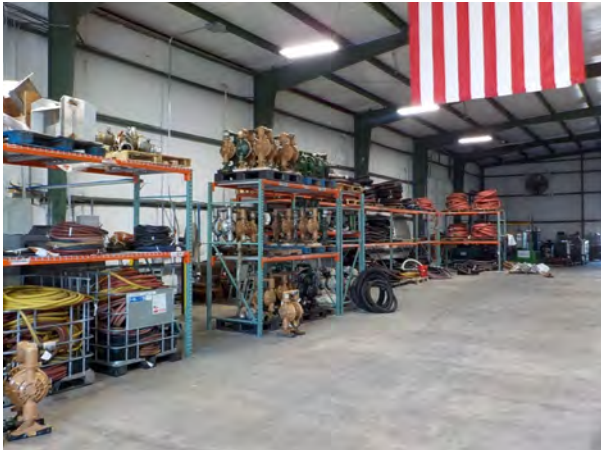
Photo 1

The main building on the property includes office and training spaces along the southeastern portion of the building, materials and equipment storage in the southwestern portion, a small maintenance area is located in the northwestern portion, and supplies and out of service equipment are stored in the northeastern portion of the building (Photo 1).

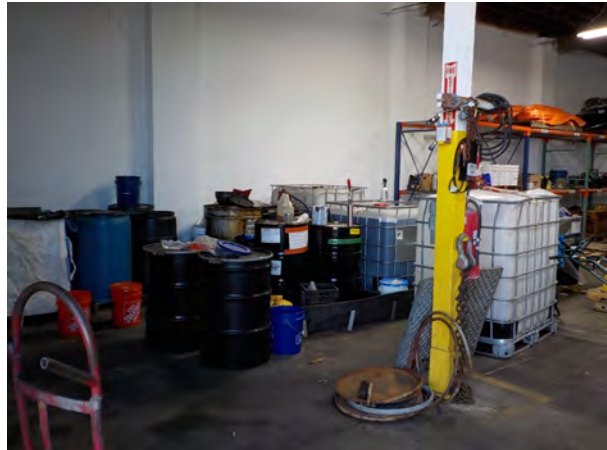
Photo 2

General maintenance is performed on AMC's vehicles and equipment, including oil and oil filter changes, in the maintenance area. Used oil and filters are accumulated in the adjacent building's Storage Area described below (Photo 2). Oily shop rags are collected in a lined fiberboard tri-wall in the Storage Area and managed as non-hazardous waste and disposed through WRI (Photo 3). Various lubrication and cleaning products are used by technicians depending upon the type of equipment being repaired and maintained. Products observed in flammable storage lockers in this area included: Rustoleum aerosol paints in several colors (no RCRA metals; flashpoint: 106°F) that are used for touch-up painting; Klean Strip Paint Thinner (flashpoint: >100°F) that is used for paint clean-up; aerosol CRC Brakleen Brake Parts Cleaner (90-100% tetrachloroethylene; DOT compressed gas) and aerosol CRC Lectra-Motive Electric Parts Cleaner (90-100% tetrachloroethylene; DOT compressed gas) that are used to clean parts and motors; Oatey Medium Blue PVC Cement (5-15% MEK; flashpoint 14°-23°F) and Oatey Purple Primer (15-30% MEK; flashpoint 14°-23°F) that are used for PVC pipe assembly. Klean Strip when used on a rag would generate a non-hazardous solid waste. Excess Klean Strip would generate a D001 hazardous waste liquid. The CRC products when used with a rag would generate an F002, and potentially a D039, hazardous waste solid. The Oatey products when used with a rag would potentially generate a D035 hazardous waste solid. Excess Oatey products would potentially generate a D035 hazardous waste liquid. The facility had not made an accurate hazardous waste determination on its shop rags [40 CFR 262.11].

Type: Violation 1  
Rule: 262.11  
Explanation: The facility failed to make an accurate hazardous waste determination on its disposable shop rags.  
Corrective Action: In order to return to compliance, the facility should make an accurate hazardous waste determination on its shop rags that are used for cleaning by having a representative sample of the rags from each maintenance process analyzed for the following:  
- Toxicity Characteristic Leaching Procedure (TCLP) for volatiles, pursuant to 40 CFR 261.24, via method 8260.

Alternatively, the facility could conservatively manage its disposable shop rags with CRC products as F002/D039 hazardous waste, and its shop rags with Oatey products as D039 hazardous waste. Or, the facility could manage its disposable shop rags used with these products as Excluded Solvent-Contaminated Wipes (ESCW) in accordance with 40 CFR 261.4(b)(18).

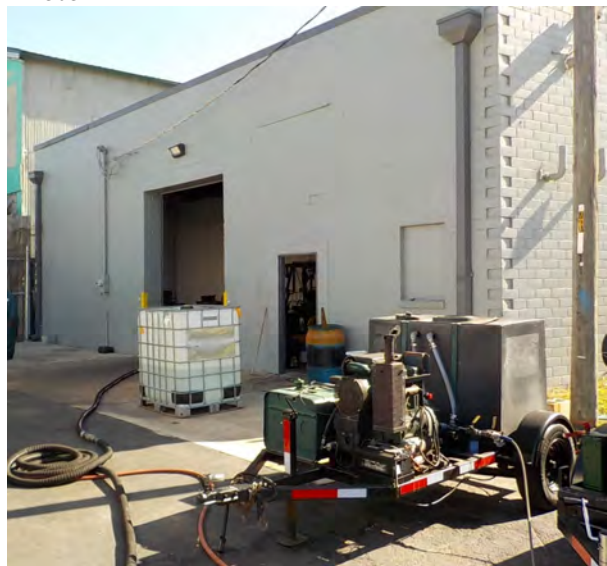
Photo 4

The second building on the property is located to the southeast of the main building (Photo 4). The majority of the building space is used for equipment storage. The used oil, used oil filter, and shop rags accumulation containers, and the aerosol can puncturer, are located in the northwest corner of the building to the left of the roll-up door. At the time of the inspection, there was one 55-gallon drum of used oil and one 55-gallon drum of used oil filters accumulating (See Photo 2). Both containers were properly labeled, and located within adequate secondary containment. There were product oil drums and a tote also located in this area. The drum of aerosol can liquid was closed. The punctured cans are recycled as scrap metal. No liquid waste has been disposed yet, but the facility is reminded that an accurate hazardous waste determination will be required prior to disposal.

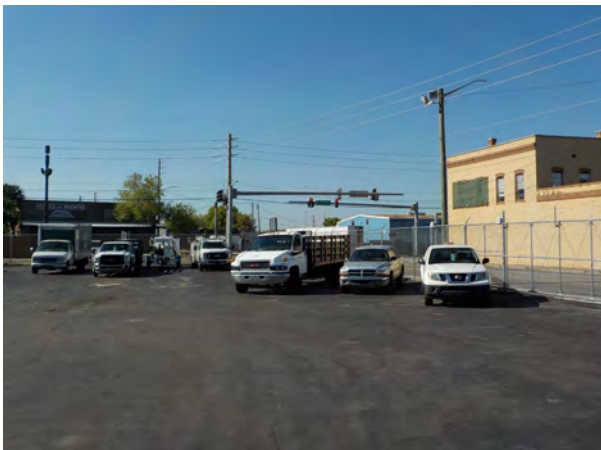
Photo 5

South of the main building is a parking lot for AMC's trucks, trailers and tankers (Photo 5). There was one vehicle in the area that is used to transport used oil. The vehicle had the appropriate transporter registration and insurance certificates in the cab.

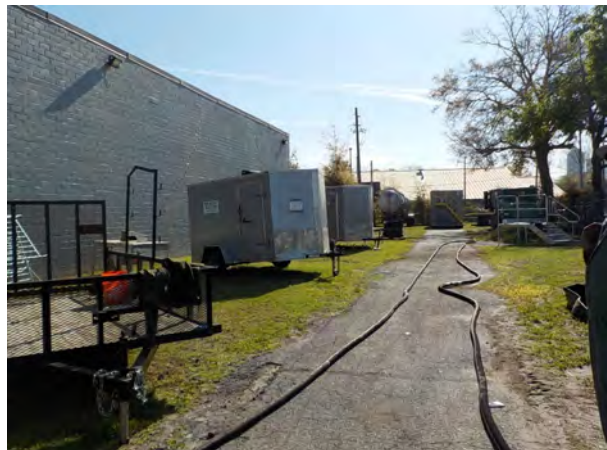
Photo 6

Immediately south of the second building and to the east of the vehicle parking area was a long, narrow section of the property that was partially grassed (Photo 6). The area is used to stage equipment, trailers, and hoses. The hoses are washed in a paved portion of the parking area adjacent to the second building using Zep Concentrate All-In-One Premium Pressure Wash (pH: 11.5-12.5) and Dawn Professional Dish Detergent. AMC uses detachable hoses to pump-out vessel bilges and tanks. The hoses are washed with Dawn or a 1:20

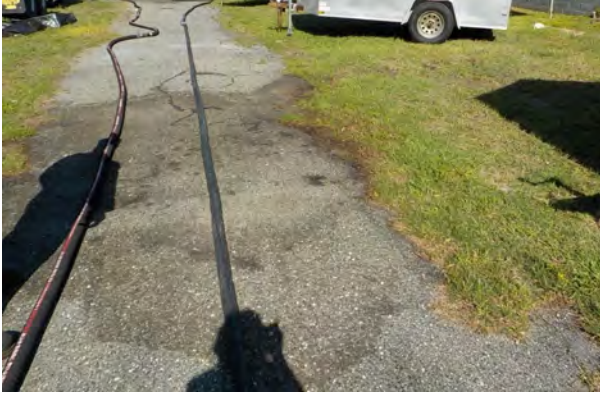
Photo 7

dilution of Zep and water and the washwater is discharged into a tote or tank. The washwater solution is circulated through the hoses until personnel determine they are clean. After washing, the hoses are drained into the tote or tank, and are then placed along the asphalt path to air-dry. In one area along the path, the asphalt was stained and the grass/dirt adjacent to the stained area was discolored (Photo 7) [40 CFR 279.22(d)].

Type: Violation 2  
Rule: 279.22(d)(3)  
Explanation: The facility failed to respond to and cleanup a release of used oil/oily water in the Outdoor Equipment Laydown Area.  
Corrective Action: No further action is required. The facility returned to compliance via an email on May 1, 2024.
