**Florida Department of  
Environmental Protection  
Hazardous Waste Inspection Report**

**Facility Name:** Alta Construction Equipment Florida LLC

**On-Site Inspection Start Date:** 03/21/2024

Routine Inspection for Used Oil Transporter Facility

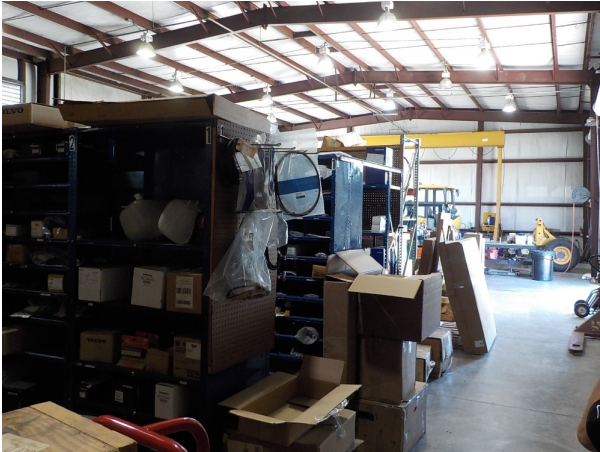
Photo 1

The western end of the main building is used for materials and supply storage (Photo 1). Maintenance on forklifts, vehicles, and various other heavy equipment is performed in one of the two bays adjacent to the Warehouse and located in the central portion of the main building. Used oil, used oil filters, oily rags and oily absorbent are generated in this area. Used oil is drained into drip pans or mobile carts located throughout the area. One drip pan that contained used oil was not properly labeled "Used Oil" (Photo 2) [40 CFR 279.22(c), 62-710.401(6), Florida Administrative Code (FAC)]. Used oil is pumped from the drip pans and mobile carts into a 250-gallon double-walled aboveground storage tank that is located on the other side of the Maintenance Bay wall in the Vehicle Wash Bay, described below. Used oil filters are drained on a rack located in the Maintenance Bay and the used oil is pumped to the storage tank. The filters are accumulated in a Used Oil Filter container located in the Vehicle Wash Bay. Oily absorbents and spill cleanup debris are accumulated in a 55-gallon drum located inside the maintenance area. If antifreeze has to be drained from a vehicle, the facility collects the antifreeze and re-uses it in the vehicle once maintenance is complete. If the antifreeze is not reusable, it is collected and disposed of by Safety-Kleen on an as-needed basis.

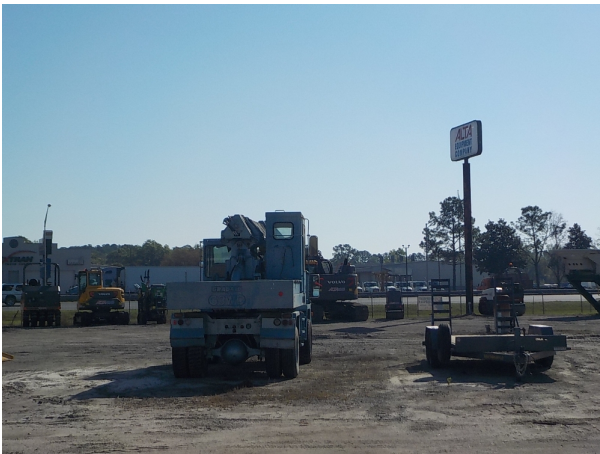
Photo 3

This yard is located east of the main building and is used as a laydown area for materials and to stage equipment for sale, lease and/or maintenance (Photo 3). Dumpsters for solid waste and scrap metal are also located in this area. No maintenance is performed in the yard. Scrap metal is recycled by Big Green Ball (aka The Recycling Center).
