**Florida Department of  
Environmental Protection  
Hazardous Waste Inspection Report**

**Facility Name:** Ranger Construction Industries Inc

**On-Site Inspection Start Date:** 07/17/2024

Routine Inspection for Used Oil Transporter Facility

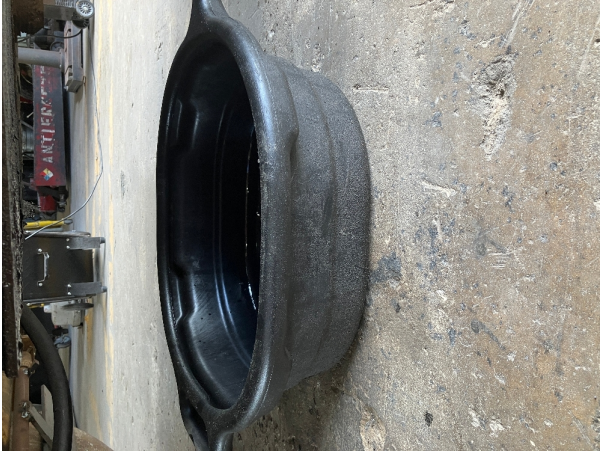
Inspectors also observed various small caddies with no label, one large caddy labeled "Used Antifreeze", and two medium caddies labeled "Used Oil" which are all used during oil changes. At the time of the inspection the large and medium caddies were half filled with used oil. The representative informed inspectors that used oil is stored in caddies until the end of the day before being pumped into used oil tanks. Compliance assistance was provided on-site and in the exit interview to provide photos of the large caddy and all the small caddies with the label "Used Oil" [40 CFR 279.22(c)(1)], additionally to provide photos of all caddies cleaned [40 CFR 279.22(d)(3)] and any storage of used oil in the future to be in a double-walled container or in a secondary containment on impervious floor [62-710.401(6) F.A.C.].

Type: Violation  
Rule: 279.22(c)(1)  
Question Number: 5.4  
Question: Are used oil containers/tanks labeled or marked clearly with the words "Used Oil"? 279.22(c)(1)  
Explanation: At the time of the inspection there was a large caddy and a bunch of smaller caddies that were not labeled "Used Oil".  
Corrective Action: Compliance assistance was provided on-site and in the exit interview to provide photos of all caddies labeled "Used Oil".

Unlabeled Small Used Oil Caddies

**Comments:**

On 08/07/2024, the corrective action was submitted.

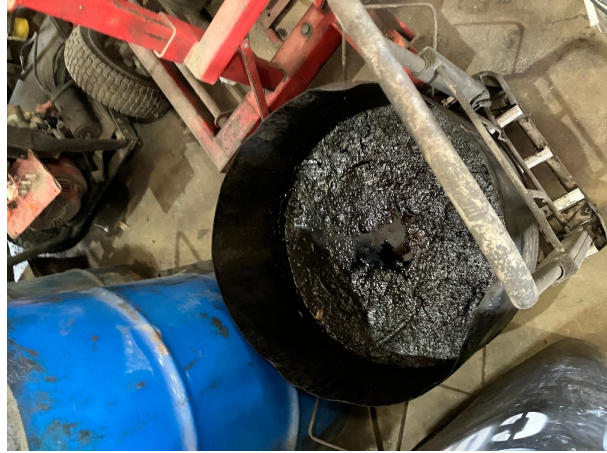
- One open 55-gallon drum cut in half filled with a dark sludge. Representative could not identify the sludge.
- One open 55-gallon drum of "Used Rags" which appeared to be free of liquid. Representative informed inspectors the rags were laundered by CrystalClean.

Unknown sludge

Compliance assistance was provided on-site and in the exit interview to provide a waste determination for sludge in drum, yellow translucent spill observed under 5-gallon buckets, and paint related materials [40 CFR 262.11], photo of used oil filter drum labeled with the words "Used Oil Filters" [62-710.850(5)(a) F.A.C.], inform inspectors if 5-gallon buckets were product or waste, photo of spill cleaned up [40 CFR 279.43(c)], disposal process for paint related materials and aerosol cans, records of recycling spent lead acid batteries for three years [40 CFR 261.6].

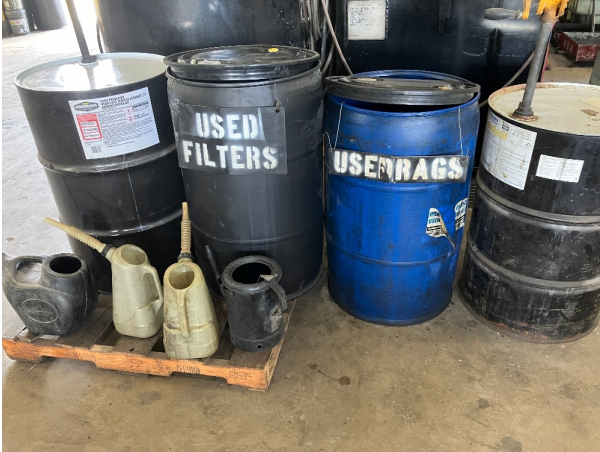
- One closed 55-gallon drum of "Used Filters". The container is used to store the facility's used oil filters.
- Various closed 5-gallon buckets. Representative could not inform the inspectors if the buckets contained product or waste and a small translucent yellow liquid was observed under buckets which could not be identified by the representative.

Type: Violation  
Rule: 62-710.850(5)(a)  
Question Number: 5.22  
Question: Are the used oil filter containers clearly labeled "Used Oil Filters"? 62-710.850(5)(a)  
Explanation: At the time of the inspection the facility had a 55-gallon drum of used oil filters which was labeled "Used Filters" and stored on permeable concrete.  
Corrective Action: Compliance assistance was provided on-site and in the exit interview to provide a photo of the container labeled "Used Oil Filters" and stored on an impermeable surface.

Used oil filters drum

On 08/07/2024, the representative submitted photo of used oil filter drum incorrectly labeled and on oil permeable surface.

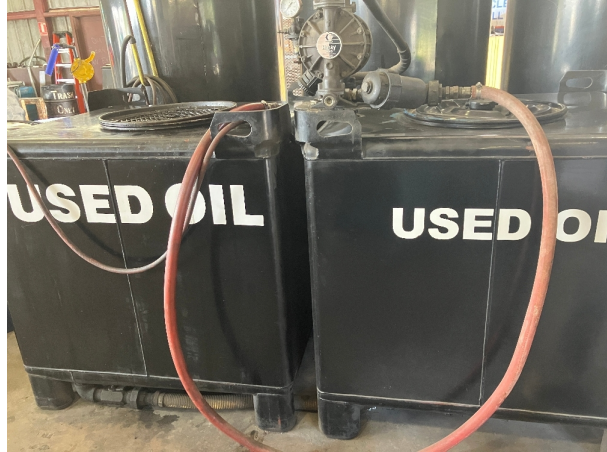
The warehouse contains two 570-gallon tanks of "Used Oil" next to four 500-gallon tanks of products. The product tanks held Motor Oil, Drive Train oil, Hydraulic oil, and one was empty. The following was observed /discussed with representative regarding the used oil tanks:

- Each tank had a metal grate on the top for used oil filters to sit and drain straight into the tank.
- Both tanks were labeled "Used Oil".
- Representative could not inform the inspectors if the tanks were double walled.
- Representative informed inspectors that the concrete floor had not be sealed to make it impermeable.

Used oil tanks

Compliance assistance was provided on-site and in the exit interview to provide documentation of the used oil tanks being doubled walled and if not to place them in a 110% capacity secondary containment and on oil impermeable floor [62-710.401(6) F.A.C.].

On 08/07/2024, the representative provided documentation confirmed the two 570-gallon tanks were double walled and no further actions are needed.
