**Florida Department of
Environmental Protection
Hazardous Waste Inspection Report**

Facility Name: Ranger Construction Industries Inc

On-Site Inspection Start Date: 07/17/2024

Routine Inspection for Used Oil Transporter Facility

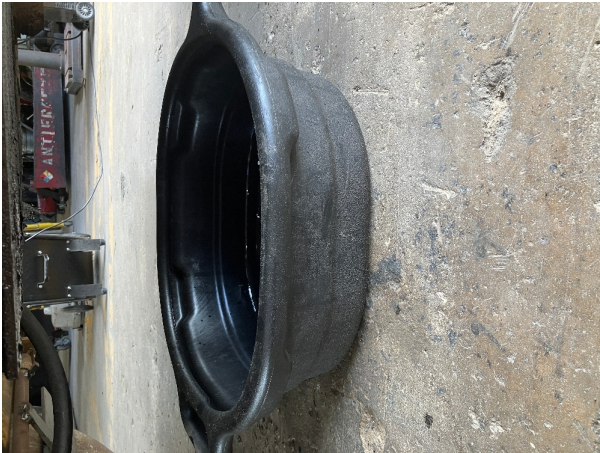
Inspectors also observed various small caddies with no label, one large caddie labeled "Used Antifreeze", and two medium caddies labeled "Used Oil" which are all used during oil changes. At the time of the inspection the large and medium caddies were half filled with used oil. The representative informed inspectors that used oil is stored in caddies until the end of the day before being pumped into used oil tanks. Compliance assistance was provided on-site and in the exit interview to provide photos of the large caddie and all the small caddies with the label "Used Oil" [40 CFR 279.22(c)(1)], additionally to provide photos of all caddies cleaned [40 CFR 279.22(d)(3)] and any storage of used oil in the future to be in a double-walled container or in a secondary containment on impervious floor [62-710.401(6) F.A.C.].

Type: Violation
Rule: 279.22(c)(1)
Question Number: 5.4
Question: Are used oil containers/tanks labeled or marked clearly with the words "Used Oil"? 279.22(c)(1)
Explanation: At the time of the inspection there was a large caddy and a bunch of smaller caddies that were not labeled "Used Oil".
Corrective Action: Compliance assistance was provided on-site and in the exit interview to provide photos of all caddies labeled "Used Oil".

Unlabeled Small Used Oil Caddies

On 08/07/2024, the corrective action was submitted.

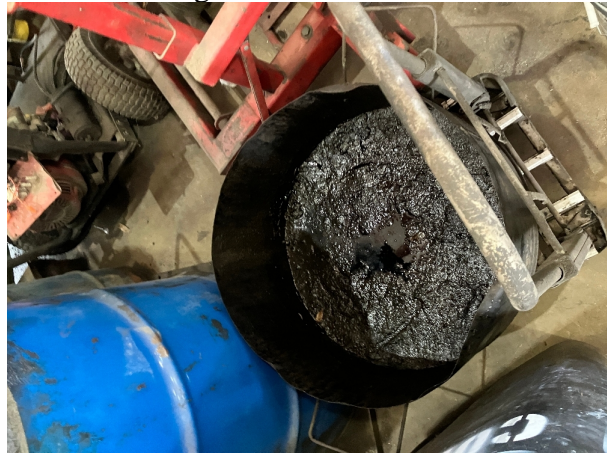
- One open 55-gallon drum cut in half filled with a dark sludge. Representative could not identify the sludge.
- One open 55-gallon drum of "Used Rags" which appeared to be free of liquid. Representative informed inspectors the rags were laundered by CrystalClean.

Unknown sludge

Compliance assistance was provided on-site and in the exit interview to provide a waste determination for sludge in drum, yellow translucent spill observed under 5-gallon buckets, and paint related materials [40 CFR 262.11], photo of used oil filter drum labeled with the words "Used Oil Filters" [62-710.850(5)(a) F.A.C.], inform inspectors if 5-gallon buckets were product or waste, photo of spill cleaned up [40 CFR 279.43(c)], disposal process for paint related materials and aerosol cans, records of recycling spent lead acid batteries for three years [40 CFR 261.6].

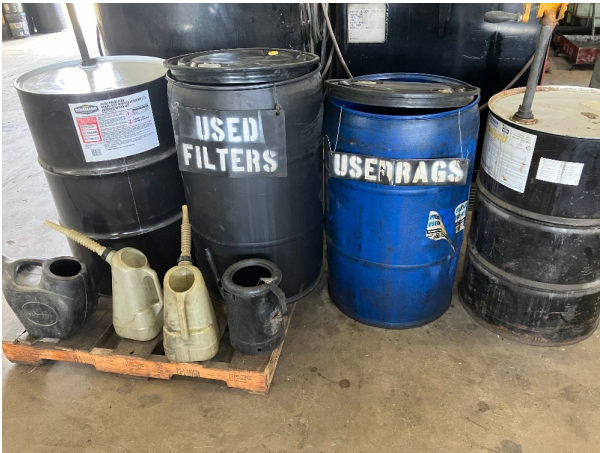
- One closed 55-gallon drum of "Used Filters". The container is used to store the facility's used oil filters.
- Various closed 5-gallon buckets. Representative could not inform the inspectors if the buckets contained product or waste and a small translucent yellow liquid was observed under buckets which could not be identified by the representative.

Type: Violation
Rule: 62-710.850(5)(a)
Question Number: 5.22
Question: Are the used oil filter containers clearly labeled "Used Oil Filters"? 62-710.850(5)(a)
Explanation: At the time of the inspection the facility had a 55-gallon drum of used oil filters which was labeled "Used Filters" and stored on permeable concrete.
Corrective Action: Compliance assistance was provided on-site and in the exit interview to provide a photo of the container labeled "Used Oil Filters" and stored on an impermeable surface.

Used oil filters drum

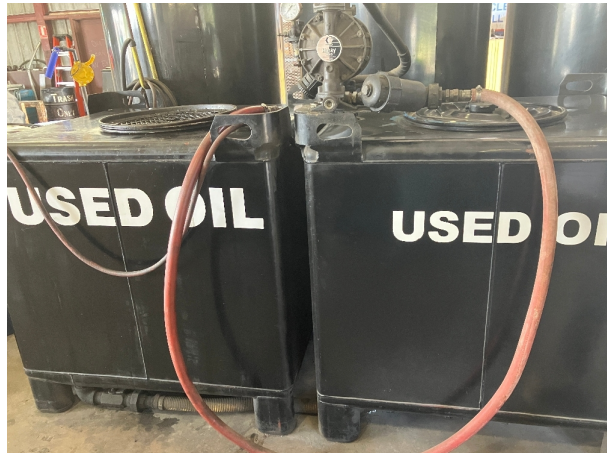
The warehouse contains two 570-gallon tanks of "Used Oil" next to four 500-gallon tanks of products. The product tanks held Motor Oil, Drive Train oil, Hydraulic oil, and one was empty. The following was observed /discussed with representative regarding the used oil tanks:

- Each tank had a metal grate on the top for used oil filters to sit and drain straight into the tank.
- Both tanks were labeled "Used Oil".
- Representative could not inform the inspectors if the tanks were double walled.
- Representative informed inspectors that the concrete floor had not be sealed to make it impermeable.

Used oil tanks

Compliance assistance was provided on-site and in the exit interview to provide documentation of the used oil tanks being doubled walled and if not to place them in a 110% capacity secondary containment and on oil impermeable floor [62-710.401(6) F.A.C.].

On 08/07/2024, the representative provided documentation confirmed the two 570-gallon tanks were double walled and no further actions are needed.
