Re: In Compliance Letter
Mobile Impact Services LLC
407 W Lake Dr, Sarasota, FL 34232
Facility ID No. FLR000203158
Sarasota County - HW

**Florida Department of
Environmental Protection
Hazardous Waste Inspection Report**

Facility Name: Mobile Impact Services LLC

Routine Inspection for Used Oil Transporter Facility

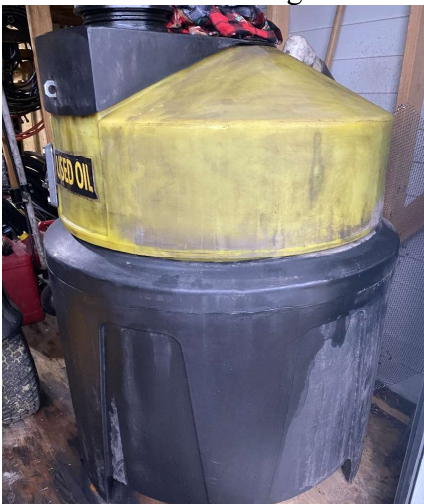
Photo 1 Used oil storage

placed directly into a 150-gallon double-walled above ground storage tank maintained in the shed (photo 1). The tank was properly labeled "used oil." A container of absorbent material and absorbent pads are maintained inside the shed to respond to spills (photo 2).

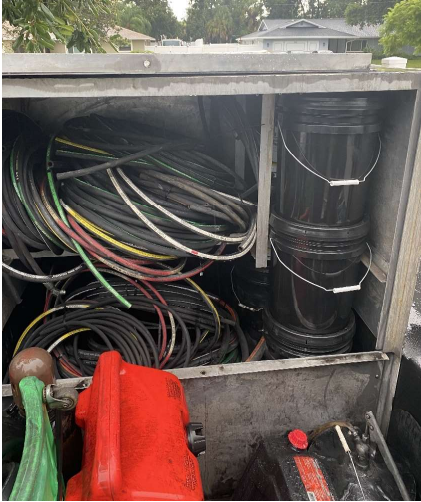
Photo 3 Used oil storage on truck

Large hydraulic lifts are serviced in the field. Used hydraulic oil is drained, collected in closed/labeled 5-gallon plastic containers and transported back to the facility. Containers holding used oil are stored inside a metal "job box" inside the bed of the truck, capable of containing releases (photo 3). A log is maintained reflecting the facility always transports less than 55-gallons of used oil at one time; and less than 500-gallons of used oil annually over public highways and is therefore not subject to the Certification Program under Rule 62-710.600, F.A.C.
