TRAIL RIDGE LANDFILL, INC.

Re: Trail Ridge Landfill Storm Event Erosion Notice

Per the telephone and email notification that was sent to you on January 26th, this letter is to inform you that Trail Ridge Landfill experienced erosions due to a 3.02-inch storm event that occurred on January 25, 2011. The event caused erosions and other minor issues as listed below. The following is a detailed description of the damage, as well as the repair schedule as required per the facility's permit.

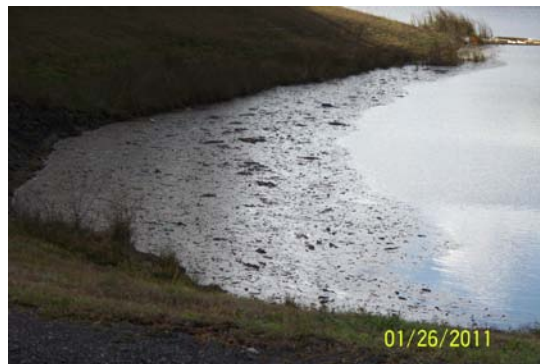
A minimal amount of sediment was transported to the pond via the stormwater conveyance system located to the south of the pond. The stormwater conveyance system and sediment was free of any refuse or debris. In addition to the sediment, a small amount of litter, mostly blown, was also found in the pond. The pond did discharge, and samples were taken per a prior request made by the Florida Department of Environmental Protection. The pictures provided below, as well as the one provided in the January 26th email, illustrate the extent of the items discussed above:

(Northern Section of SW Pond 2 With Minor Debris)

The cleanup of Stormwater Pond 2 began immediately following the storm event. The debris was removed from the northern portion of the pond. In addition, the stormwater conveyance systems were inspected to ensure that no additional debris was present. The pictures provided below illustrate the cleanup efforts.

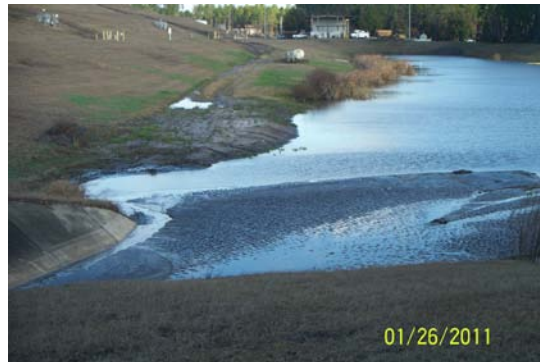
(Southern Section of SW Pond 2 With Deposited Sediment)

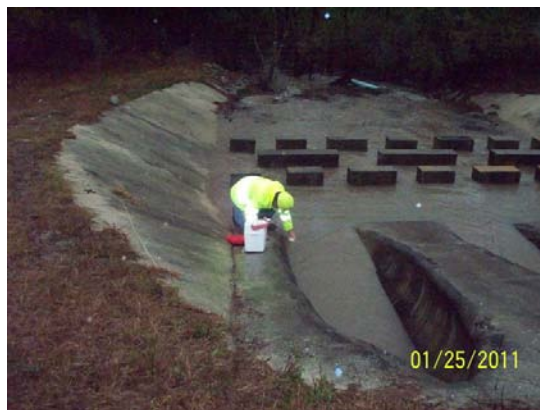
(Discharge Sampling at SW Pond 2)

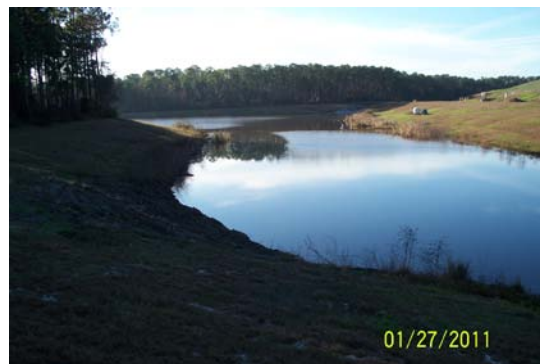
(Northern Section of SW Pond 2 With Debris Removed)

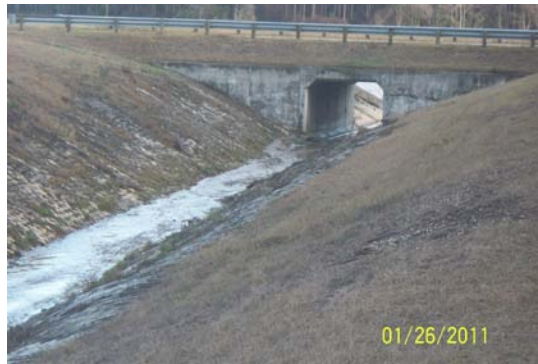
(Stormwater Conveyance System Located on Southern Section of SW Pond 2)

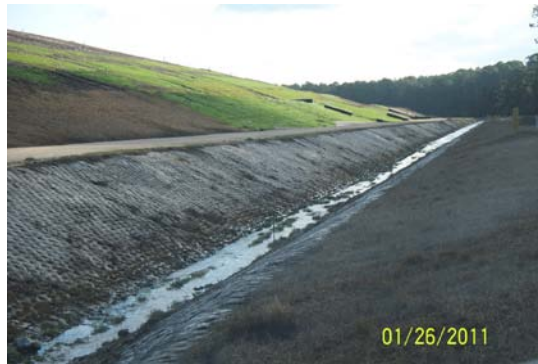
(Stormwater Conveyance System Located on Southern Perimeter of Landfill)

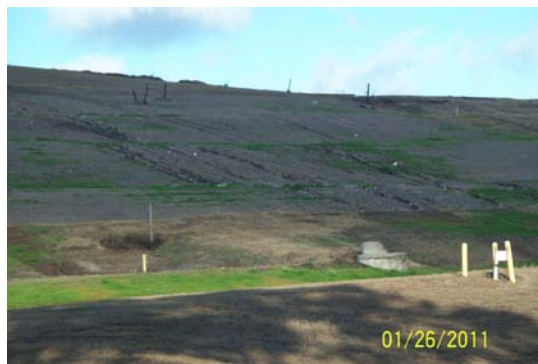
The storm event caused erosions along the uncapped portions of the landfill, specifically on the western, southern and eastern slopes. The erosions transported sediment into the stormwater collection system and structures located on the landfill. The following pictures further demonstrate the storm related issues.

(Erosions Along Eastern Slope of Landfill)

The cleanup of landfill slopes began immediately following the storm event. Additional equipment and labor have been obtained to facilitate the prompt repair of the affected areas. The initial focus has been with the immediate covering of any exposed refuse and removal of sediment from the stormwater collection system. In addition, the installation of additional stormwater collection piping, re-grading of the affected terraces and hand collection of any blown/exposed litter. A major seeding event has also been scheduled for upcoming month. The pictures below illustrate the early efforts that are currently underway.

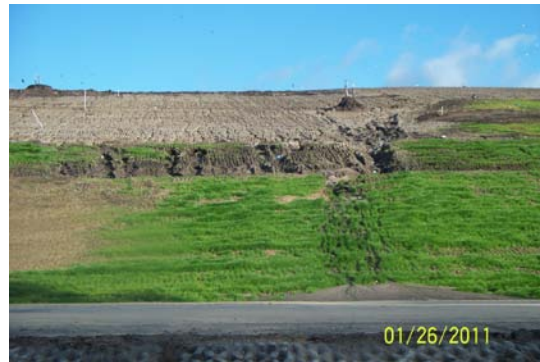
(Erosions Along Southern Slope of Landfill)

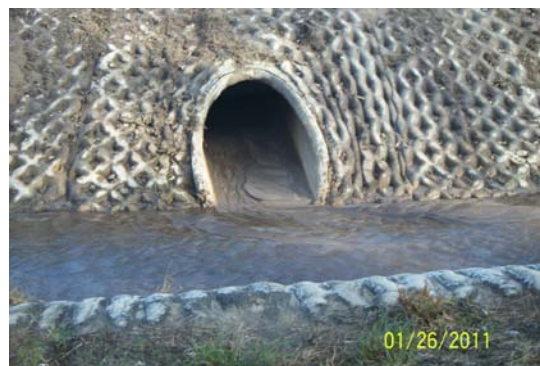
(Sediment in Stormwater Pipe Along Southern Slope)

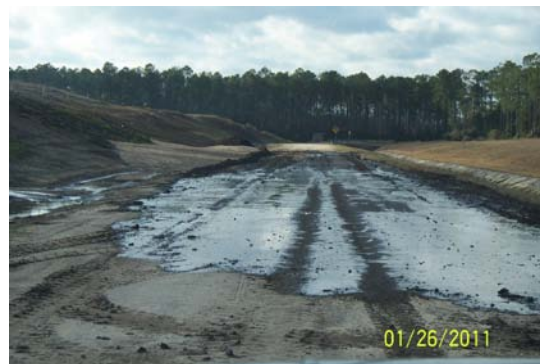
(Erosions Along Western Slope of Landfill)

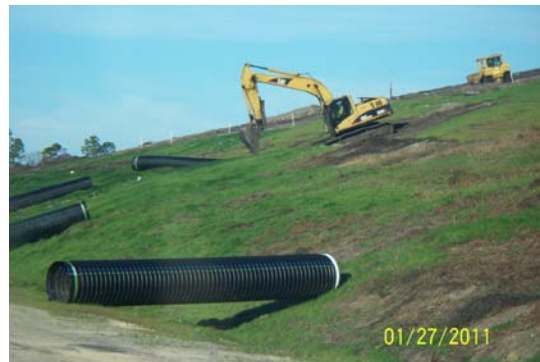
(Sediment Removal & Pipe Installation Along Southern Slope)

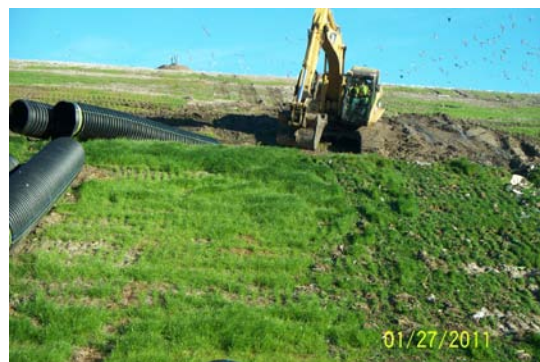
(Sediment Removal & Pipe Installation Along Southern Slope)
