TRAIL RIDGE LANDFILL, INC.

January 28, 2011

Re: Trail Ridge Landfill Storm Event Erosion Notice

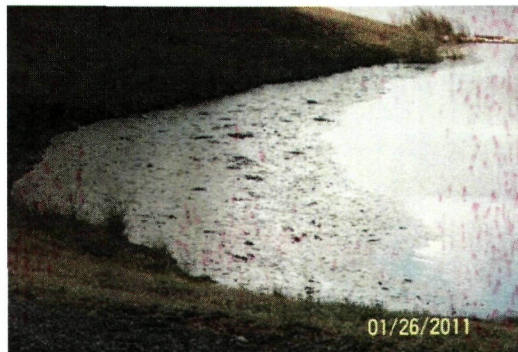
A minimal amount of sediment was transported to the pond via the stormwater conveyance system located to the south of the pond. The stormwater conveyance system and sediment was free of any refuse or debris. In addition to the sediment, a small amount of litter, mostly blown, was also found in the pond. The pond did discharge, and samples were taken per a prior request made by the Florida Department of Environmental Protection. The pictures provided below, as well as the one provided in the January 26th email, illustrate the extent of the items discussed above:

(Northern Section of SW Pond 2 With Minor Debris)

The cleanup of Stormwater Pond 2 began immediately following the storm event. The debris was removed from the northern portion of the pond. In addition, the stormwater conveyance systems were inspected to ensure that no additional debris was present. The pictures provided below illustrate the cleanup efforts.

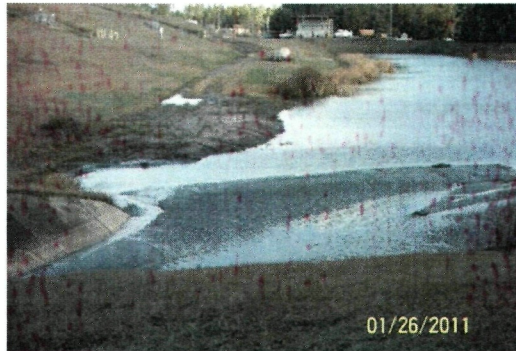
(Southern Section of SW Pond 2 With Deposited Sediment)

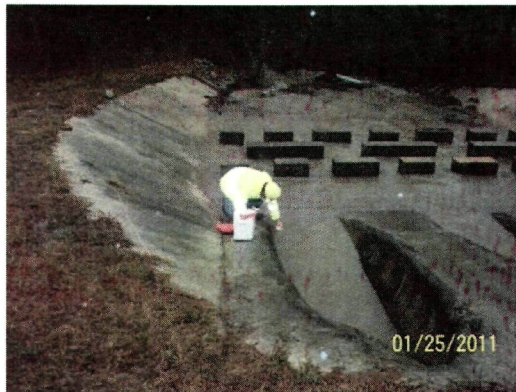
(Discharge Sampling at SW Pond 2)

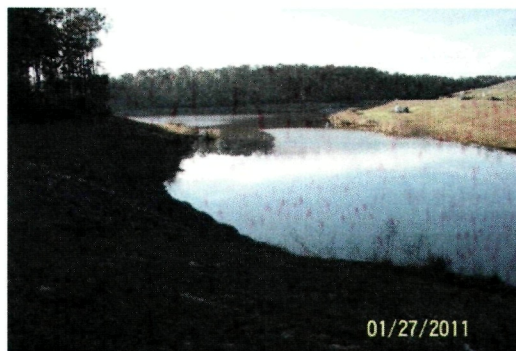
(Northern Section of SW Pond 2 With Debris Removed)

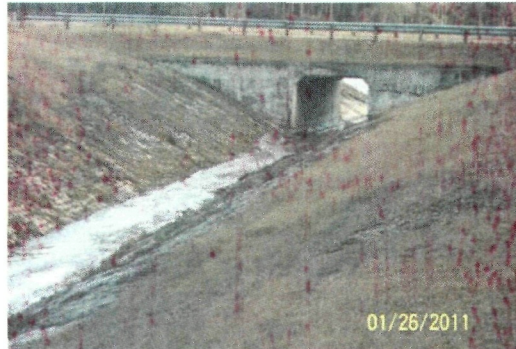
(Stormwater Conveyance System Located on Southern Section of SW Pond 2)

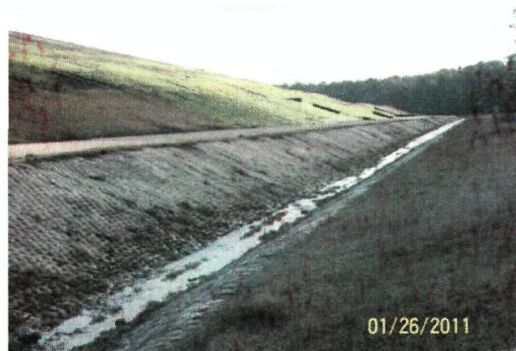
(Stormwater Conveyance System Located on Southern Perimeter of Landfill)

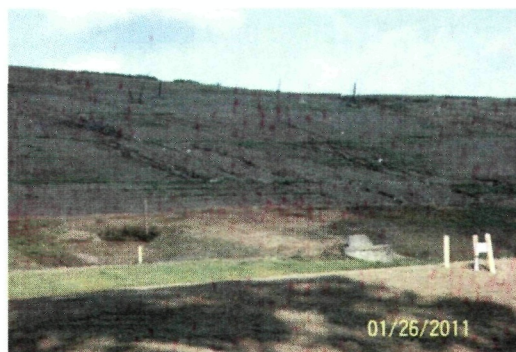
The storm event caused erosions along the uncapped portions of the landfill, specifically on the western, southern and eastern slopes. The erosions transported sediment into the stormwater collection system and structures located on the landfill. The following pictures further demonstrate the storm related issues.

(Erosions Along Eastern Slope of Landfill)

The cleanup of landfill slopes began immediately following the storm event. Additional equipment and labor have been obtained to facilitate the prompt repair of the affected areas. The initial focus has been with the immediate covering of any exposed refuse and removal of sediment from the stormwater collection system. In addition, the installation of additional stormwater collection piping, re-grading of the affected terraces and hand collection of any blown/exposed litter. A major seeding event has also been scheduled for upcoming month. The pictures below illustrate the early efforts that are currently underway.

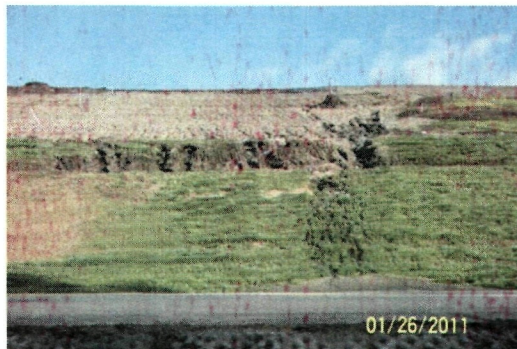
(Erosions Along Southern Slope of Landfill)

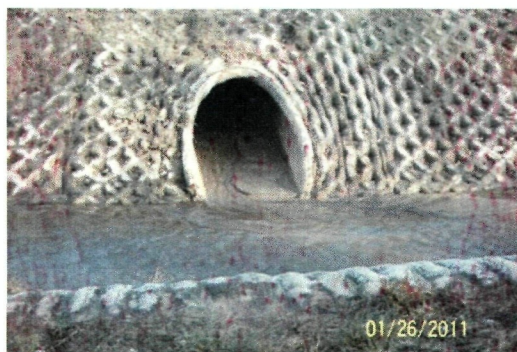
(Sediment in Stormwater Pipe Along Southern Slope)

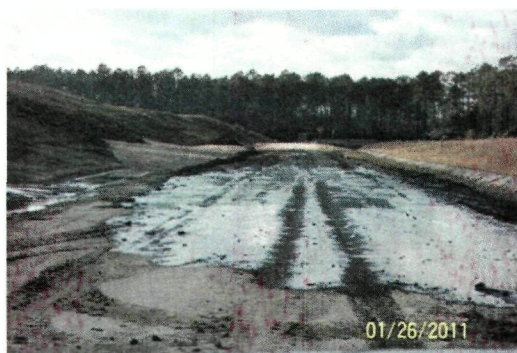
(Erosions Along Western Slope of Landfill)

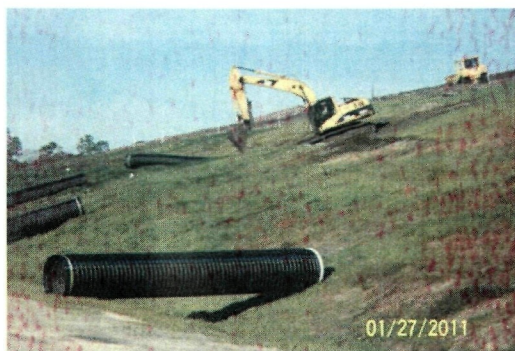
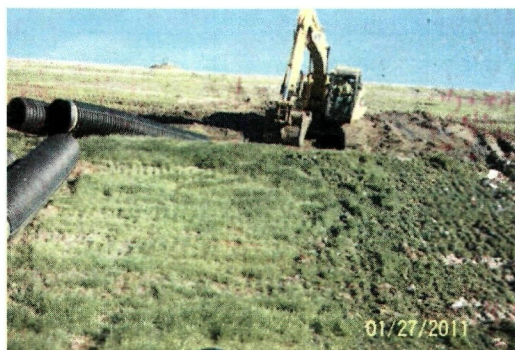
(Sediment Removal & Pipe Installation Along Southern Slope)

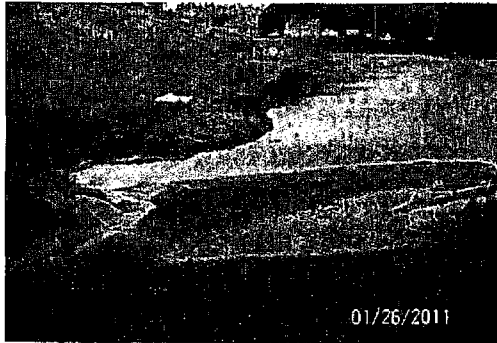
A minimal amount of sediment was transported to the pond via the stormwater conveyance system located to the south of the pond. The stormwater conveyance system and sediment was free of any refuse or debris. In addition to the sediment, a small amount of litter, mostly blown, was also found in the pond. The pond did discharge, and samples were taken per a prior request made by the Florida Department of Environmental Protection. The pictures provided below, as well as the one provided in the January 26th email, illustrate the extent of the items discussed above:

(Southern Section of SW Pond 2 With Deposited Sediment)

The cleanup of Stormwater Pond 2 began immediately following the storm event. The debris was removed from the northern portion of the pond. In addition, the stormwater conveyance systems were inspected to ensure that no additional debris was present. The pictures provided below illustrate the cleanup efforts.

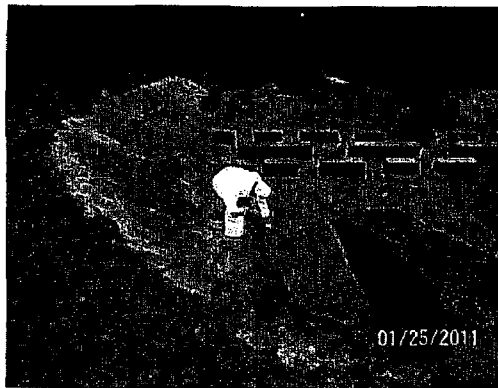
(Discharge Sampling at SW Pond 2)

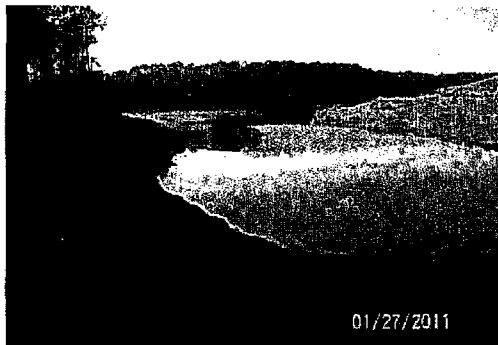
(Northern Section of SW Pond 2 With Debris Removed)

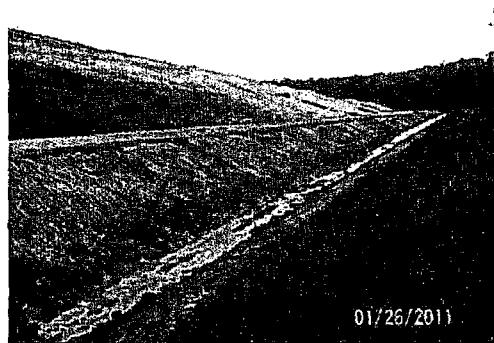
(Stormwater Conveyance System Located on Southern Perimeter of Landfill)

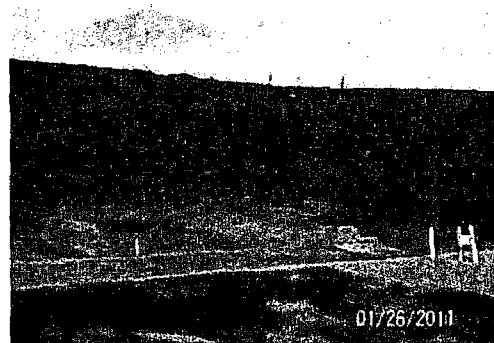
The storm event caused erosions along the uncapped portions of the landfill, specifically on the western, southern and eastern slopes. The erosions transported sediment into the stormwater collection system and structures located on the landfill. The following pictures further demonstrate the storm related issues.

(Erosions Along Eastern Slope of Landfill)

The cleanup of landfill slopes began immediately following the storm event. Additional equipment and labor have been obtained to facilitate the prompt repair of the affected areas. The initial focus has been with the immediate covering of any exposed refuse and removal of sediment from the stormwater collection system. In addition, the installation of additional stormwater collection piping, re-grading of the affected terraces and hand collection of any blown/exposed litter. A major seeding event has also been scheduled for upcoming month. The pictures below illustrate the early efforts that are currently underway.

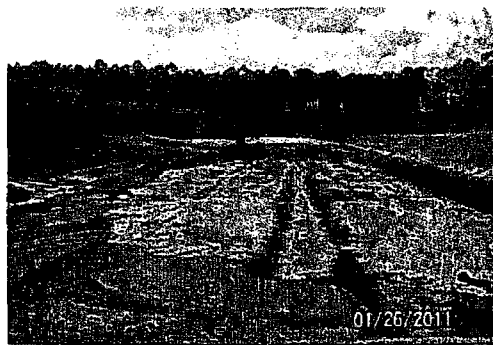
(Erosions Along Western Slope of Landfill)

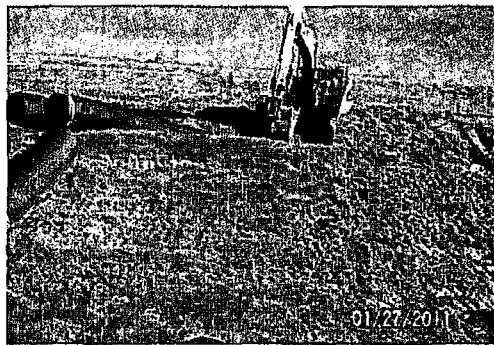
(Sediment Removal & Pipe Installation Along Southern Slope)
