Re: Citrus County Central Landfill – Permit No. 21375-018-SO/01
Landfill Gas Monitoring

Subject: Landfill Gas Monitoring Report, First Quarter 2012
Central Landfill, Citrus County, Florida

Figure 1. Landfill Gas Monitoring Probe Locations, Central Landfill, Citrus County, Florida

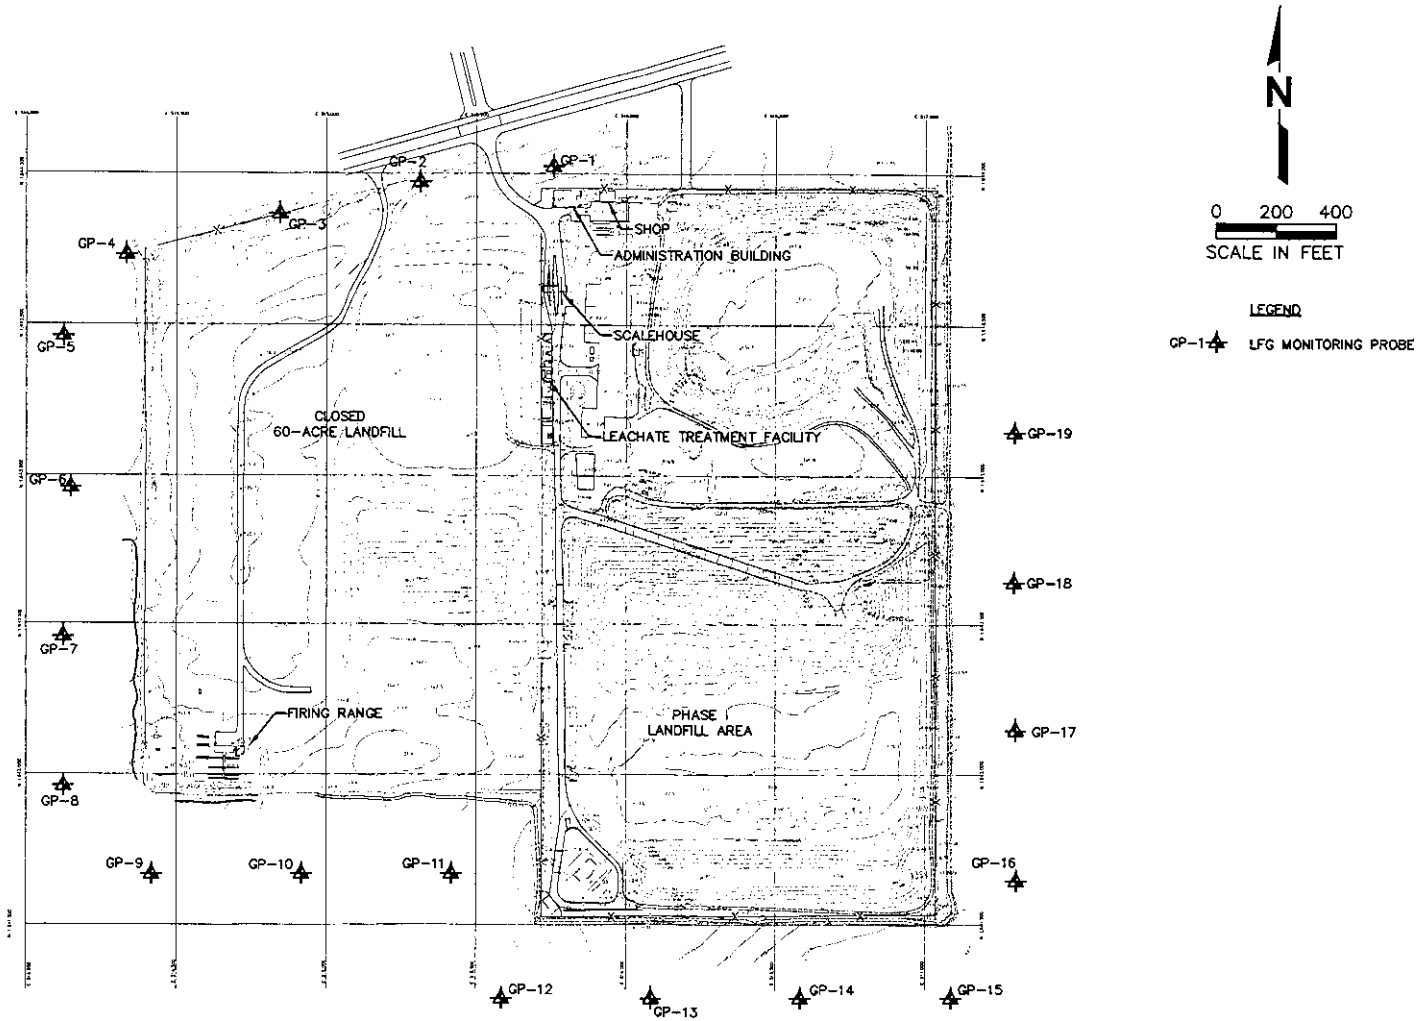
In April 2007, the Florida Department of Environmental Protection (FDEP) approved extending the compliance boundary for LFG migration monitoring at the site to coincide with the boundaries of the 2006 lease agreement between Citrus County and the Florida Division of Forestry. As a result, 18 LFG monitoring probes installed along the new property boundary were to serve as the compliance points for migration monitoring. The remaining 62 permanent LFG probes and 12 interim probes have been abandoned in place and are no longer monitored on a quarterly basis. In November 2010, as part of the Phase III cell expansion, GP-19 was installed. Figure 1 in Attachment 1 includes a site map that shows all LFG monitoring probe locations.

Table 1 of Attachment 2 shows the readings obtained from the 19 probes along the property boundary. Methane was not detected in any of the monitoring probes. A site plan showing the probe locations is included in Attachment 1.

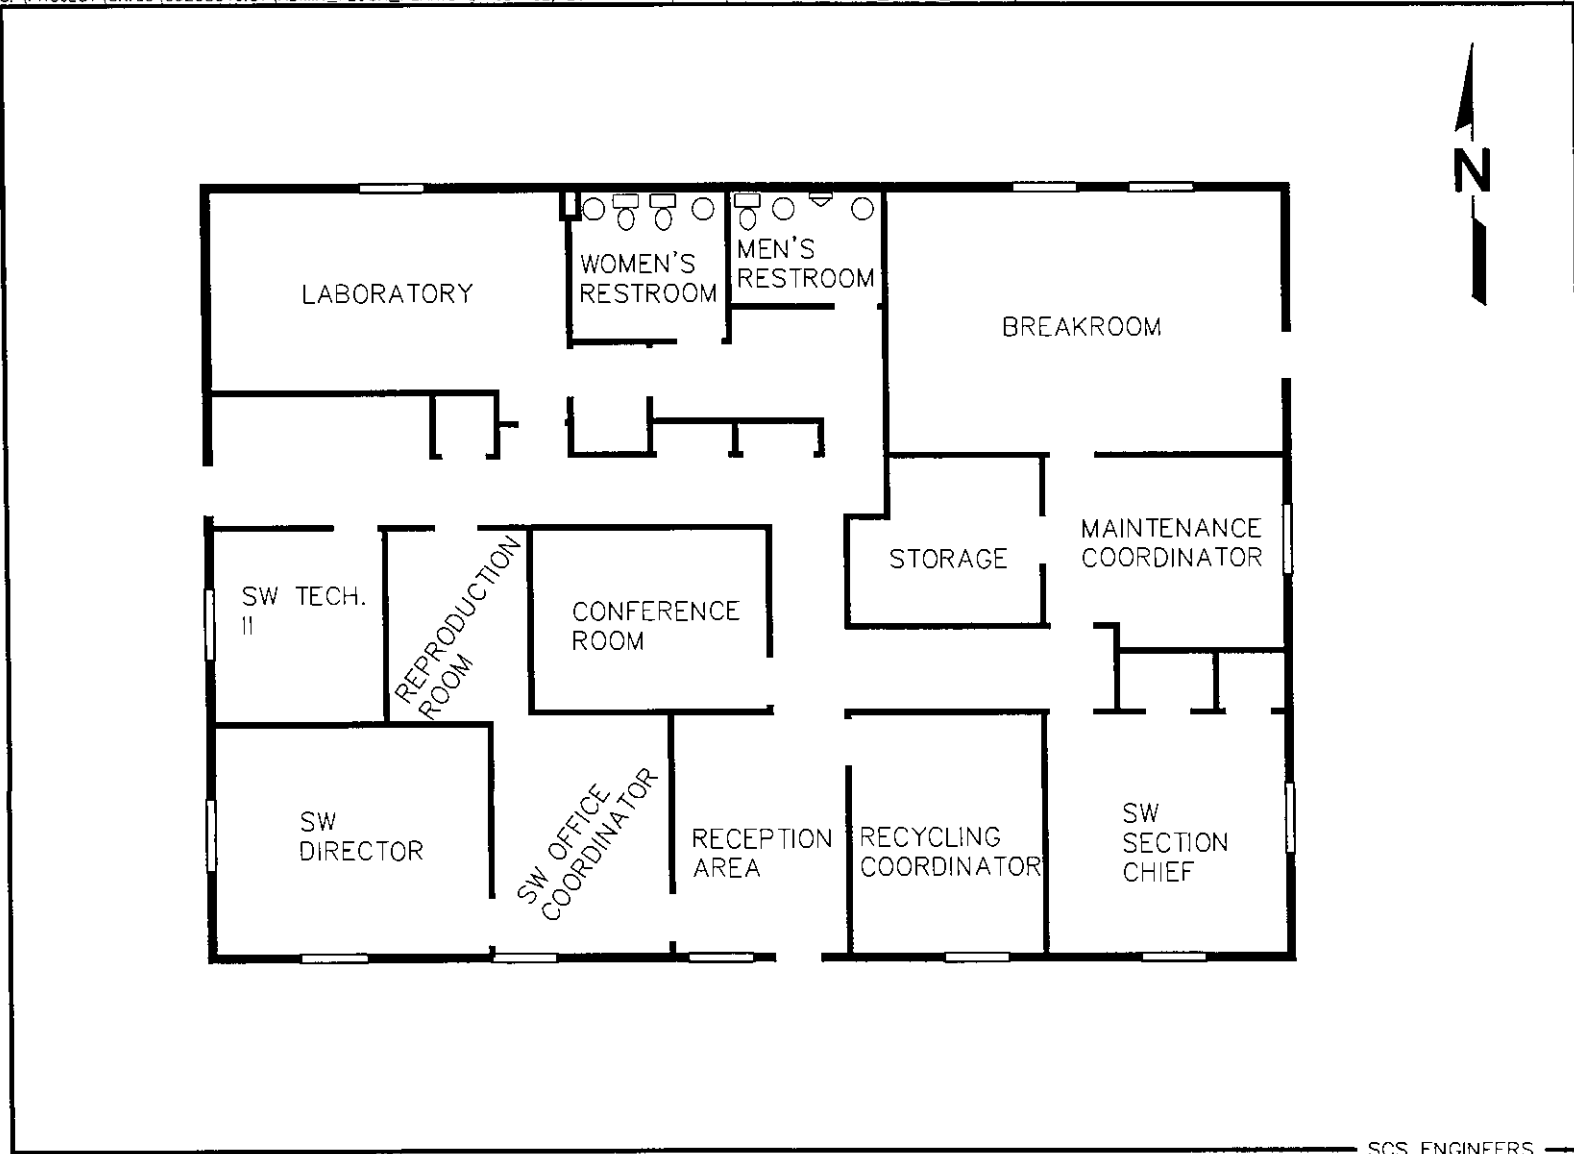
Figure 2. Administration Building Floor Plan

No methane was detected in the scalehouse, administration building, shop, leachate treatment facility, or firing range as shown in Table 1 of Attachment 2. Floor plans of the scale house and the administration building are included in Attachment 1.

SCS monitored in the restrooms of the administration building, as well as in select closets, the break room, conference room, and hallways. In the scalehouse, SCS monitored the main work area, cabinets, the restroom, and at electrical outlets. Monitoring of the leachate treatment facility included around the base of structures, at the control panel, and inside the electrical room.
