Florida Department of
Environmental Protection
Inspection Checklist

Facility Name: PASCO COUNTY RESOURCE RECOVERY

Routine Operation Inspection for Landfill - Class I facility

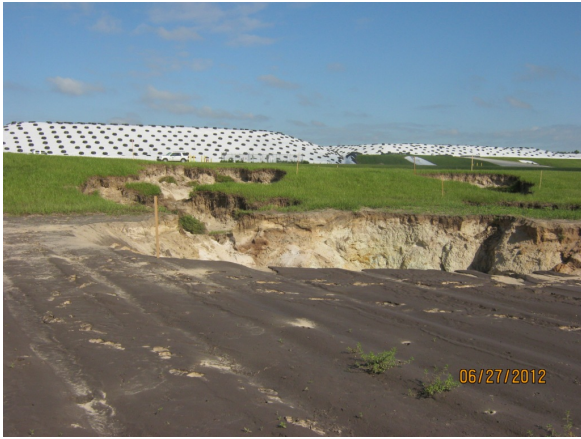
SW pond, E A-3

The purpose of this inspection was to observe site conditions after Tropical Storm(TS) Debby (June 23-26, 2012). The Department received notification on June 26, 2012 from Mr. John Power, Solid Waste Manager for Pasco County, that as a result of heavy rainfall, numerous sinkholes had opened in the stormwater pond east of A-3. The features observed (~18) by Department staff during the June 27, 2012 inspection appeared to range in size from ~1' to ~50' in diameter, with depths ranging from ~1' to ~20'.

The County submitted a plan for initial investigation of the features on June 29, 2012. The Department approved this plan via email on July 2, 2012. A subsequent, detailed plan for investigation and corrective actions will be submitted to the Department for review by August 1, 2012.
