Volusia County – SW WACS # 100465
Consolidated Tire – Waste Tire Processing Facility
Permit # WT64-0310464-001
Inspection Report Transmittal

Florida Department of
Environmental Protection
Inspection Checklist

Routine Operation Inspection for Waste Processing - Tire Processing Facility

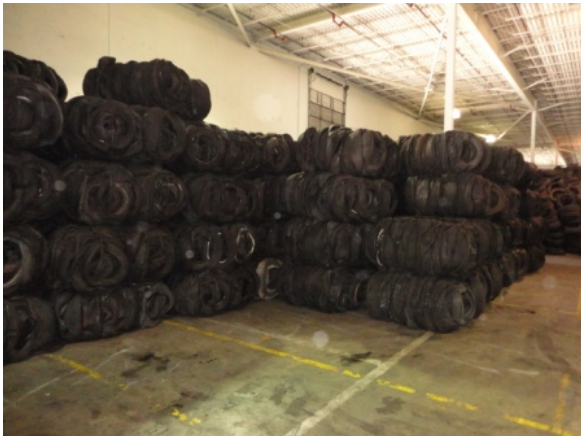
Baled Tires

During the previous inspection, the facility was storing approximately 15,000 total tires. The current amount of total tires was significantly less. Dennis Mulberger estimates there are currently between 5000-6000 whole tires and 2400 baled tires. There were approximately 300 tires set aside for resale. He said the facility is reducing the amount of tires it takes in by half while the facility bales the stored tires and finds new shipping destinations. Dennis stated that the facility will soon be in compliance with Specific condition # 12, DEP Permit #WT64-0310464-001 and will have less than 7,000 total tires stored on-site.

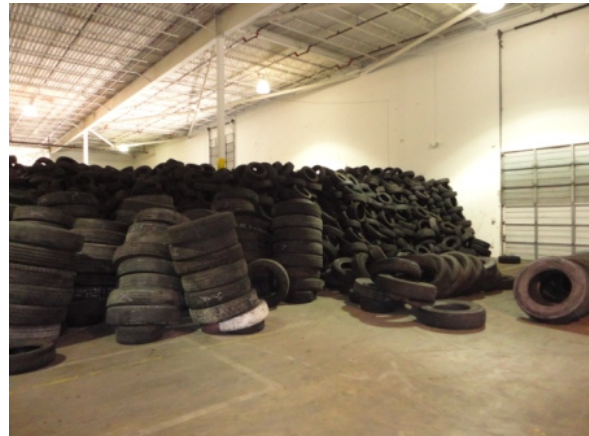
Waste Tire Storage

Explanation: The main storage pile did not have an aisle 25 feet from the outer wall.

There was no aisle 25 feet from the outside wall of the main storage pile. Dennis Mulberger said that the aisle caved in. He said that this will no longer be an issue once the size of the tire pile is reduced. He said the facility is on track to reduce the pile with the new baler in operation.

Corrective Action: An 8 foot aisle must be established within 25 from the outer wall or the size of the tire pile must be reduced to no more than 25 feet from the outer wall.

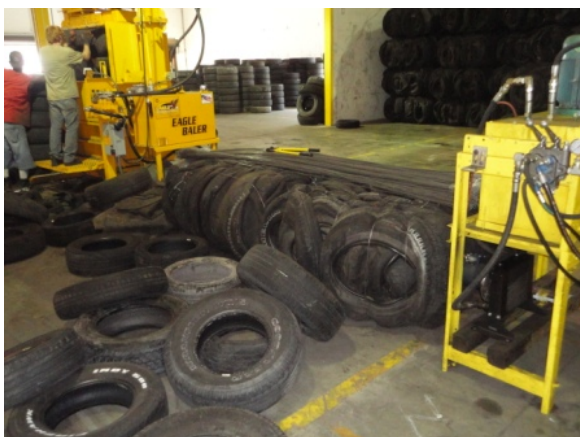
New Baling Machine

A new tire baler is now in operation. Dennis Mulberger said it is approximately 3 times more efficient and is able to bale tires at a much faster rate. Dennis said the facility is actively working towards baling the remaining waste tires stored on-site and shipping them out. He believes the facility is close to its goal of minimal tire storage and being able to bale the tires as they arrive.
