**Re: Citrus County Central Landfill – Permit No. 21375-008-SO/01  
Landfill Gas Monitoring**

August 13, 2010  
File No. 09208040.05

Subject: Landfill Gas Monitoring Report, Third Quarter 2010  
Central Landfill, Citrus County, Florida

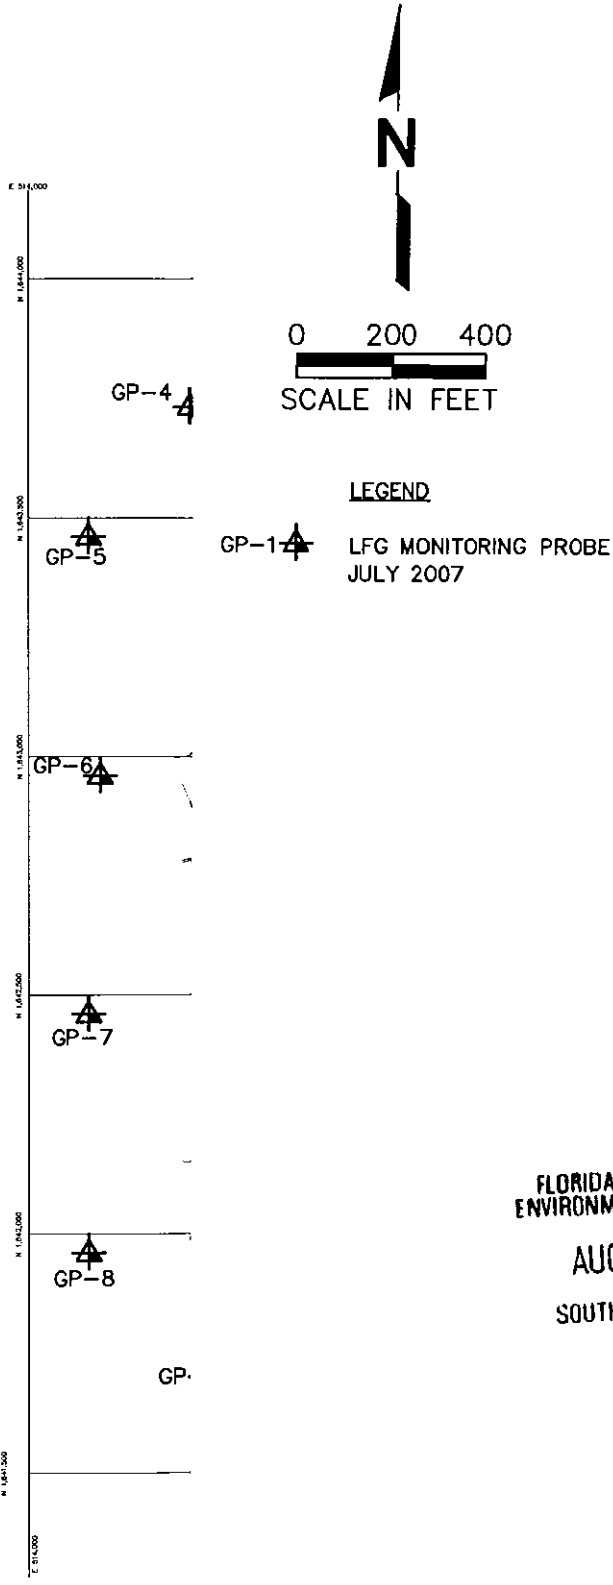
In April 2007, the Florida Department of Environmental Protection (FDEP) approved extending the compliance boundary for LFG migration monitoring at the site to coincide with the boundaries of the 2006 lease agreement between Citrus County and the Florida Division of Forestry. As a result, the 18 LFG monitoring probes installed along the new property boundary now serve as the compliance points for migration monitoring. The remaining 62 permanent LFG probes and 12 interim probes have been abandoned in place and are no longer monitored on a quarterly basis. Figure 1 in Attachment 1 includes a site map that shows the LFG monitoring probe locations.

Table 1 of Attachment 2 shows the readings obtained from the 18 probes along the property boundary. Methane was not detected in any of the monitoring probes. A site plan showing the probe locations is included in Attachment 1.

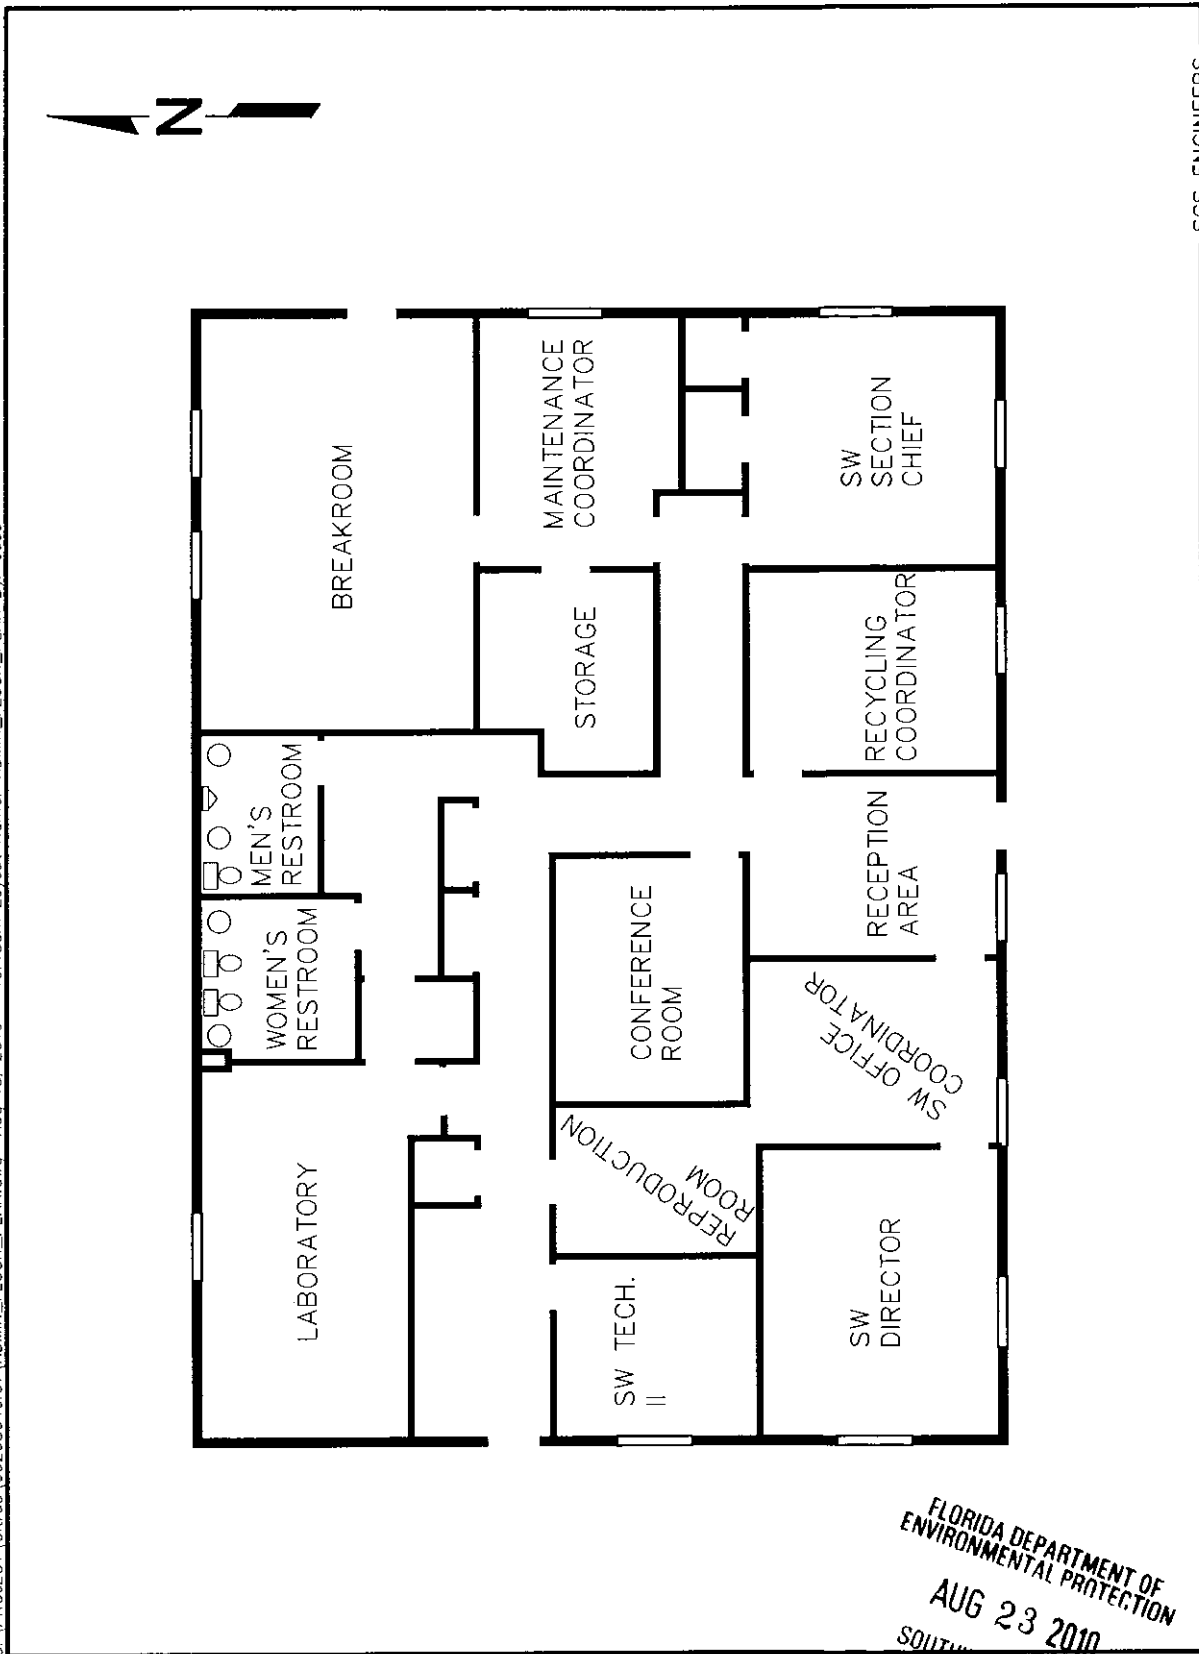
Figure 2. Administration Building Floor Plan

No methane was detected in the scalehouse, administration building, shop, leachate treatment facility, or firing range as shown in Table 1 of Attachment 2. Floor plans of the scale house and the administration building are included in Attachment 1.

SCS monitored in the restrooms of the administration building, as well as in select closets, the break room, conference room, and hallways. In the scalehouse, SCS monitored the main work area, cabinets, the restroom, and at electrical outlets. Monitoring of the leachate treatment facility included around the base of structures, at the control panel, and inside the electrical room.
