**Re: Citrus County Central Landfill – Permit No. 21375-018-SO/01
Landfill Gas Monitoring (Electronically Submitted)**

Subject: Landfill Gas Monitoring Report, Third Quarter 2015
Central Landfill, Citrus County, Florida

ATTACHMENT 1
MONITORING LOCATIONS

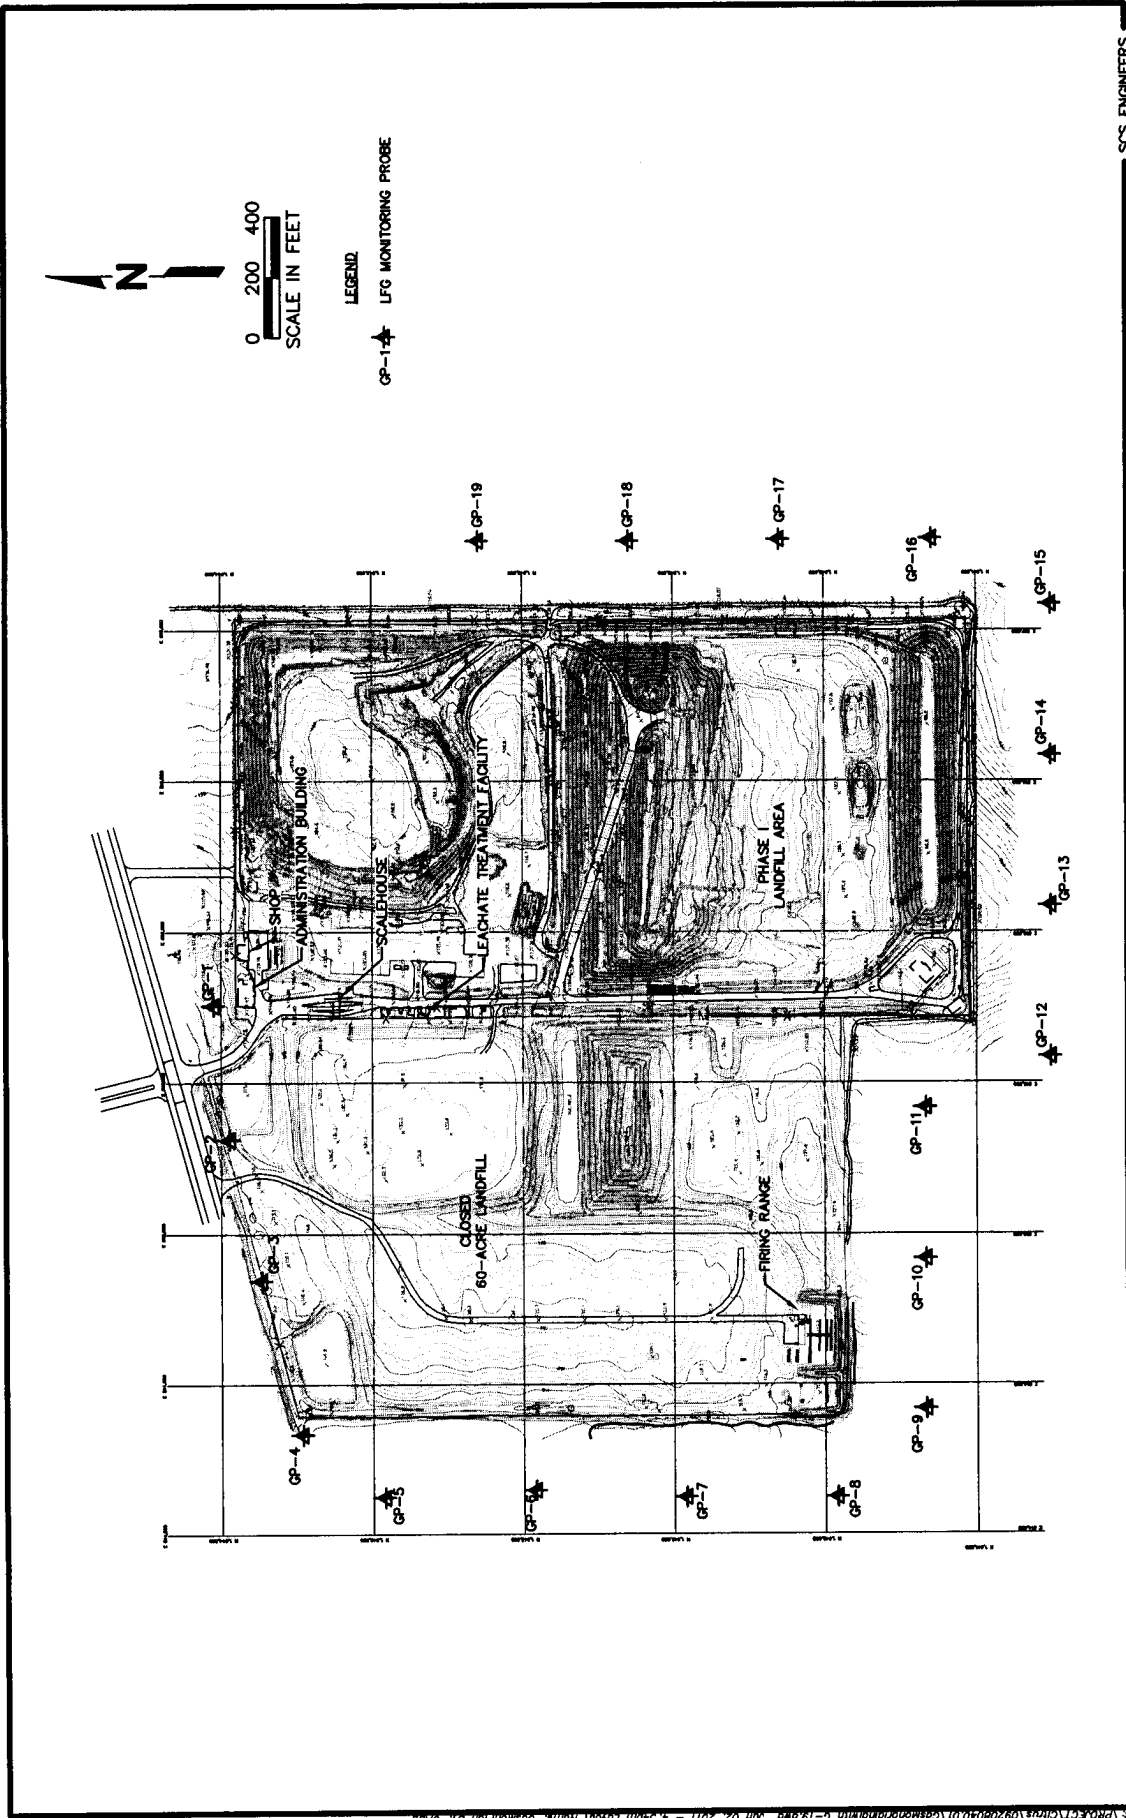
Figure 1. Landfill Gas Monitoring Probe Locations, Central Landfill, Citrus County, Florida

In April 2007, the Florida Department of Environmental Protection (FDEP) approved extending the compliance boundary for LFG migration monitoring at the site to coincide with the boundaries of the 2006 lease agreement between Citrus County and the Florida Division of Forestry. As a result, 18 LFG monitoring probes installed along the new property boundary were to serve as the compliance points for migration monitoring. The remaining 62 permanent LFG probes and 12 interim probes have been abandoned in place and are no longer monitored on a quarterly basis. In November 2010, as part of the Phase III cell expansion, GP-19 was installed. Figure 1 in Attachment 1 includes a site map that shows all LFG monitoring probe locations.

Table 1 of Attachment 2 shows the readings obtained from the 19 probes along the property boundary. As shown in Table 1, no methane was detected in the gas monitoring probes. A site plan showing the probe locations is included in Attachment 1.

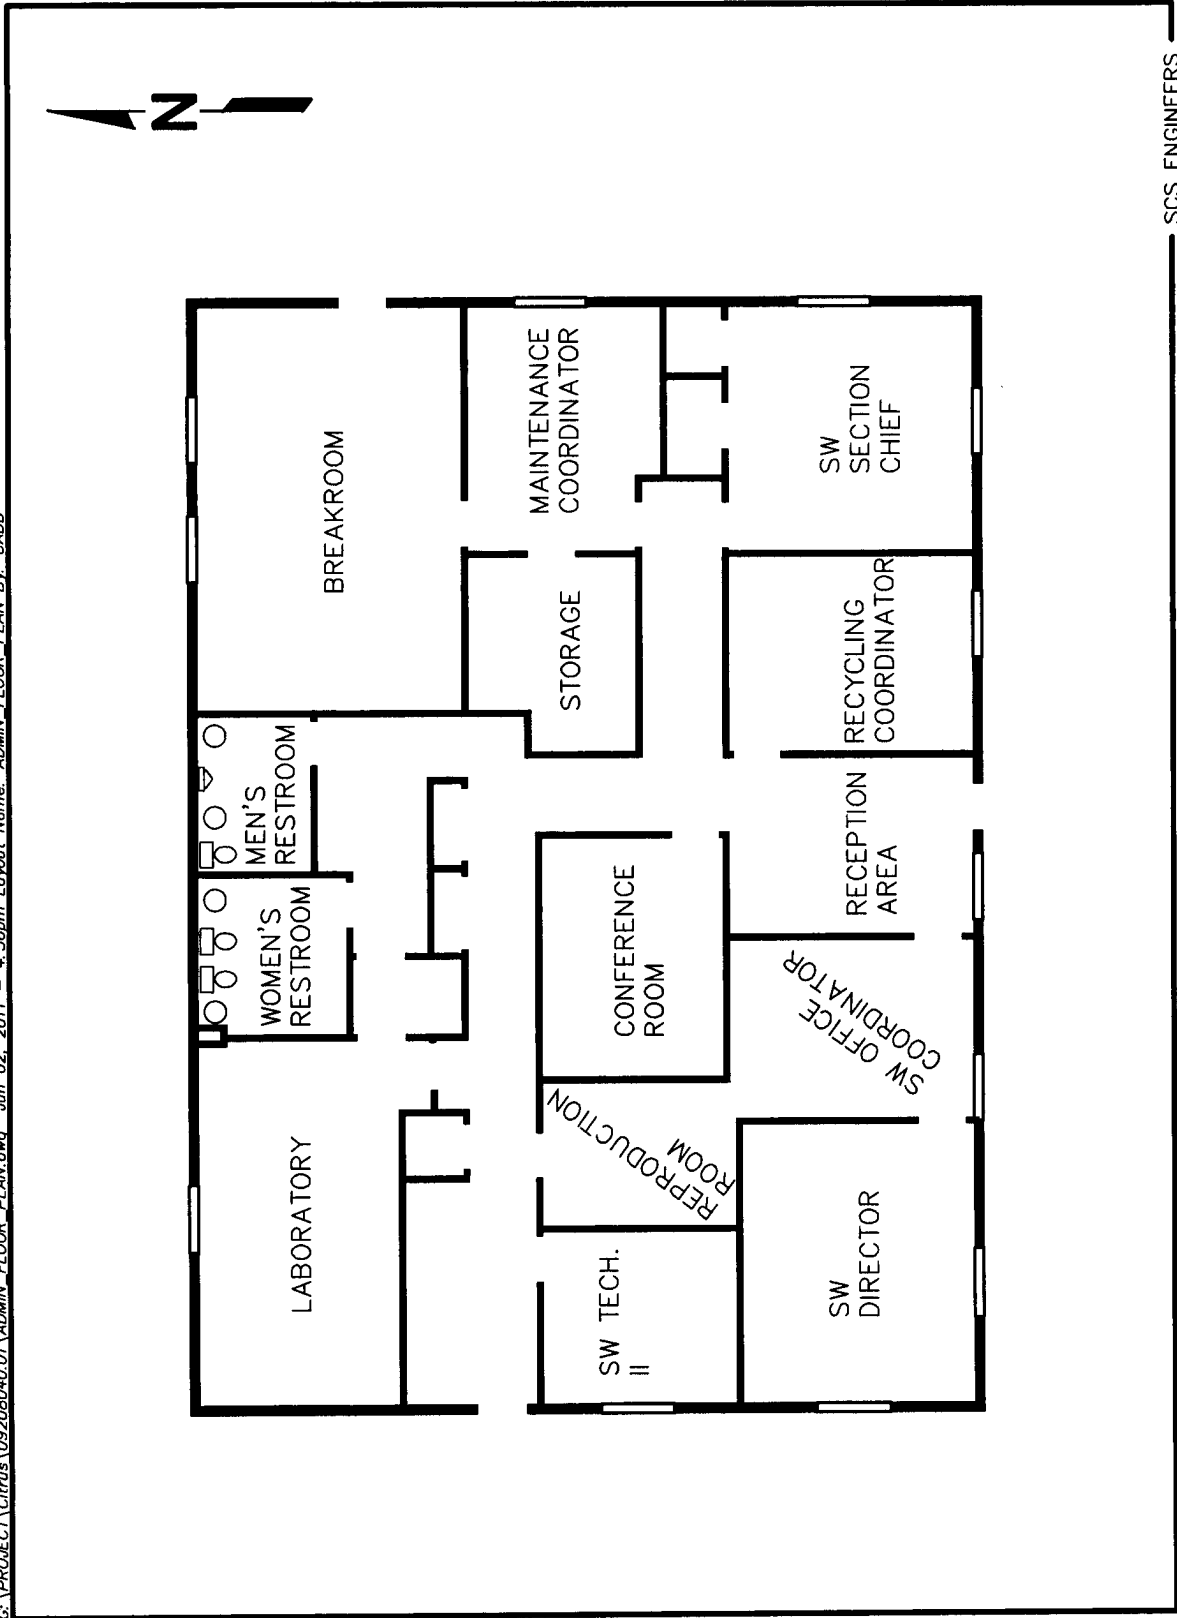
Figure 2. Administration Building Floor Plan

No methane was detected in the scalehouse, administration building, shop, leachate treatment facility, or firing range as shown in Table 1 of Attachment 2. Floor plans of the scale house and the administration building are included in Attachment 1.

SCS monitored in the restrooms of the administration building, as well as in select closets, the break room, conference room, and hallways. In the scalehouse, SCS monitored the main work area, cabinets, the restroom, and at electrical outlets. Monitoring of the leachate treatment facility included around the base of structures, at the control panel, and inside the electrical room.
