Re: Tomoka Farms Road Landfill
WACS Facility ID #27540
Volusia County

**Florida Department of
Environmental Protection
Inspection Checklist**

Facility Name: TOMOKA FARMS ROAD LANDFILL

Routine Operation Inspection for Landfill - Class I

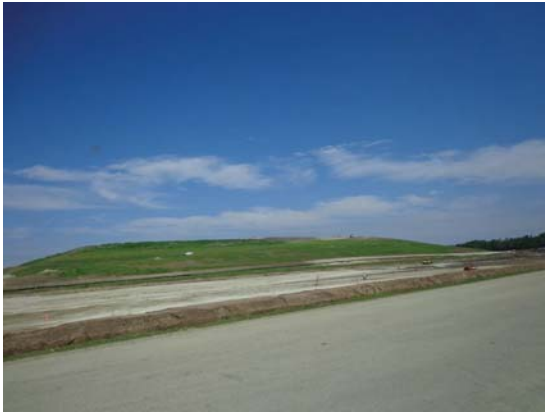
Construction of Expansion Area

Solid Waste Construction Permit number 0078767-041-SC-01 was issued 7/20/2018 and expires 7/20/2023. The permit was issued for the construction of Phase III Expansion Area 4 for the Class I North Cell. The expansion area consists of a total of 12.8 acres and is located east of Phase II.

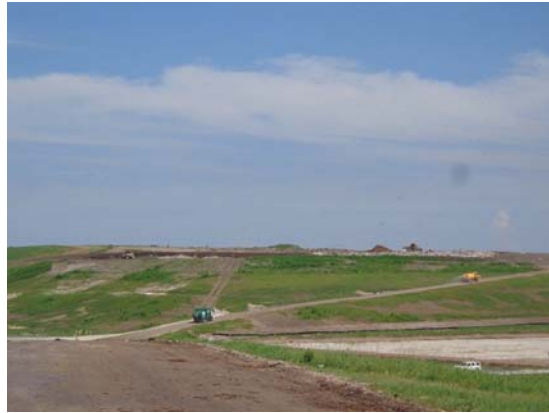
Class I Landfill

Item 2.13 - Waste was being placed in Phase II Area 3 in the Class I landfill. Waste was being placed in the west side of the Class III landfill.

Item 2.20 - A litter control fence was used in the Class I and Class III working face.

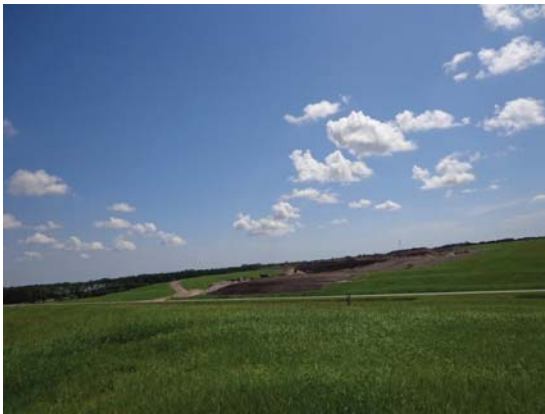
Class III Landfill

Item 2.21 - There were a few areas of exposed sediment observed on the slopes with intermediate cover on the Class III landfill. The Department recommends that these areas are carefully watched and maintained to avoid potential erosion, especially during the rainy season.

Item 2.33 - A water truck was in use at the Class III landfill at the time of the inspection.

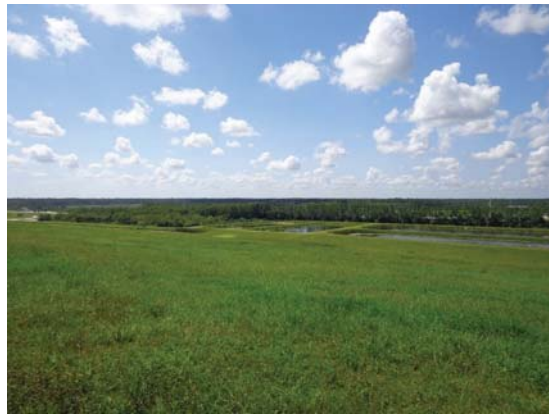
Stormwater ponds near South Cell

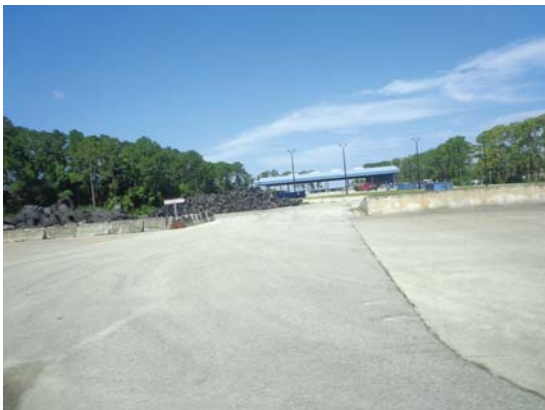
Storage of waste tires

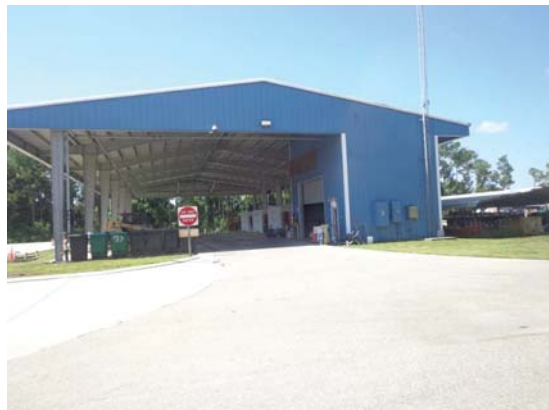
HHW Center
