Re: Vista Landfill
SW Facility ID #87081
Orange County

**Florida Department of
Environmental Protection
Inspection Checklist**

Facility Name: VISTA LANDFILL, LLC (BUTTREY/KEENE RD SOUTH)

Routine Operation Inspection for Landfill - Class III

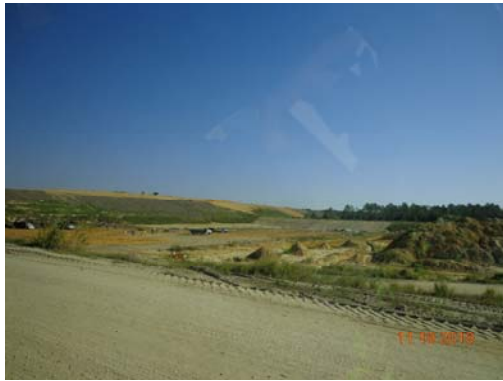
Item 2.13 - Waste is currently being placed in Cell 6. Select waste is being used to fill the first lift of Cell 6 following construction of the Cell 6 liner. Metal and large pieces of wood are being removed from Cell 6 while filling with select waste.

Cell 6 working face

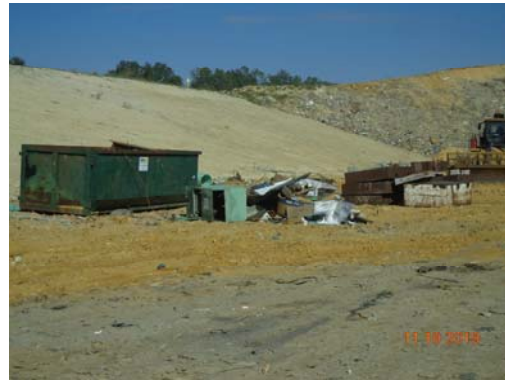
Removing metals for select waste
