Re: Empire Tire  
SW Facility ID #95062  
Orange County

**Florida Department of  
Environmental Protection  
Inspection Checklist**

**Facility Name:** EMPIRE TIRE INC  
**On-site Inspection Start Date:** 02/06/2020  
**On-site Inspection End Date:** 02/06/2020  
**WACS No.:** 95062  
**Facility Street Address:** 550 MISSION RD  
**City:** Orlando  
**County Name:** ORANGE  
**Zip:** 32808

Routine Operation Inspection for WPF - Waste Tire Processing Facility

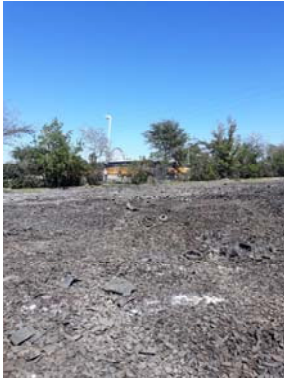
North side cleared of waste tires

Corrective Action: On February 28, 2020, Cliff McFadden submitted photos demonstrating that the north side of the property had been completely cleared of waste tires.

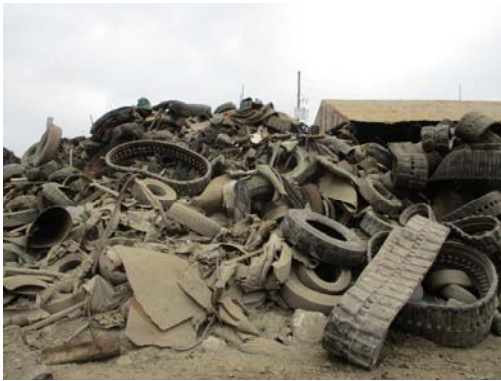
Processing involves storage and sorting of whole waste tires, tire chips and residuals. All storage and operations are performed outdoors and under cover. On-site permitted waste tire storage capacity is 825 tons and includes 200 tons of whole waste tires, 500 tons of processed tire chips, 125 tons of residuals, and used tires for resale (5% of daily collection).

Residuals

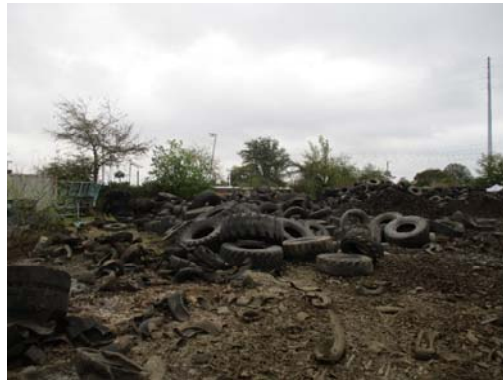
Explanation: Tires stored along the fence on the north side of the property do not have a 50-foot wide fire lane around the perimeter of the outdoor waste tire pile.

The small outdoor storage area at the north end of the property did not have an adequate fire perimeter lane at the time of the inspection. On February 28, 2020 Cliff McFadden submitted photos of corrective action.

North side needs fire lane

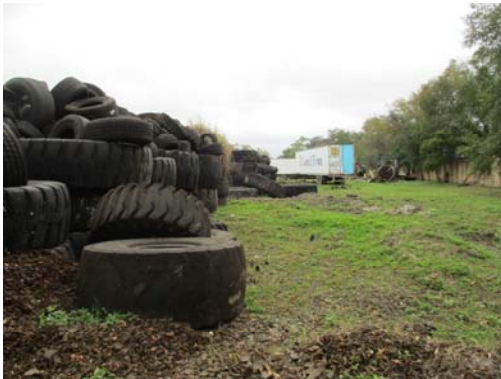
According to the 4th quarter 2019 waste tire quarterly report, the facility had an ending inventory below the permitted on-site storage capacity. Outdoor waste tire piles had an area less than 10,000 square feet and a height less than 15 feet. The outdoor storage pile along the south end of the property was well maintained with an adequate fire perimeter lane and internal fire lane. While this pile is comprised mostly of large tires, DEP recommends that smaller passenger tires are removed from the pile and processed in an effort to reduce on-site storage.

Fire perimeter lane - south side

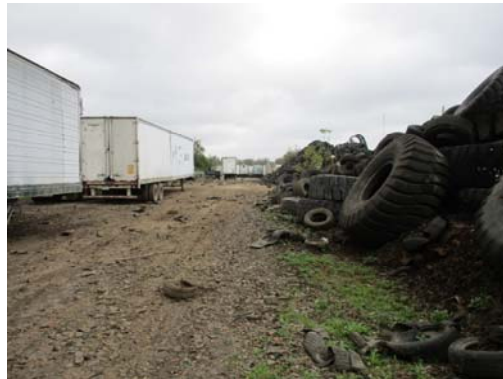
Fire perimeter lane - SW side

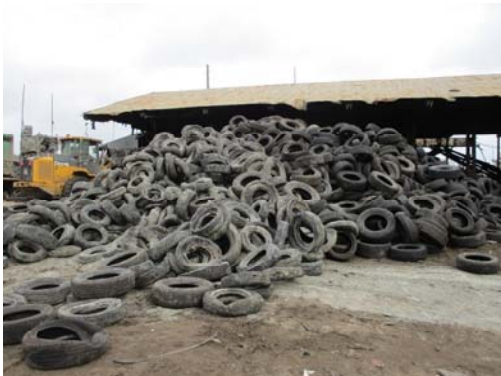
Working whole tires pile

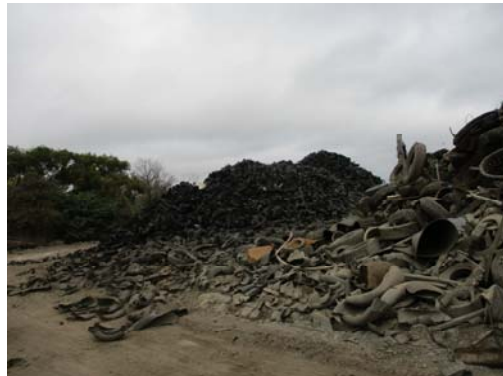
Processed pile
