Re: J.E.D. Landfill
SW Facility ID #89544
Osceola County

**Florida Department of
Environmental Protection
Inspection Checklist**

Facility Name: J.E.D LANDFILL (F/K/A OAK HAMMOCK DISPOSAL)

On-site Inspection Start Date: 11/06/2020

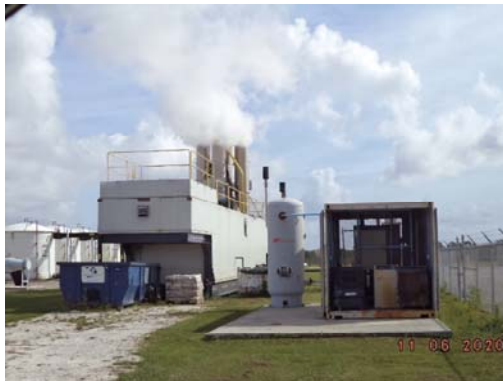
The leachate generated on-site is pumped to one of three leachate storage ponds on-site. A leachate evaporator system is on-site and is used as the primary method of leachate treatment/disposal (Permit 0199726-039-SO-21). The facility keeps records of leachate evaporation, and the records were reviewed on-site. Leachate that is not processed by the leachate evaporator is sent to Aqua Clean Environmental Company for treatment/disposal. In emergency situations, leachate is sent to Liquid Environmental Solutions for treatment/disposal. In extreme emergency situations, the facility recirculates leachate. The facility has recirculated leachate this year, and leachate recirculation records were reviewed on-site.

Leachate evaporator

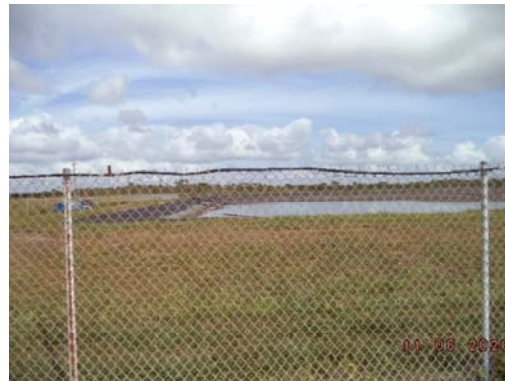
Leachate ponds

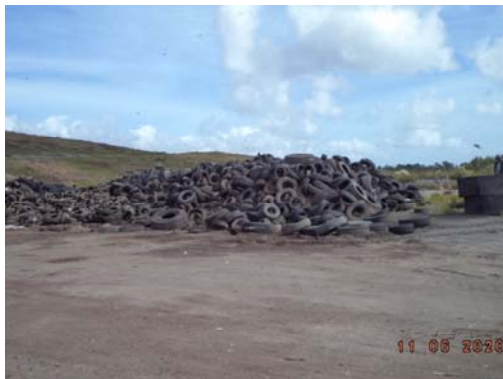
The facility accepts waste tires for collection and sends the tires out to Empire Tire for processing when the pile reaches the permitted capacity. The tires are then sent back to the landfill for disposal or for use as alternate cover (approved in permit). The facility is current on quarterly records required by the WTPF permit. The WTPF is in compliance.

Waste tire storage

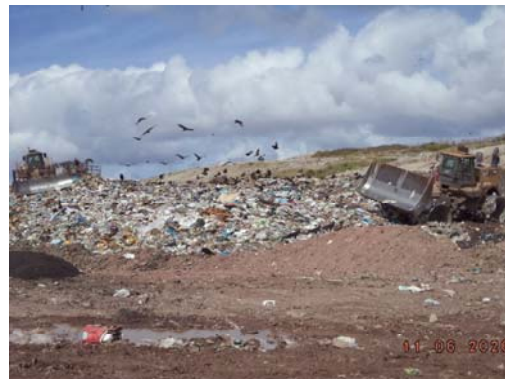
Waste is currently being placed Cell 12. The facility currently has two working faces on Cell 12. The facility performs load checks at least 3 times a week. The facility is using alternate cover materials including 50/50 mulch/soil blend, tarps, processed tires, contaminated soils, posi-shell and topcoat.

Working face

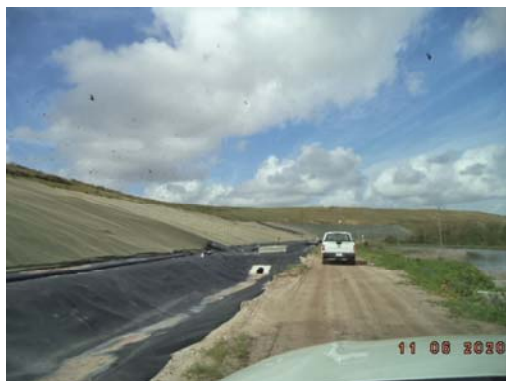
Waste Connections has completed the project meant to address leachate seeps and to prevent future seeps on the eastern and western slopes. In accordance with the Corrective Action Plan submitted by Waste Connections in January 2020, Waste Connections hired contractors who have installed exposed geo-membrane covers (EGCs) and/or toe interceptors on the outer slopes of the eastern slopes (Cells 3, 6, 9, 10, 11, and 13) and on the western slopes (Cells 5, 7, and 8). No leachate seeps were noted during the inspection. Waste Connections provided a report with a summary of the project on November 10, 2020.

EGC on eastern slopes

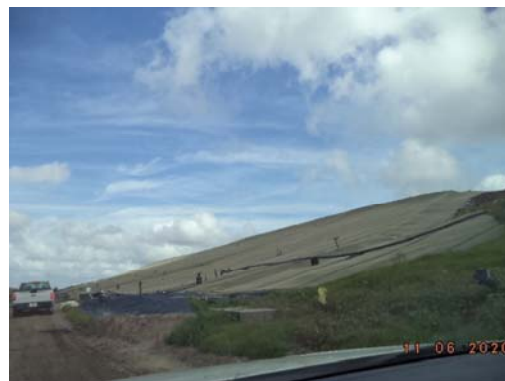
EGC on western slopes
