**Florida Department of
Environmental Protection
Inspection Checklist**

Facility Name: ENTERPRISE LF & RECYC (FKA SID LARKIN & SON, INC.)

On-site Inspection Start Date: 01/28/2022

Routine Operation Inspection for Landfill - Class III

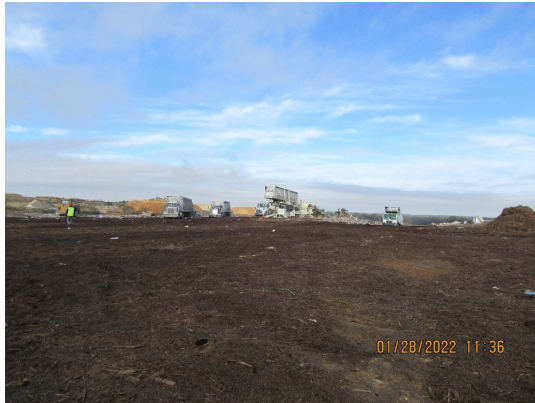
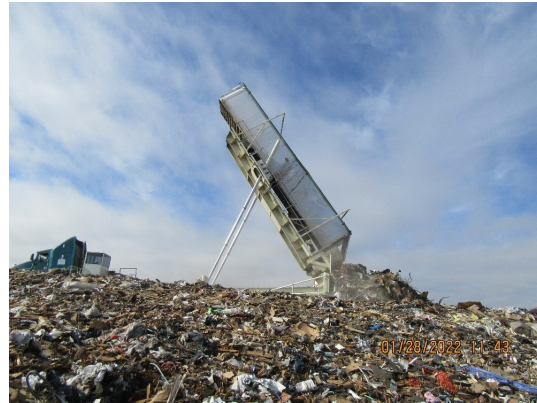
Working Face

Explanation: Department staff observed that adequate spotting of all incoming wastes was not being conducted. Some loads were pushed and compacted prior to spotter review due to number of spotters compared to volume of incoming waste and need for space for additional trucks to unload. Additional spotters may be necessary to ensure Op Plan Section 5.1 procedures are being met (2 loads/spotter at working face.)

Corrective Action: Facility response on February 9, 2022 states that "the landfill manager has been actively looking to hire an additional new spotter to address peak activities at the working face and to ensure Section 5.1 procedures of the Operations Plan are being met." Please provide the Department with a staffing update once hiring has been completed.

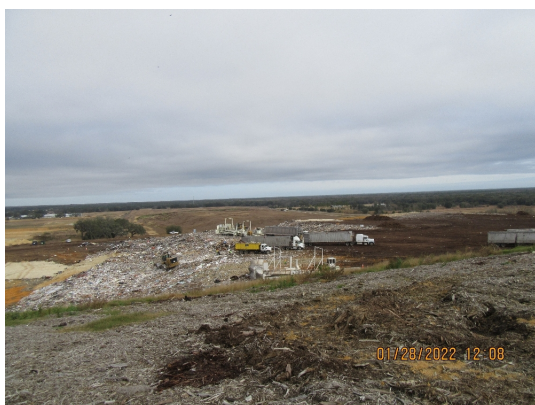
Explanation: Lift thickness in Op Plan stated to be generally less than 10-12'. During the inspection, lift thickness was observed to be 16-18' +, however, two levels, which could be two lifts, were observed due to flat packing. Working face also appeared much wider than Op Plan description of 100' based on site conditions (turning corner) and current waste volumes. Modification of Op Plan Section 8.1/Permit may be necessary to modify fill sequence or restore practices to Op Plan Fill Sequence.

WF - lift thickness

Corrective Action: Facility response on February 9, 2022 states, "we propose to modify the appropriate sections of the Operations Plan to better address the average/approximate lift thickness and width of working face to include upper ranges that are at times required." A minor modification of Class III permit no. 177982-003-SO/T3 should be requested to incorporate proposed Operation Plan updates.

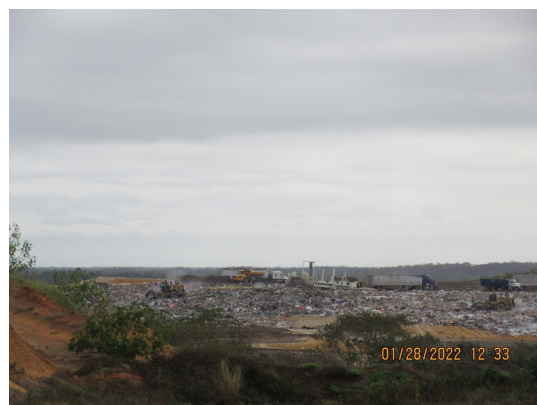
Large active area

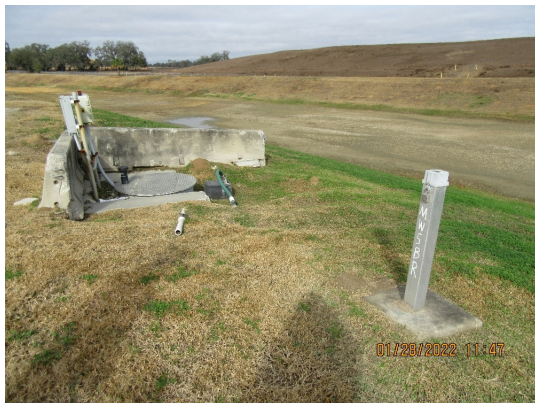
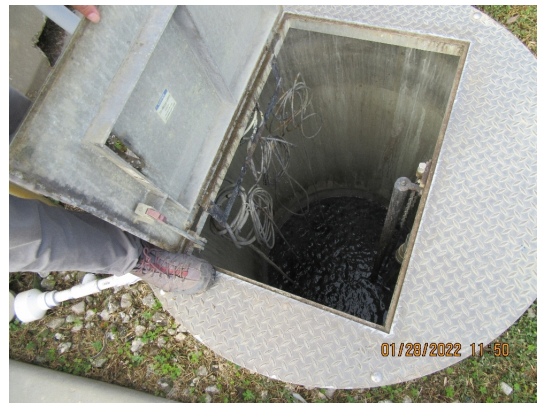
LCS Pump Station

Explanation: During the inspection, it was observed that leachate was allowed to accumulate in the toe drain manhole and pumping systems were turned to manual. Leachate was observed to be approximately 5' above the level of the high level alarm float, however elevation was unknown at time of inspection. The high level alarm had

been silenced prior to the inspection when pump was turned off. The facility is in the process of turning over the leachate treatment ponds and are not currently filling them while awaiting sample results prior to moving liquids to the next stage. It was unclear if the accumulated leachate had backed up into the toe drain and onto the liner in excess of the design elevation (i.e. head accumulation on liner). Please provide the elevation of the liquid in the manhole.

Corrective Action: Facility response provided on February 9, 2022 stated, "The power was engaged at the end of day (01/28/22) and the pump station was placed in automatic mode.

The elevation of the leachate level in the pump station was surveyed on 02/03/22 using a GPS system that relies on the FDOT FPRN network and was measured to be EL 79.1'. The elevation of the top of the toe drain sump in Cell 16 is EL 79.0' and in Cell 17 is 80.5'. The lowest elevation corresponding to 12 inches of head on the "liner" would be EL 80.0 in Cell 16 and EL 81.5' in Cell 17. The high-level float in the pump station is set at EL 76.0', which is at a working level that is conservatively below the top-of-bank elevation of the leachate toe drain in both Cells 16 and 17."

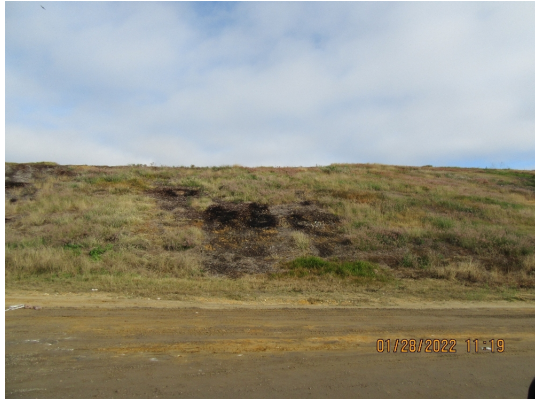
Explanation: Minor offsite odor was observed at corner of Auton Rd. & Enterprise Rd. at 09:30A. Gas breakouts and stressed vegetation noted on S slope and top deck of Cells 1-7, 15 which needed repair.

Stressed vegetation

Corrective Action: Documentation (photos) of repair was received on February 4, 2022. Additional proposals for gas remediation in these areas may be warranted if odors persist.

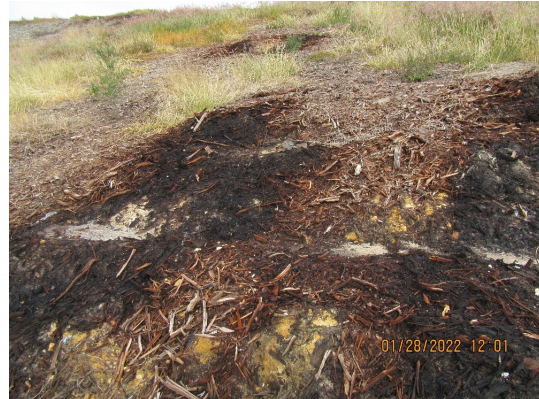
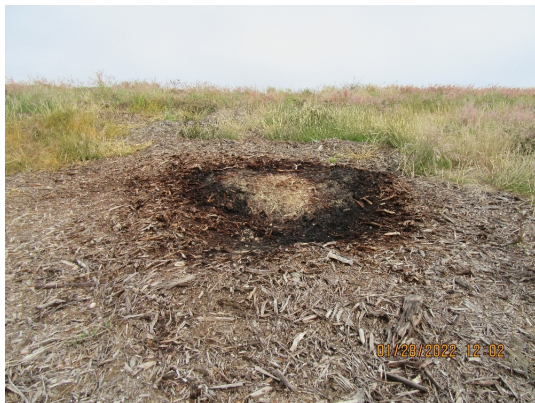
S slope - gas/stressed veg

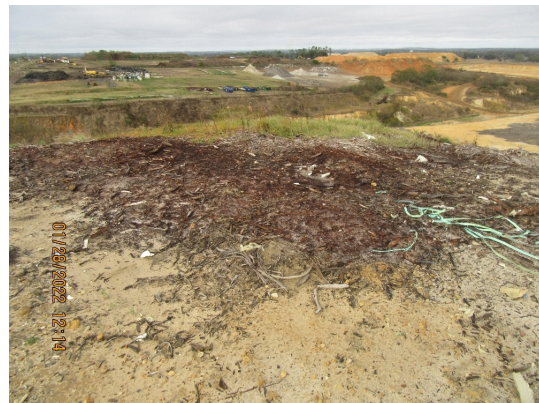
Top deck - stressed veg

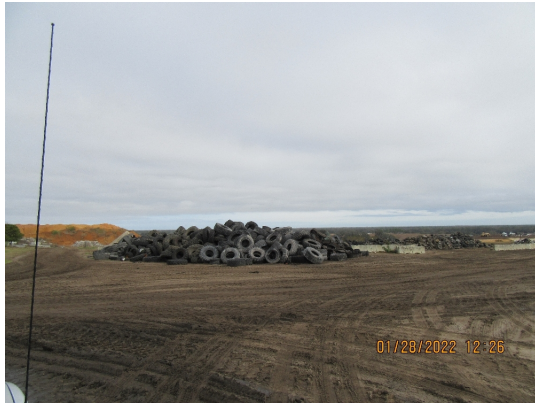
Explanation: A pile of aluminum rimmed tires and large truck tires were observed at WTPF which were awaiting processing by tire shear. Processing by tire shear not currently in permit/plan. Truck and unprocessed Al rimmed tire pile locations not included on site plan.

Truck tires

Corrective Action: Minor modification of waste tire permit no. 303741-004-WT/02 should be requested to revise site plan, include maximum storage quantities and update processing equipment specs and throughput.

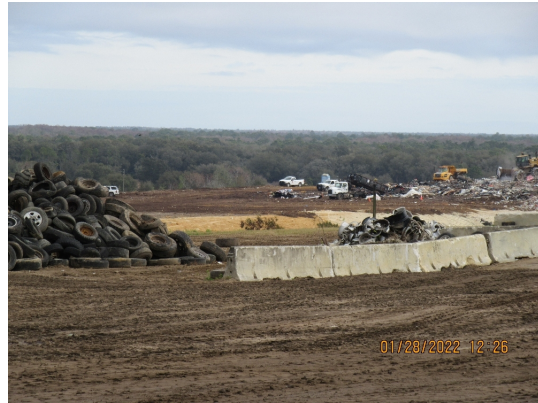
Al Rims

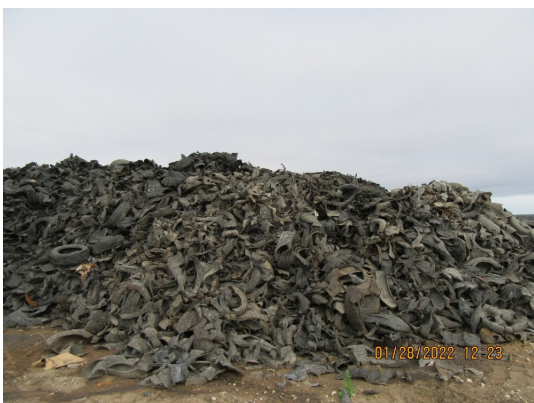
Item 9.35 – During the inspection, whole tires and pieces that appeared to be larger in size than 1/8 tire were observed in the shred pile. Please ensure that these are reprocessed prior to landfilling.

Shredded Tires
