**Florida Department of  
Environmental Protection  
Inspection Checklist**

**Facility Name:** EMPIRE TIRE INC  
**On-site Inspection Start Date:** 05/18/2022  
**On-site Inspection End Date:** 05/18/2022  
**WACS No.:** 95062  
**Facility Street Address:** 550 N MISSION RD  
**City:** ORLANDO  
**County Name:** ORANGE  
**Zip:** 32808

Routine Operation Inspection for WPF - Waste Tire Processing Facility

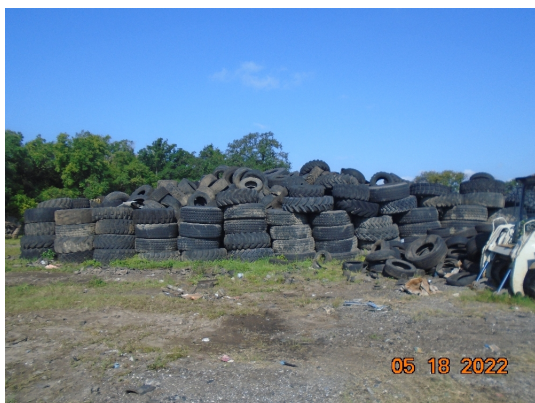
Explanation: Several tire piles and processed tire piles had a width greater than 50 feet. Specifically, the oversized tire pile was 80 ft X 95 ft; the oversized/processed tire pile was 100 ft X 100 ft; the tire pile in the Northwest corner of the property was 60 ft X 200 ft.

Oversized tire pile &gt; 50 ft wide

Several tire piles were not well maintained. Specifically, the oversized tire pile on the South side of the property had a width greater than 50 feet. The pile with oversized tires and processed tires on the South side of the property was 100 ft X 100 ft, so the width was too wide. The tire storage area on the Northeast border of the property along Mission Road did not have adequate fire lanes. The pile of tires in the Northwest portion of the property did not have a fire lane on one side, and the width and area of the pile was too large (60 ft X 200 ft = 12,000 sq. ft).

Corrective Action: Reduce the width of piles such that all tire piles have a width less than 50 feet.

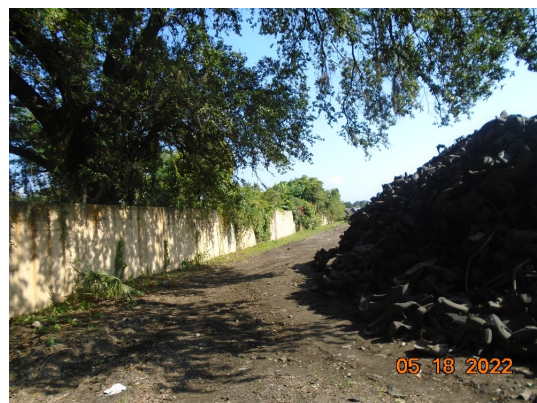
Pile &gt; 50 ft wide

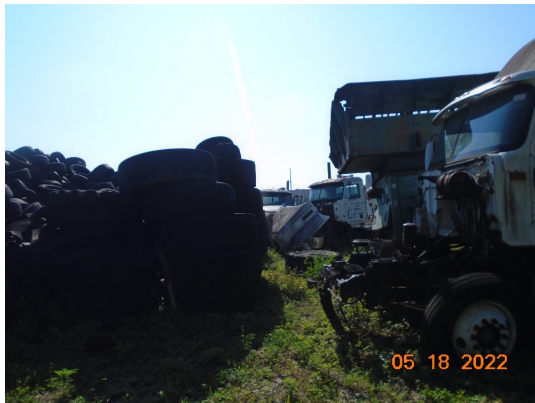
Explanation: Several outdoor tire piles did not have adequate 50-foot wide fire lanes around the perimeter of the pile. Specifically, the tire storage area on the Northeast border of the property along Mission Road was not properly maintained and did not have 50-foot wide fire lanes. Additionally, the pile of tires in the Northwest portion of the property did not have a fire lane on one side.

Northwest pile needs fire lane

Corrective Action: Ensure each outdoor tire pile has an unobstructed 50-foot wide fire lane at all times.

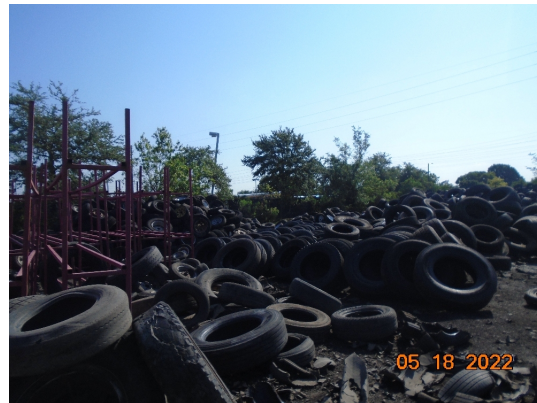
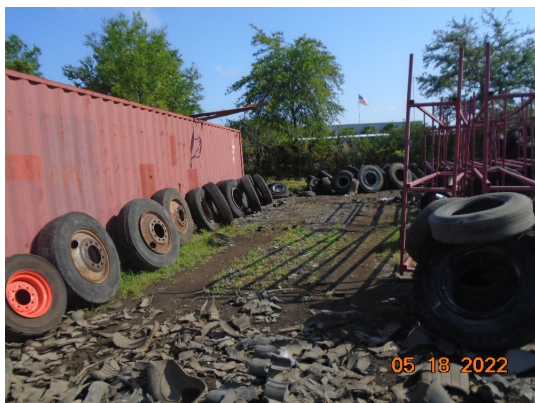
Northeast pile needs fire lanes

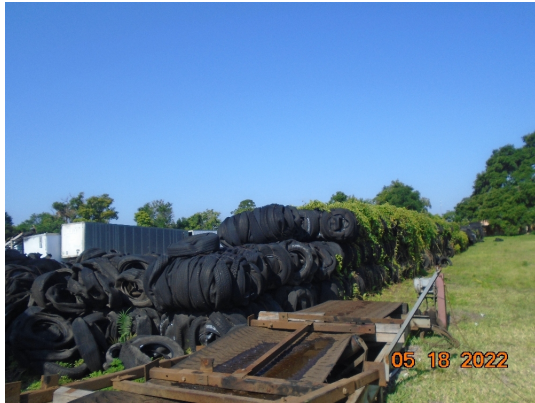
Explanation: Some tire piles had vegetation growing on the tires, posing a potential fire hazard.

Vegetation growing on tires

Some tires had vegetation growing on them. The vegetation must be removed or the tires must be removed or processed to reduce the potential for fire.

Corrective Action: Remove vegetation or remove or process tires that have vegetation growing on them to reduce the potential for fire.
