**Florida Department of  
Environmental Protection  
Inspection Checklist**

**Facility Name:** J.E.D LANDFILL (F/K/A OAK HAMMOCK DISPOSAL)  
**On-site Inspection Start Date:** 07/12/2022  
**On-site Inspection End Date:** 07/12/2022  
**WACS No.:** 89544  
**Facility Street Address:** 1501 OMNI WAY  
**City:** SAINT CLOUD  
**County Name:** OSCEOLA  
**Zip:** 34773

Routine Operation Inspection for Landfill - Class I

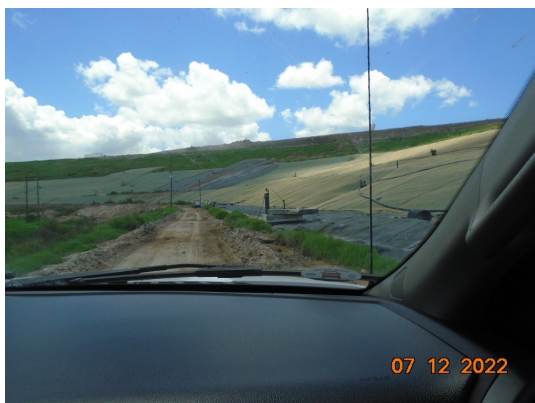
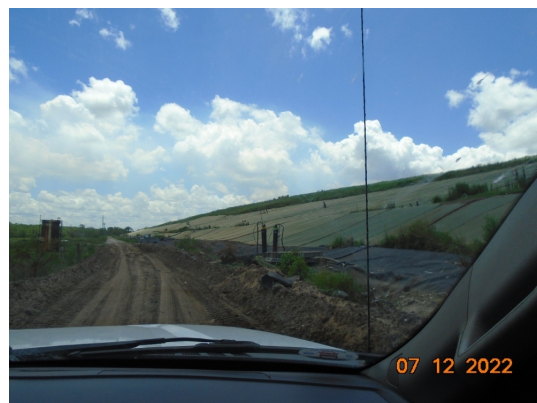
## Temporary Change Leachate West #1

Specifically on the day of inspection the leachate collection system was operating under a temporary design closed loop system and not as the permitted designed system.

Item 2.22 - See additional comments and pictures in the violation cited.

Corrective Action: Provide the Department with a design plan for the temporary leachate collection system and an estimated length of time that this system will be in place.

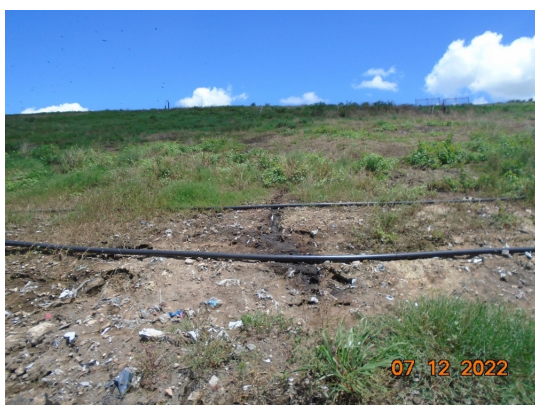
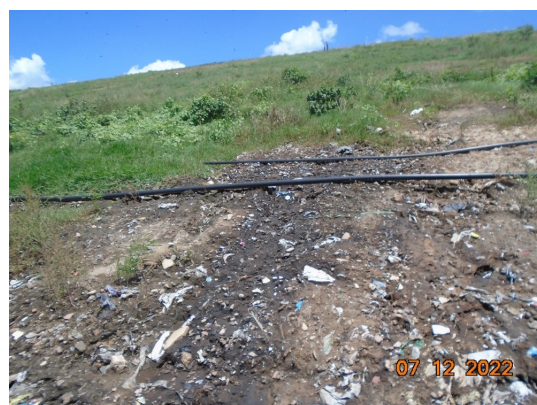
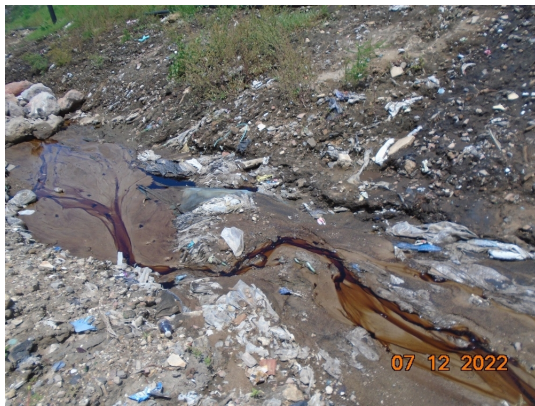
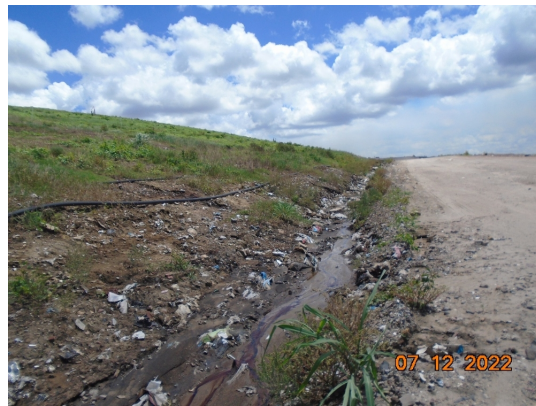
Leachate Seep Picture #1

Specifically on the day of inspection leachate seeps were noted along the landfill access road in Cell 13, this road led up to the landfill working face. Leachate was also noted to be mixed with storm water in the temporary drainage ditch along this road, although it did not appear to be discharging off the landfill and into the surrounding storm water ponds. Leachate seeps were noted in a previous solid waste inspection conducted on 11/26/2019.

Item 2.28 - See additional comments and pictures in the violation cited.

Corrective Action: According to an email received by the Department on 07/15/2022, a new sump with pump has been installed at the Cell 13 seep, along the landfill access road. No further information is needed at this time.

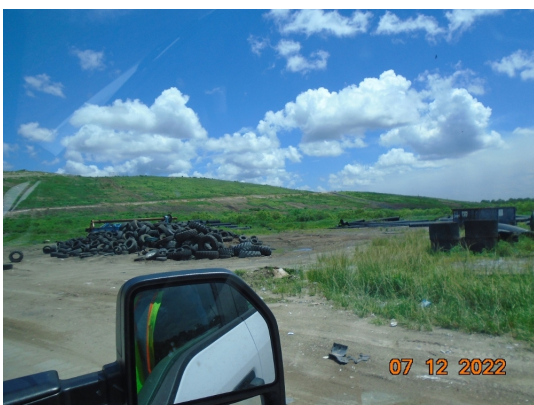
Waste Tire Storage Area

This facility accepts waste tires for collection and sends the tires out to Empire Tire for processing when the pile reaches the permitted capacity. The tires are then sent back to the landfill for disposal or for use as alternate cover (approved in the permit). The facility is current on the quarterly records as required by the WTPF permit, the last report quarterly report was received on 07/06/2022 for the 2nd Quarter 2022.

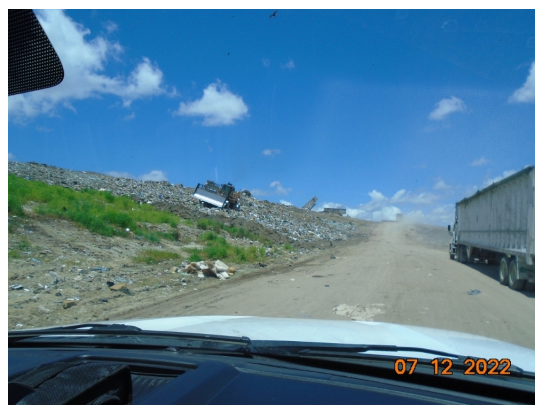
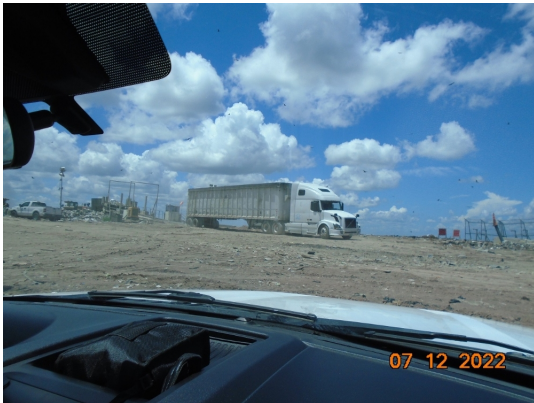
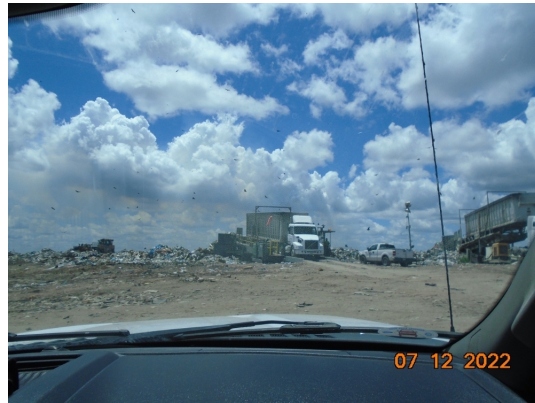
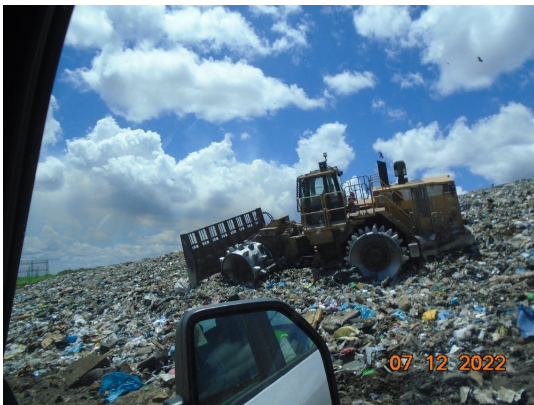
Working Face #1

Item 2.13 & 2.15 - The working face was located in Cell 12 at the time of inspection and waste was being placed and compacted in this area. This facility was performing and documenting random load checks in an area adjacent to working face location at least 3 times a week.

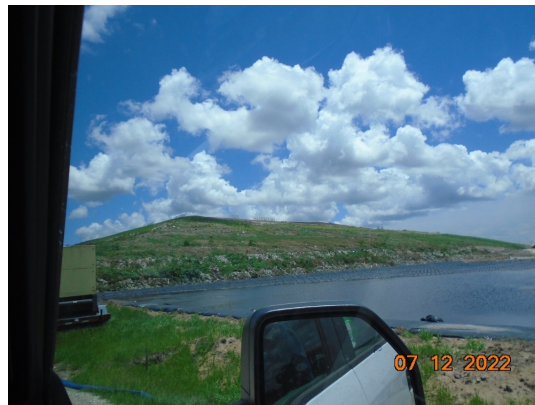
Looking NE at Litter Fences on WF

Item 2.20 - Litter fences are utilized at the working face to assist in controlling windblown litter from this area. Three full-time laborers are employed as a litter crew that routinely cleanup litter on the property and access roadways. Some litter flagging was noted along the southern access road in Cells 13 and 12. A few pieces of windblown litter were noted in the northern storm water perimeter ponds at the time of inspection.

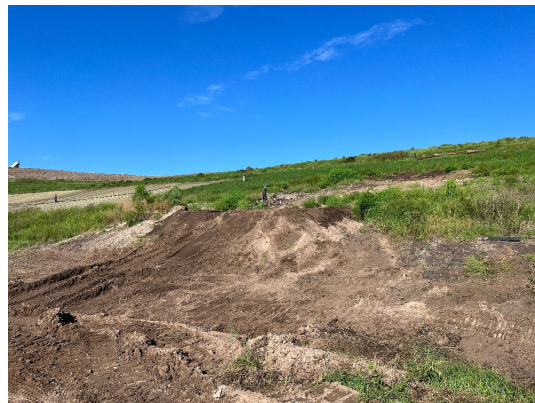
Corrective Action 07/15/2022

Item 2.21 - At the time of inspection a large gully was noted at the bottom of Cell 3 slope. According to an email with corrective action picture received by the Department on 07/15/2022, the Cell 3 slope had been restored and was scheduled to be hydroseeded within one week. It was also mentioned that other areas would be "touched up" while the company was onsite at the landfill into to prevent further erosion.
