Re: Warning Letter
J.E.D Landfill
SW Facility ID #89544
Osceola County

**Florida Department of
Environmental Protection
Inspection Checklist**

Facility Name: J.E.D LANDFILL (F/K/A OAK HAMMOCK DISPOSAL)
On-site Inspection Start Date: 07/12/2022
On-site Inspection End Date: 07/12/2022
WACS No.: 89544
Facility Street Address: 1501 OMNI WAY
City: SAINT CLOUD
County Name: OSCEOLA
Zip: 34773

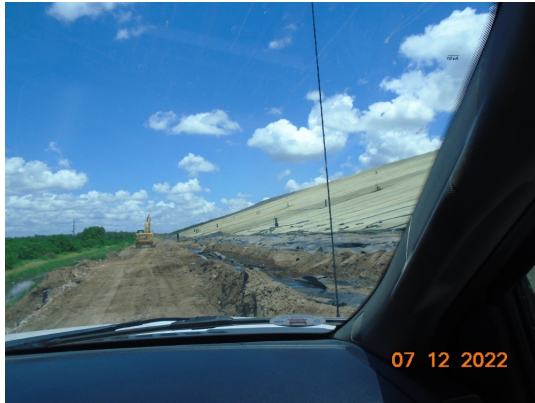
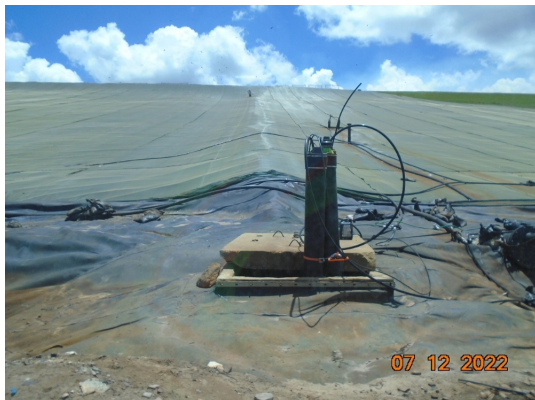
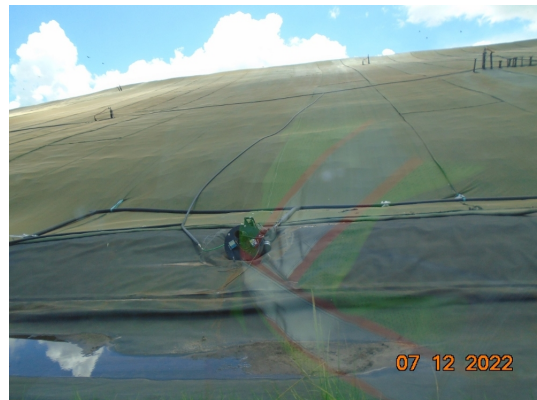
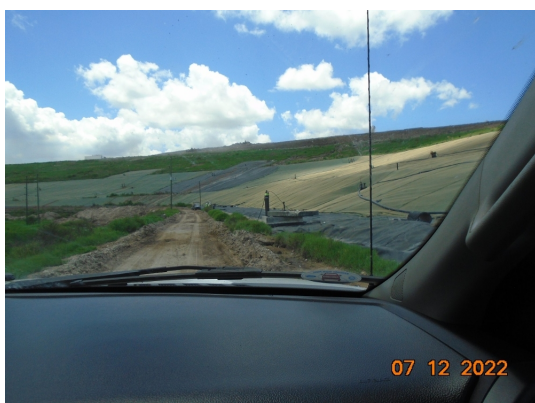
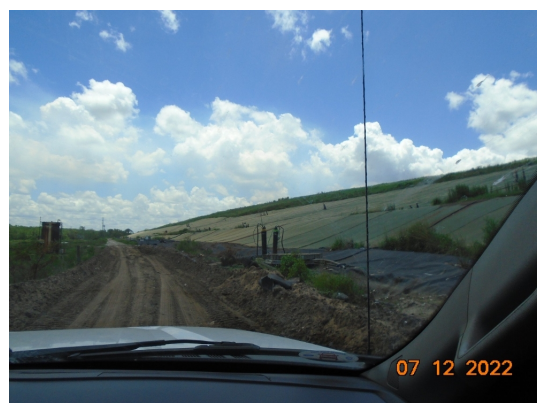
Explanation: The landfill operator is responsible for the operation of the leachate collection and removal system and for maintaining the system as designed for the design period. Leachate shall be collected and treated as necessary so that water quality standards and criteria are not violated. If the leachate is classified as a hazardous waste, it shall be managed in accordance with Chapter 62-730, F.A.C. Leachate treatment or disposal facilities that may be used shall be identified in the operating plan, and the Department shall be notified as to which facility is actually being used.

Specifically on the day of inspection the leachate collection system was operating under a temporary design closed loop system and not as the permitted designed system.

Corrective Action: Provide the Department with a design plan for the temporary leachate collection system and an estimated length of time that this system will be in place.

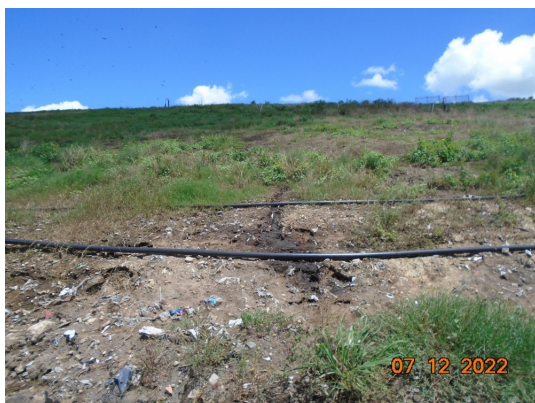
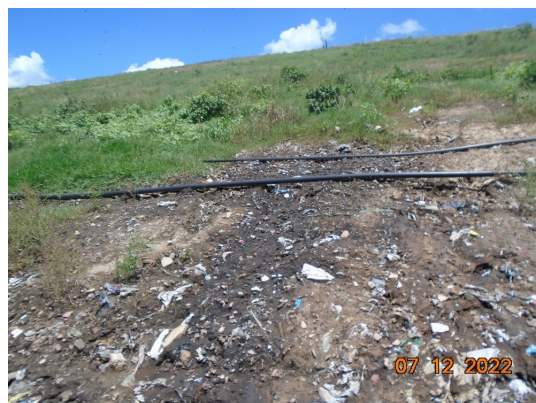
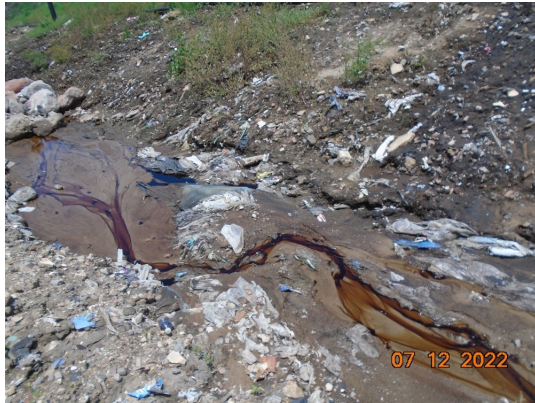
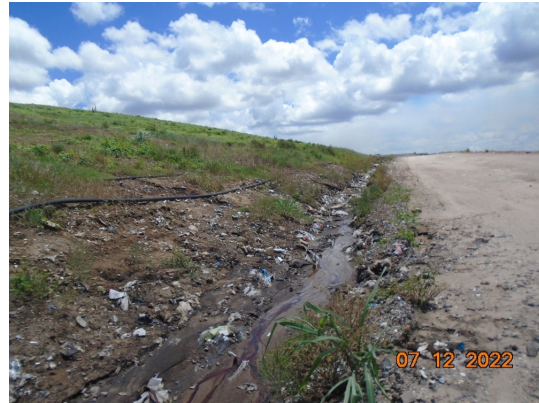
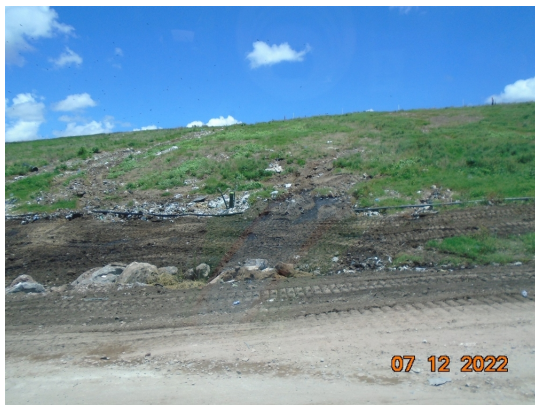
Specifically on the day of inspection leachate seeps were noted along the landfill access road in Cell 13, this road led up to the landfill working face. Leachate was also noted to be mixed with storm water in the temporary drainage ditch along this road, although it did not appear to be discharging off the landfill and into the surrounding storm water ponds. Leachate seeps were noted in a previous solid waste inspection conducted on 11/26/2019.

Corrective Action: According to an email received by the Department on 07/15/2022, a new sump with pump has been installed at the Cell 13 seep, along the landfill access road. No further information is needed at this time.

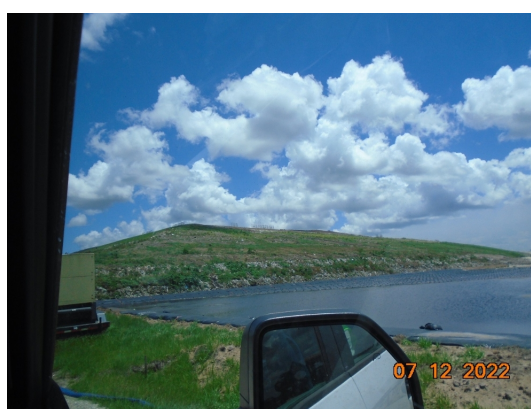
Looking NE at Litter Fences on WF

Item 2.20 - Litter fences are utilized at the working face to assist in controlling windblown litter from this area. Three full-time laborers are employed as a litter crew that routinely cleanup litter on the property and access roadways. Some litter flagging was noted along the southern access road in Cells 13 and 12. A few pieces of windblown litter were noted in the northern storm water perimeter ponds at the time of inspection.

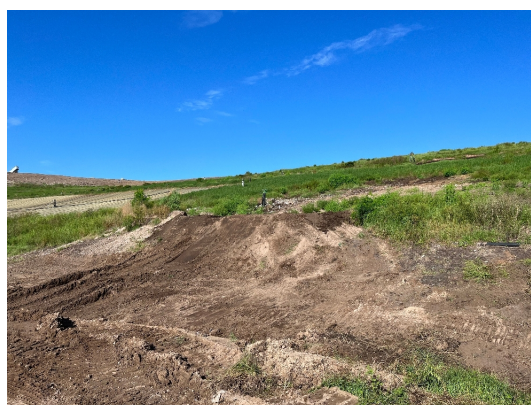
Corrective Action 07/15/2022

Item 2.21 - At the time of inspection a large gully was noted at the bottom of Cell 3 slope. According to an email with corrective action picture received by the Department on 07/15/2022, the Cell 3 slope had been restored and was scheduled to be hydroseeded within one week. It was also mentioned that other areas would be "touched up" while the company was onsite at the landfill into to prevent further erosion.
