# Florida Department of Environmental Protection

Volusia County - SW  
Tomoka Farms Road Landfill WACS # 27540  
Class I - Permit # S064-0078767-023  
Inspection Report Transmittal

Florida Department of  
Environmental Protection  
Inspection Checklist

**Facility Name:** TOMOKA FARMS ROAD LANDFILL

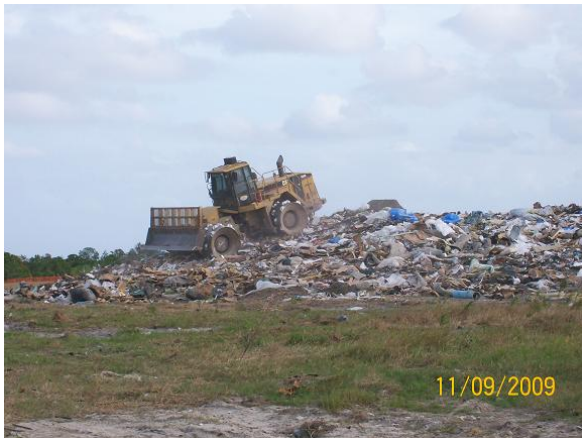
The Class III landfill is in good order. The yard trash/land clearing debris piles have been reduced in size and fire lanes are adequate.

Class III working face

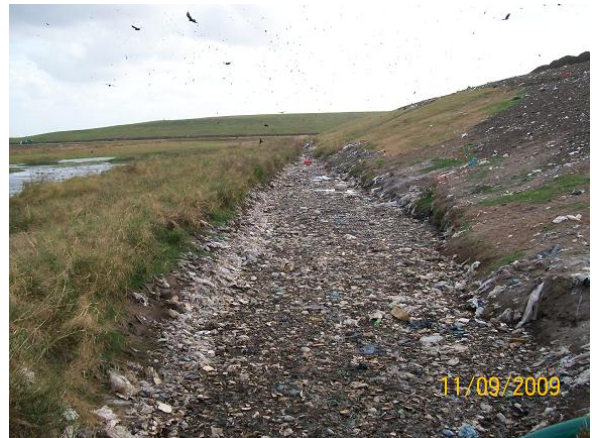
bermed area (toe of E. side slope)

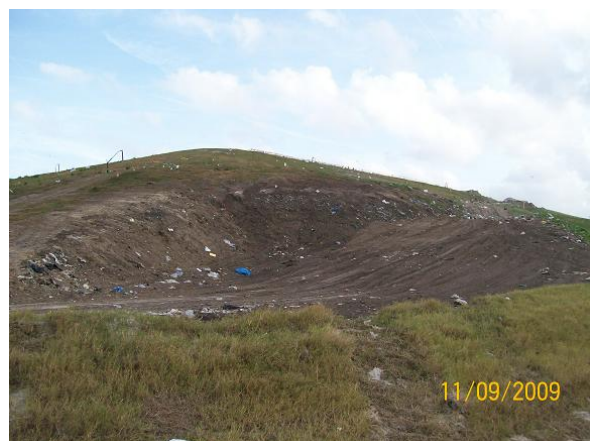
The NW corner was previously excavated due to leachate riser repair. The waste has been covered, but the corner still remains excavated to assist the new haul road construction. The footprint of the road has been laid out in preparation for liner installation.

Class I NW corner

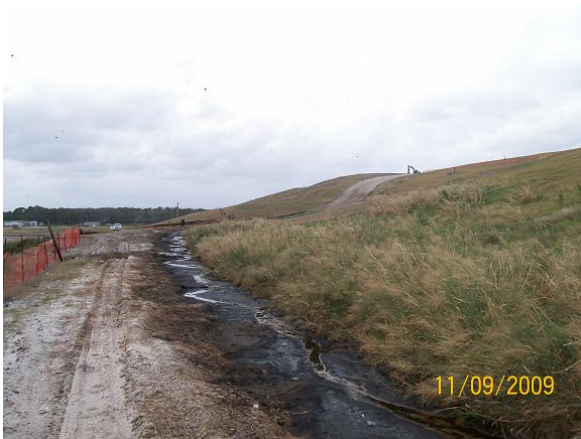
1. On the south side of the Class I landfill, leachate continues to actively flow from an eroded area west of the haul road. The seepage appears to remain in the lined area of the landfill.
2. Due to heavy winds, blown litter was excessive throughout the facility.

Area: South Side Slope  
Rule: 62-701.500(8)(b), 62-701.500(2)(j), 62-701.500(8)(h)  
Question Number: 2.24  
Explanation: Leachate continues to actively flow on the south side slopes west of the haul road. As before, the leachate flow is directed to an area at the toe of the east side of the active cell and remains in the lined area of the landfill.  
Corrective Action: The facility is in the initial stages of implementing the approved sequence of fill plan. The facility believes that once the plan is in effect and the south side slopes are re-worked, the leachate problems will cease. The facility is to continue these efforts.

Leachate flowing on S side slope

The inspection on November 9 revealed that the implementation of the fill sequence plan is in its initial phases. Within 10 days of receipt of this letter, please submit to the Department an implementation schedule regarding the completion of the initial work and when the disposal area will be shifted to address the south side slope seepage.

As before, once the new haul road on the west side is complete, the area will be reworked to cover eroded areas and activities will shift elsewhere to hopefully eliminate seepage in this area. The next step regarding the sequence of fill plan is the partial closure and liner installment on the west side of the active cell in the area of the new haul road.

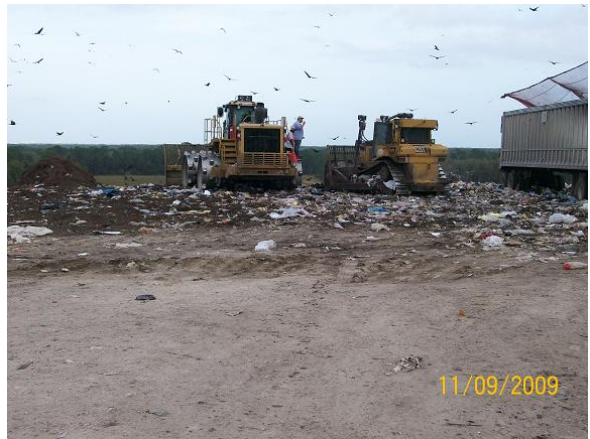
Top of Class I Working Face

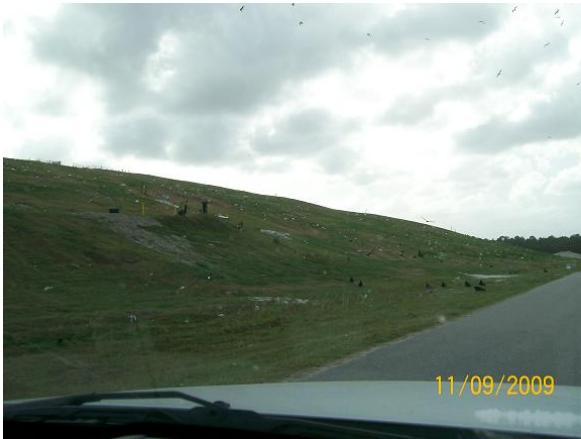
North Side Slopes

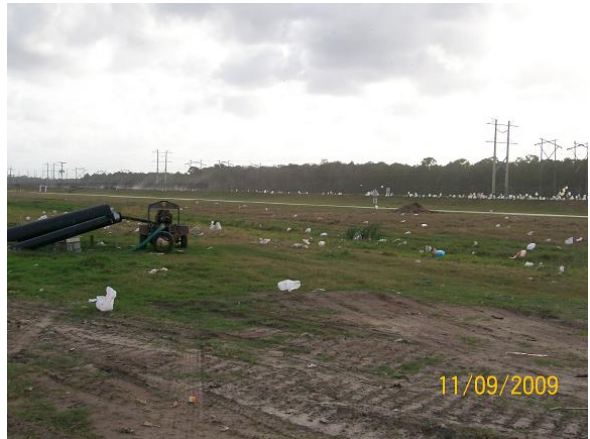
Rule: 62-701.500(7)(i), 62-701.500(11)(f)  
Question Number: 2.22  
Explanation: Blown litter was considerable throughout the facility. Winds were heavy the day of the inspection and the blown litter consisted mostly of plastic bags.  
Corrective Action: The facility is to take efforts to further control blown litter.

Blown litter throughout the facility was considerable. It should be noted that winds were very strong during the entire inspection. Jennifer Stirk stated that the facility's laborers have been working continuously to address the issue. Their work day was over by the time of inspection, however. The blown litter consisted mostly of empty plastic bags.

Blown litter near leachate ponds

Please ensure that all blown litter is collected and disposed of in a timely manner.
