**Florida Department of
Environmental Protection
Inspection Checklist**

Facility Name: TOMOKA FARMS ROAD LANDFILL

On-Site Inspection Start Date: 01/27/2010

Routine Operation Inspection for Landfill - Class I facility

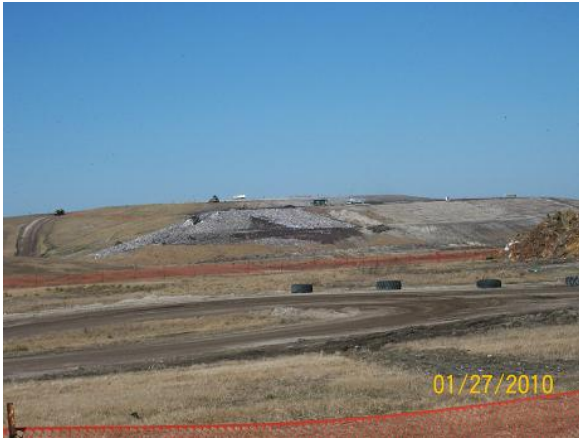
Class I overview

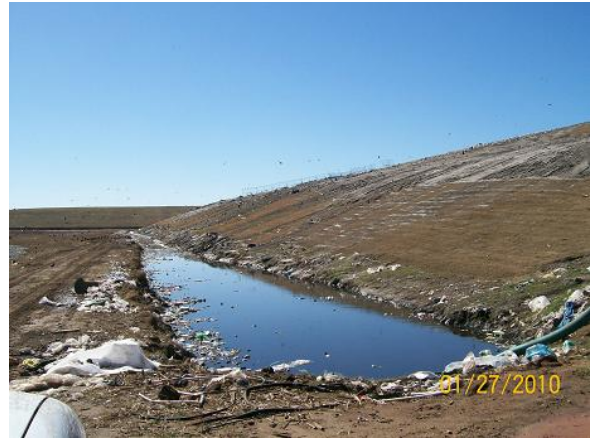
As in past inspections, leachate continues to flow just east of the current haul road (South side). An active flow is still observed originating on the side slopes near the surface. Flow continues to be diverted via a channel that wraps around the East side of the landfill into a trench. This leachate is pumped into riser number 5 via a portable pump. The trenched area continues to contain a large amount of waste from the above working face. This waste needs to be removed as soon as possible. As before, the leachate seepage appears to not mix with stormwater and remains within the lined area of the landfill.

Trenched Area on Class I East side

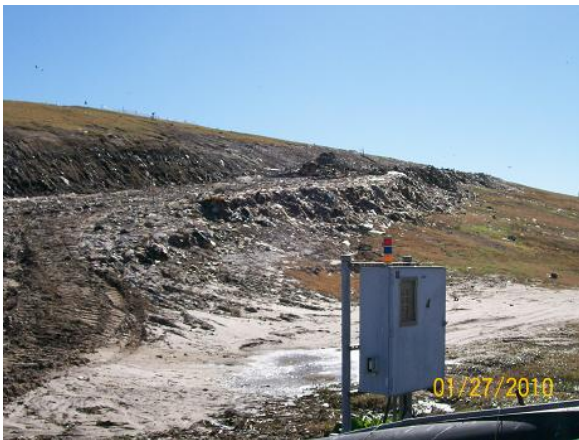
The new haul road's footprint is in place on the west side of the landfill. This process is producing large areas of exposed waste and should be covered as soon as possible. Chris Ellis said that the facility is planning to place roofing shingles over this area in the near future. Completion of the road should soon follow. It should be noted that record rainfall levels in the area have been contributing to delays on all of the facility's projects.

New Haul Road Construction

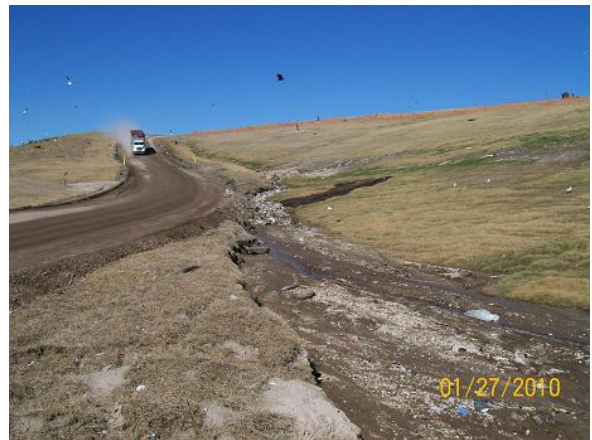
Explanation: Leachate continues to actively flow on the south side slopes west of the haul road where it is directed into a trench and is then pumped into the leachate ponds. It appears that the leachate continues to remain within the lined area of

the landfill.

Explanation: Leachate continues to actively flow on the south side slopes west of the haul road. As before the leachate flow is directed to an area at the toe of the east side of the active cell and remains in the lined area of the landfill.

Leachate Flow Near Haul Rd.

Corrective Action: Continue efforts with the gas system expansion in combination with the sequence of fill modifications to alleviate leachate seepage in this area.

Corrective Action: The facility is in the initial stages of implementing the approved sequence of fill plan. The facility believes that once the plan is in effect and the south side slopes are re-worked the leachate problems will cease. The facility is to continue these efforts.

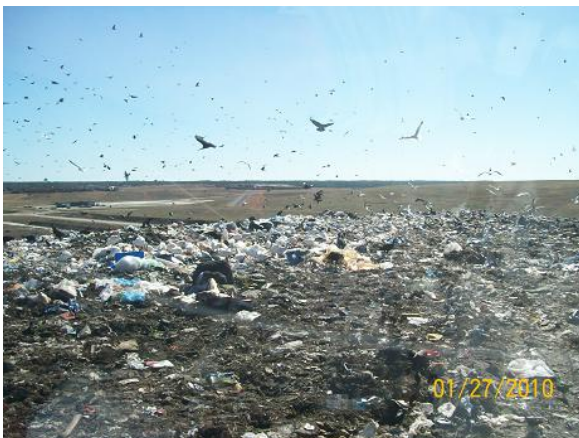
The working face is now on the SE side of the landfill. Intermediate cover is in place in the previous disposal area.

Class I Working Face

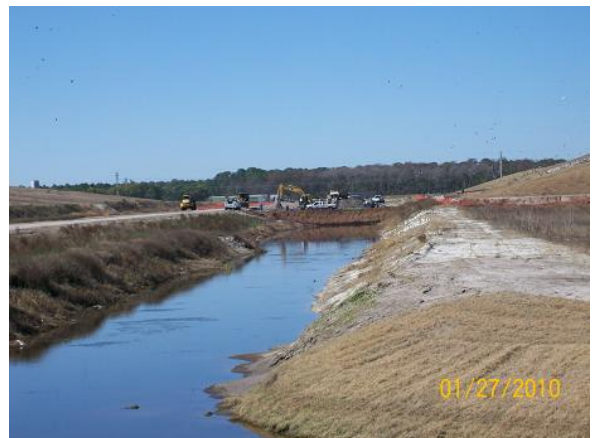
According to Chris Ellis, the facility plans to fill in an area of the stormwater ditch on the southeast side of the landfill adjacent to the toe of the slope. This is the only area the stormwater ditch currently extends to the adjacent side of the current south side slopes. A divider has been constructed on the far end of the area to be filled. The facility plans to fill in the rest of the area in the coming days.

Stormwater Canal Construction
