Florida Department of
Environmental Protection
Inspection Checklist

Facility Name: TOMOKA FARMS ROAD LANDFILL

On-Site Inspection Start Date: 04/21/2010

Routine Operation Inspection for Landfill - Class I facility

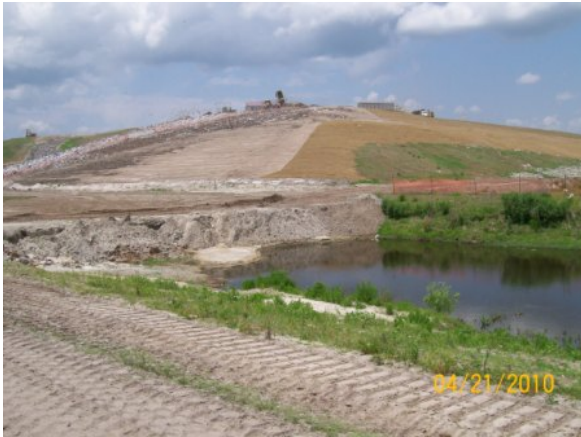
Class I overview

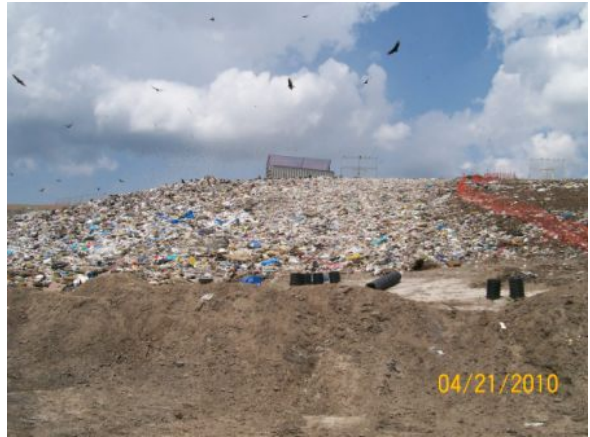
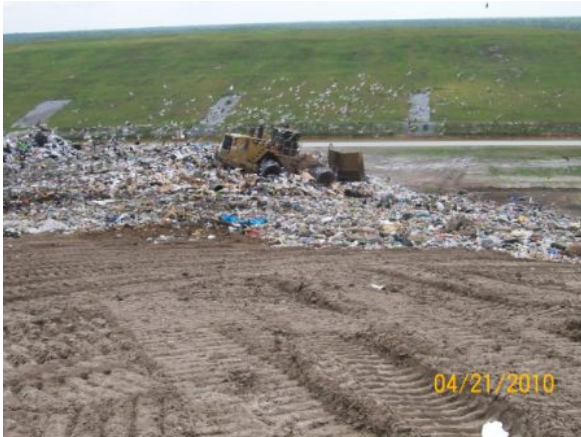
The working face has been relocated to the SE corner of the north cell in the area of the previous haul road. The road has been excavated and the working face covers the lower part of this former area. The upper part of the excavated road has not been filled in yet. The working face is now located over the former leachate seepage areas where the leachate channeled down the sides of the road (noted in previous inspections). There were no leachate seeps observed in this area. There was a decent amount of whole tires present in the working face. Jennifer Stirk called to have them picked up during the inspection. The facility is now utilizing the newly constructed haul road on the west side of the landfill.

Class I working face

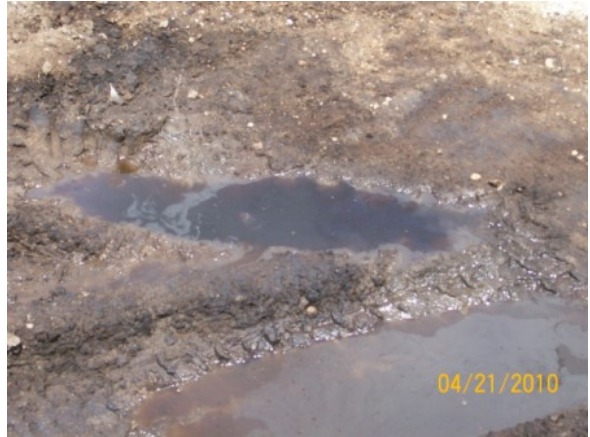
Explanation: A small leachate puddle was seen forming outside the lined area near the toe of

the south side slopes.

At the toe of the south side slope below the working face area, there was a discolored area with a small amount of leachate bubbling up from the ground. A small puddle of leachate was formed. This was just outside the liner boundary. Jennifer Stirk said that the facility will investigate the seep and take remedial actions.

Leachate seep at toe of slope

Corrective Action: The facility is to proceed with corrective actions to prevent leachate seepage outside the lined area of the landfill.

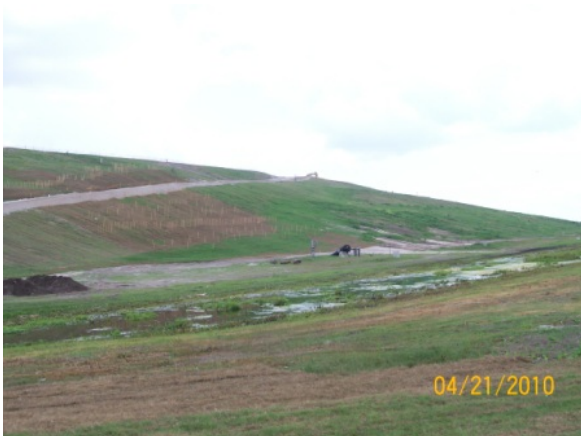
New haul road

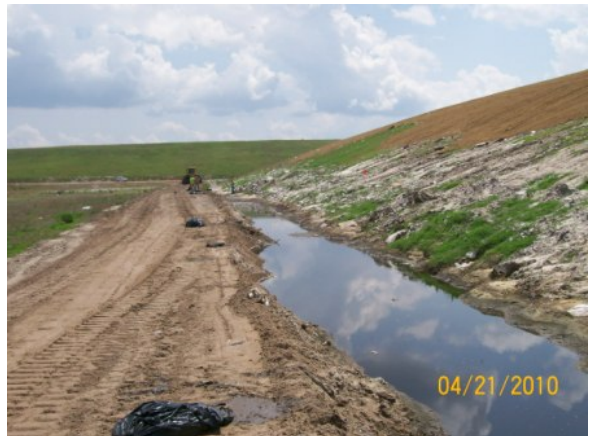
The facility is raising the height of the berm on the opposite side of the ditch along the east side slopes. This is being done in anticipation of heavier rains to prevent leachate from overflowing to unlined areas. At the time of inspection, leachate does not appear to flow off the south side slopes into the ditch as in previous inspections. However, a significant amount of leachate still is contained in the ditch which is deeper on the north side where the elevations are lower. The leachate is pumped into riser #5 as before. The leachate appears to be contained in the lined area.

E side slope ditch and berm

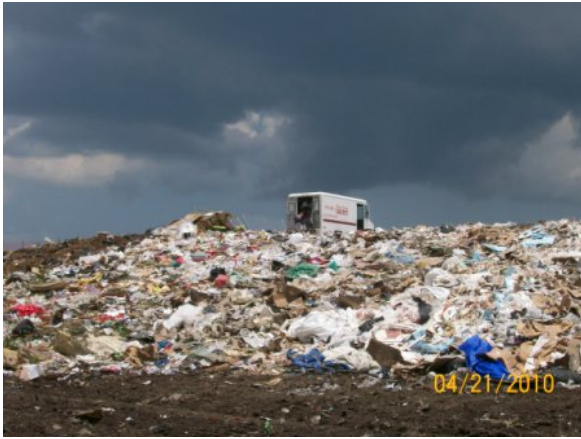
The current yard trash drop-off area is where the class III working face has been during previous inspections. The new class III working face has been shifted south along the west side slopes with about a 20 ft. lift.

Class III working face
