# THE IMPACT OF HURRICANE ELENA AND TROPICAL STORM JUAN ON COASTAL CONSTRUCTION IN FLORIDA

Beaches and Shores Post-Storm Report No. 85-3

March, 1986

Bureau of Coastal Engineering and Regulation  
Division of Beaches and Shores  
FLORIDA DEPARTMENT OF NATURAL RESOURCES

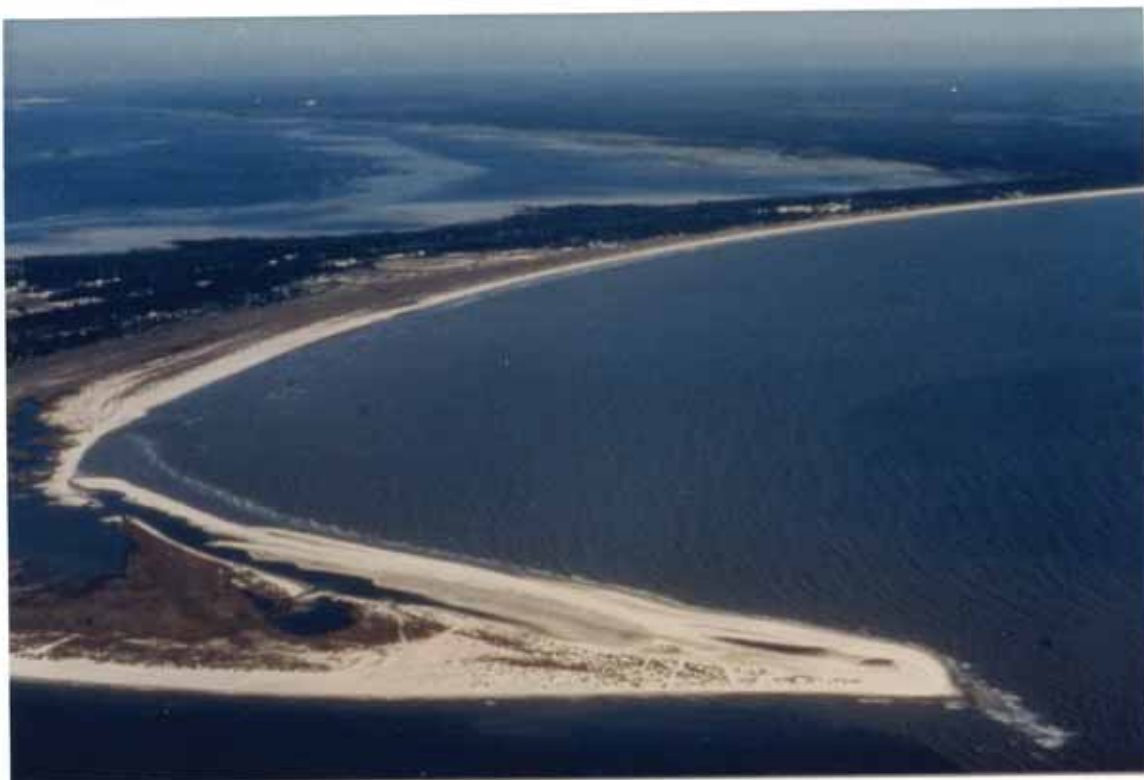
FIGURE 4. Cape San Blas, November, 1984 (K. R. Bodge)

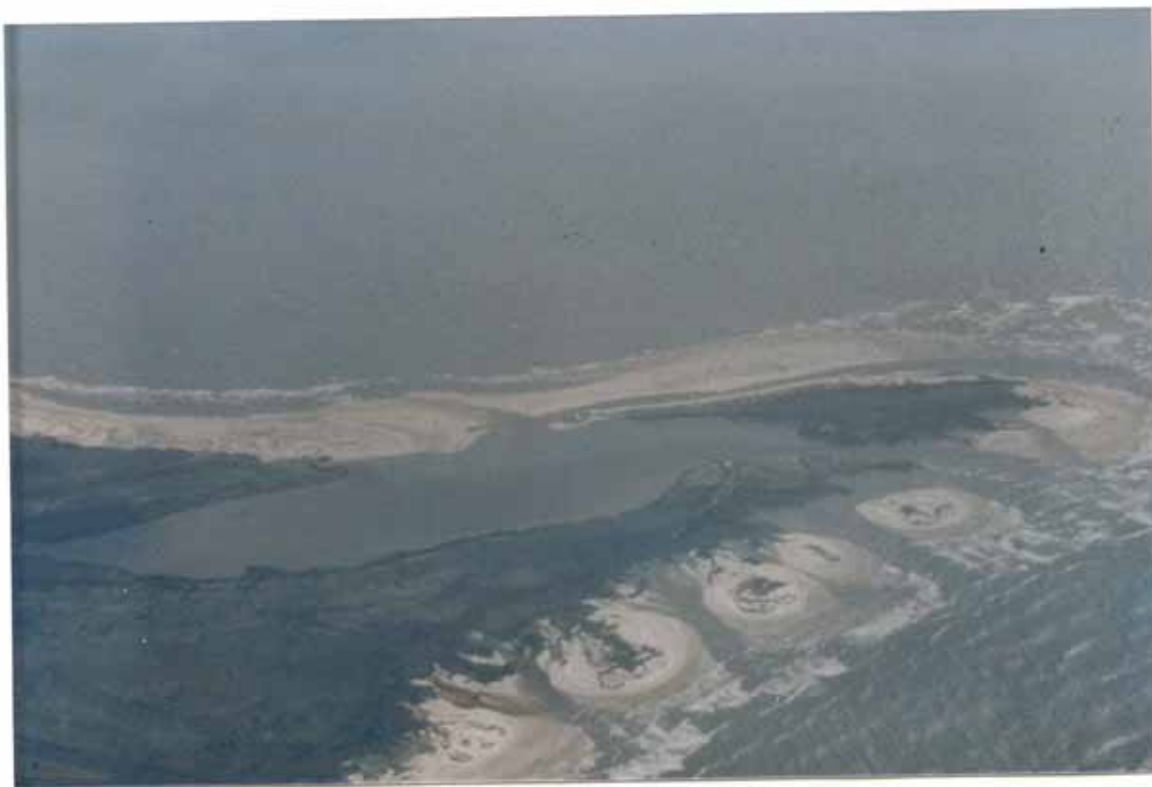
Because of the nearness to hurricane Elena moderate to heavy beach and dune erosion occurred along the St. Joseph Peninsula and eastward from Cape San Blas to Indian Pass. Approximately 1,500 feet off the exposed south tip of Cape San Blas disappeared as the hurricane's center passed by approximately 30 miles offshore (Figures 4 and 5). Several tidal channels were formed across the Cape south of the lighthouse beach access was inundated by coastal flooding. While the storm tide elevation was reported to be approximately +7.0 feet NGVD (Balsillie, 1985) there was undoubtedly a substantial head differential of the storm tide from east to west across the Cape and outer shoals as witnessed by the depth and alignment of the scour channels and the flattening of the dune and wetland vegetation covering the Cape. The fishing pier on Indian Peninsula was damaged by Elena. No other major structures on the Gulf County beaches were damaged

FIGURE 5. Cape San Blas, September 3, 1985 (K. R. Bodge)

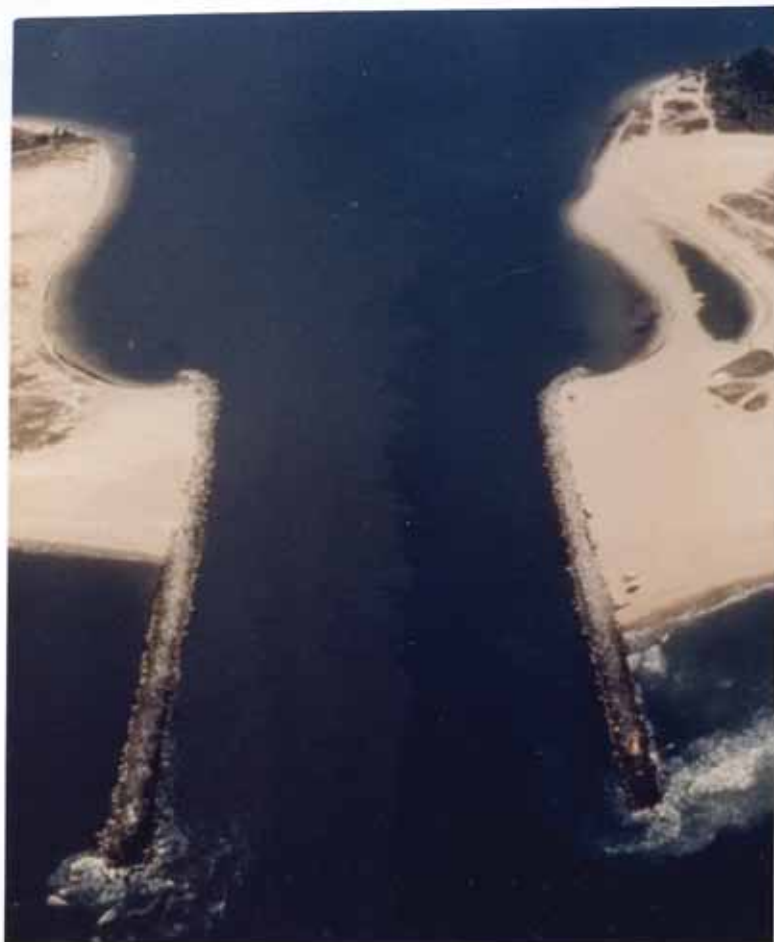
FIGURE 6. St. George Island Channel, November, 1984  
(K. R. Bodge)

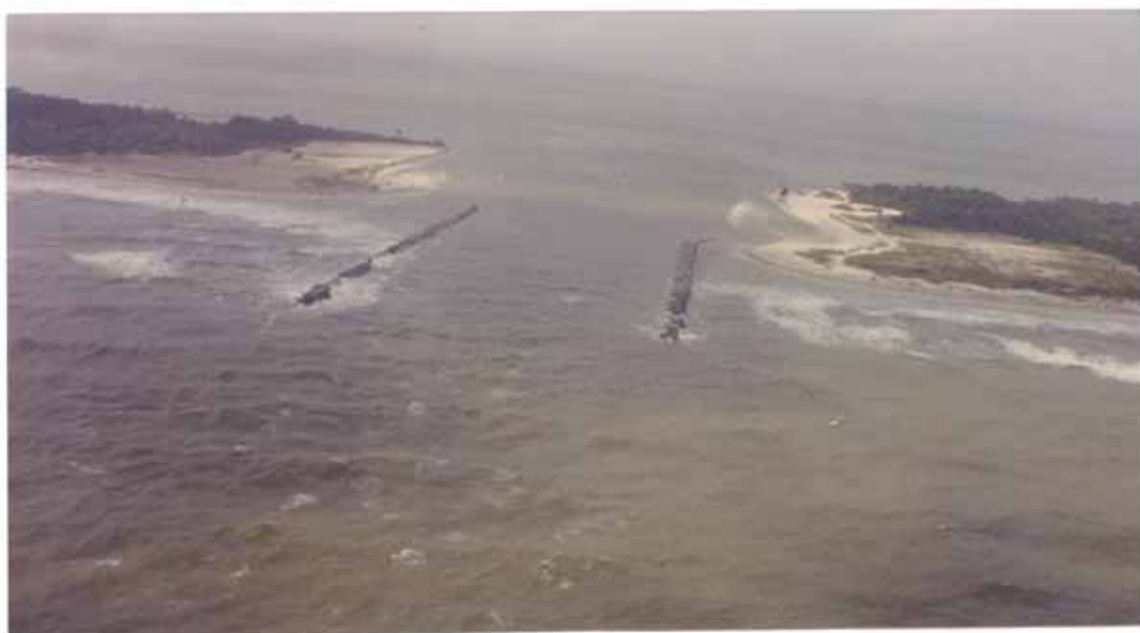
FIGURE 7. St. George Island Channel, September 2, 1985  
(H. N. Bean)

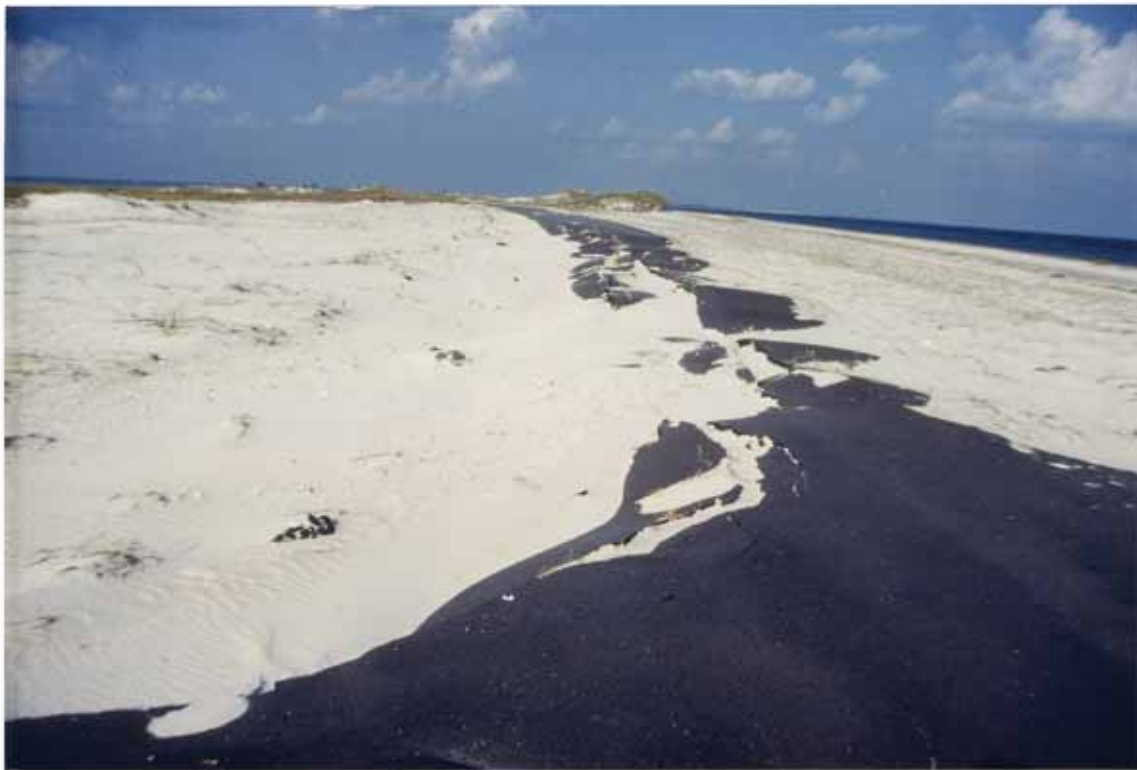
The park road was destroyed along much of its length in 1972 by hurricane Agnes. Reconstructed by the Florida Department of Transportation in the mid-1970's, the road has performed well for the past decade. Elena totally destroyed approximately 400 feet of the road at its eastern end (Figure 10). An additional 350 feet of the south pavement edge was damaged due to direct wave attack and undermining. Along approximately 20,650 feet or 3.91 miles of the road, the north pavement edge was damaged due to the hydraulic scour by storm surge overtopping. The pavement edge damage rendered this narrow two lane asphalt road unsuitable for safe driving conditions.

FIGURE 10. Park road segment destroyed by Elena,  
St. George Island

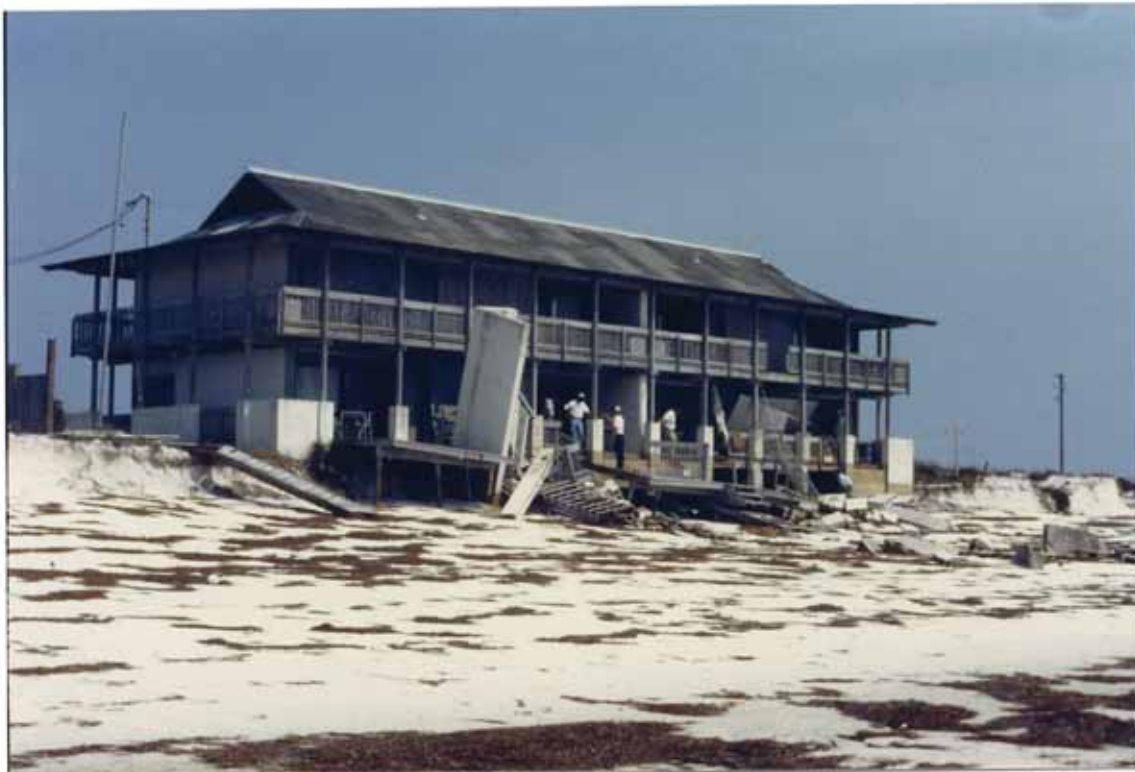
beach (Figure 12). It is not known whether the structure was damaged on August 30 when Elena initially passed offshore; however, following the erosion event of August 30 the building was certainly placed in imminent danger of collapse from further erosion which did occur on September 1 during the second and most devastating of offshore passes. Nearby, the multi-unit Pelican Inn sustained major deck and walkway damage and the concrete block stairwells on the front of the building were destroyed (Figure 13).

FIGURE 13. Pelican Inn damaged by Elena, Dog Island (G. L. Hill)

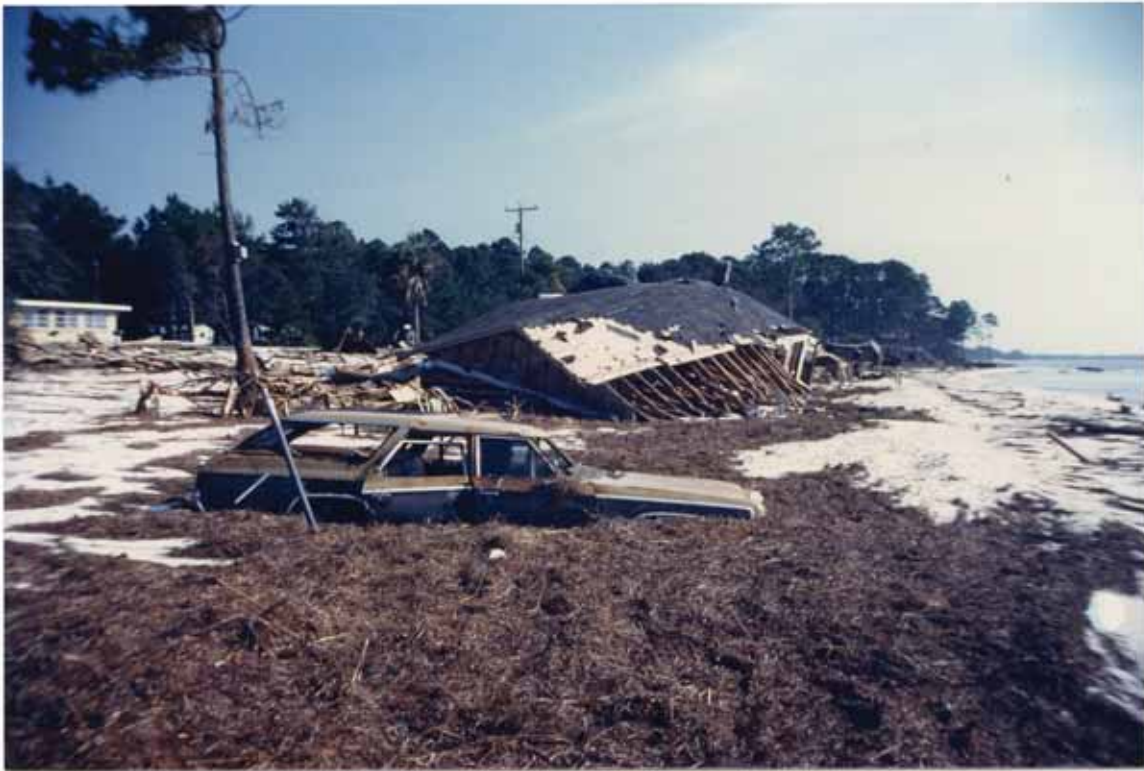
FIGURE 18. Carrabelle Beach after Elena

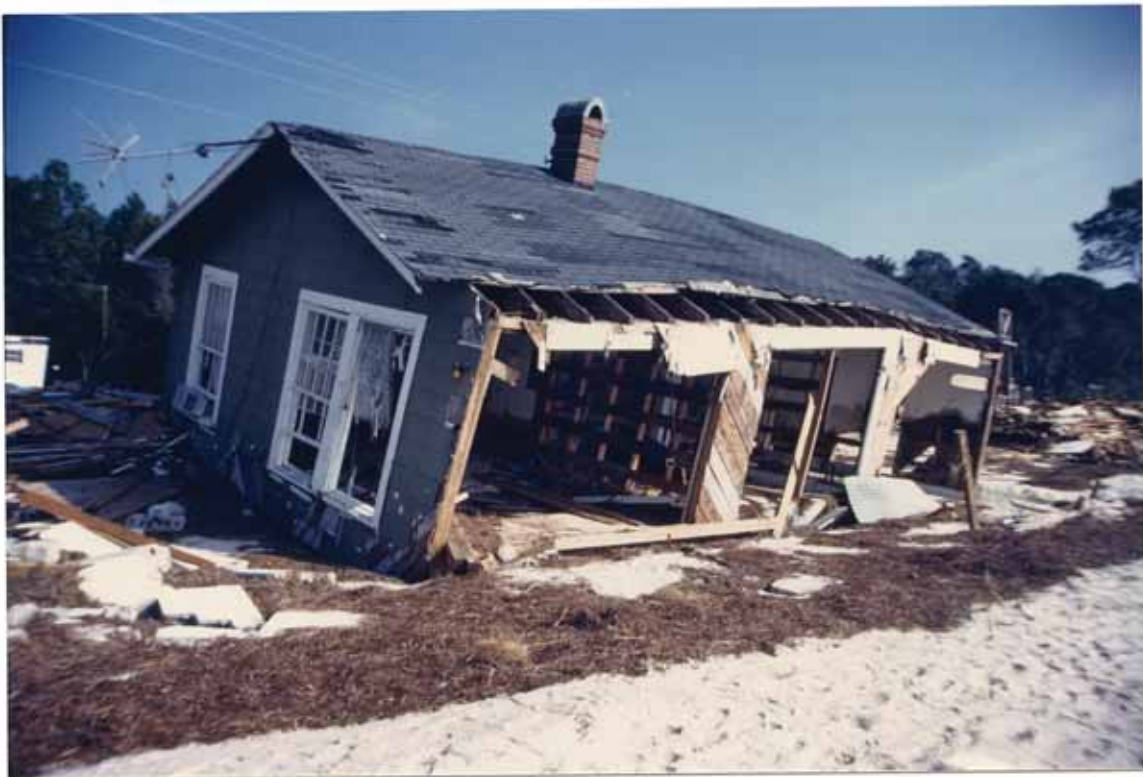
FIGURE 19. Carrabelle Beach dwelling destroyed by Elena

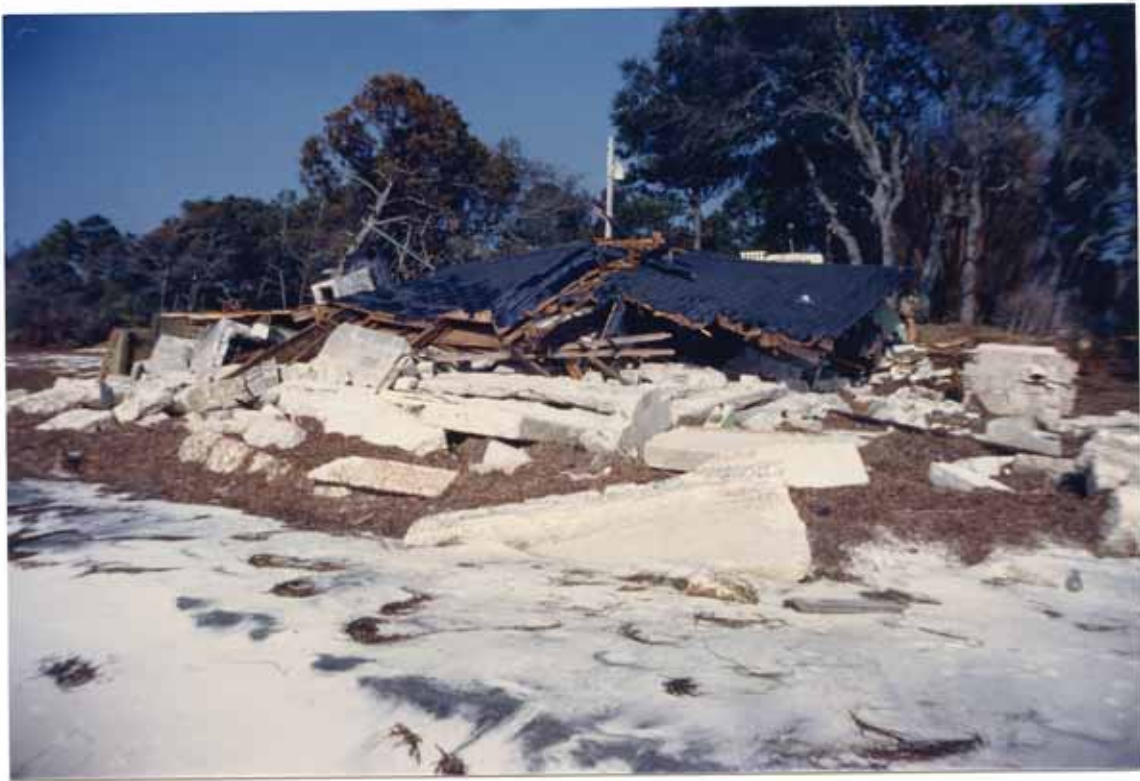
FIGURE 20. Carrabelle Beach dwelling destroyed by Elena

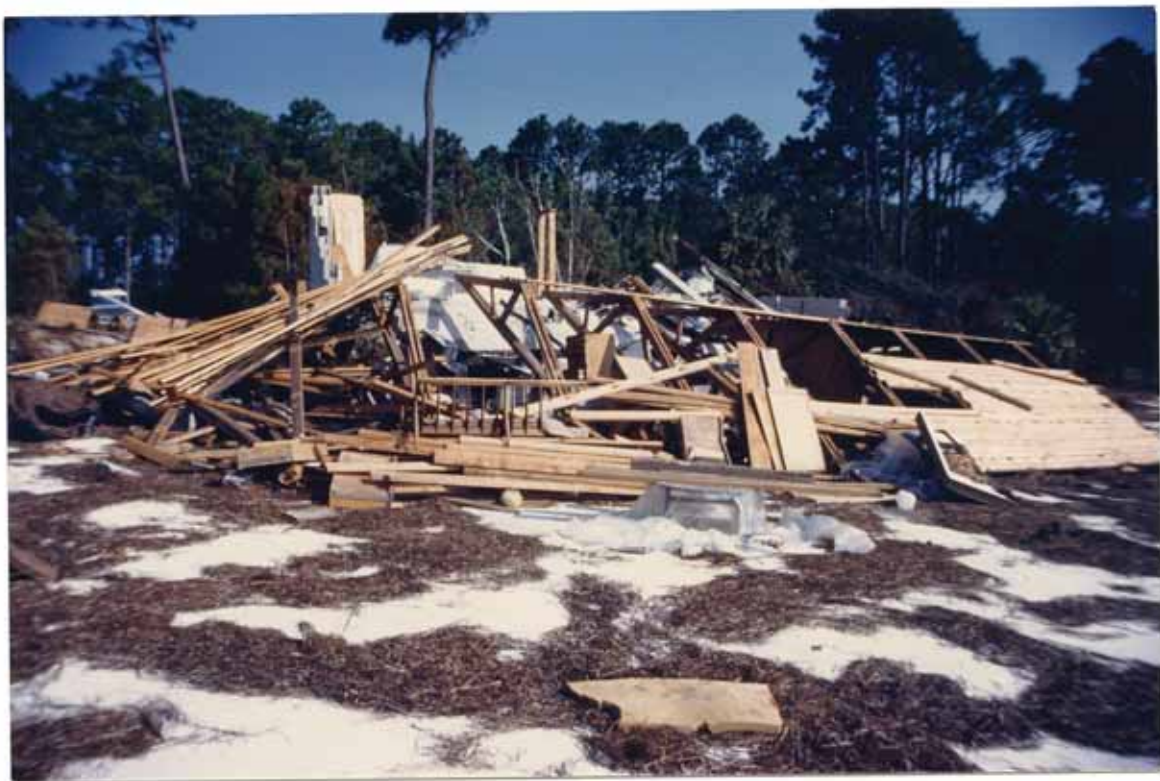
FIGURE 21. Carrabelle Beach dwelling destroyed by Elena

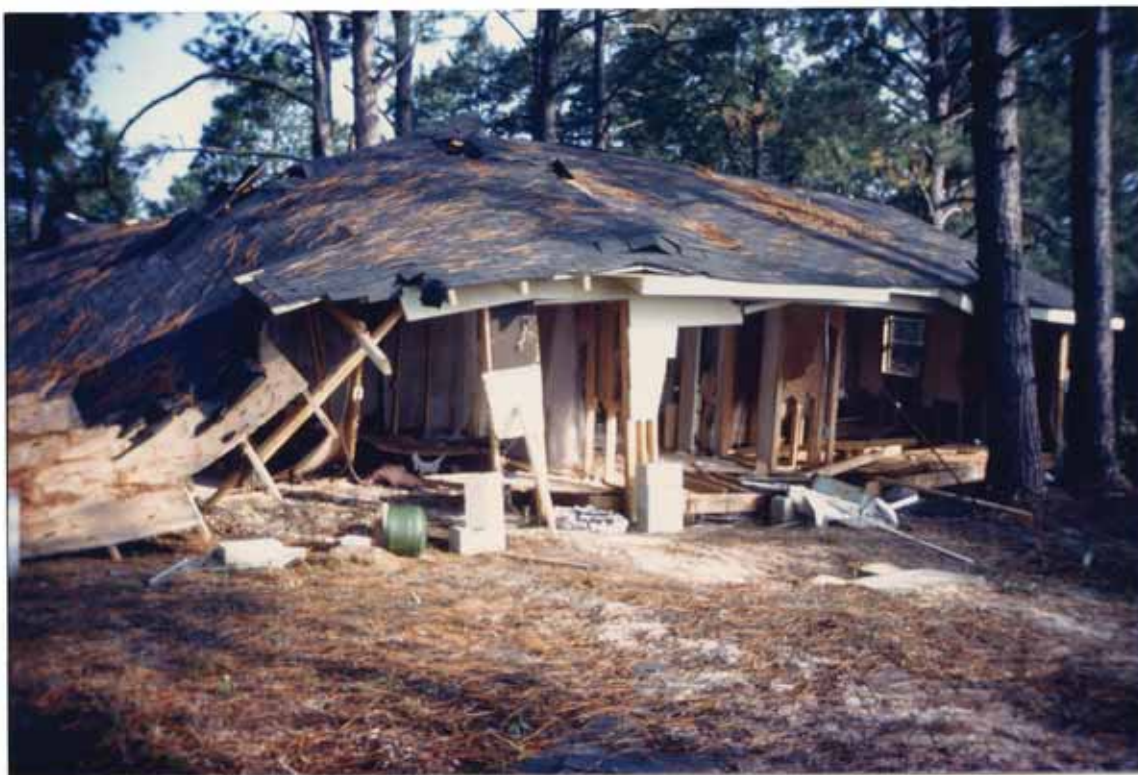
Along the shoreline near Lanark, adjacent the open water expanse between Dog Island and Alligator Point, one wood framed single-family dwelling was destroyed (Figure 22). This structure was not inappropriately sited because its location was a couple hundred feet from the shoreline in an upland stand of pines; however, the structure was not sufficiently elevated and it sustained heavy damage from the storm tide and direct wave activity.

FIGURE 22. Lanark dwelling destroyed by Elena

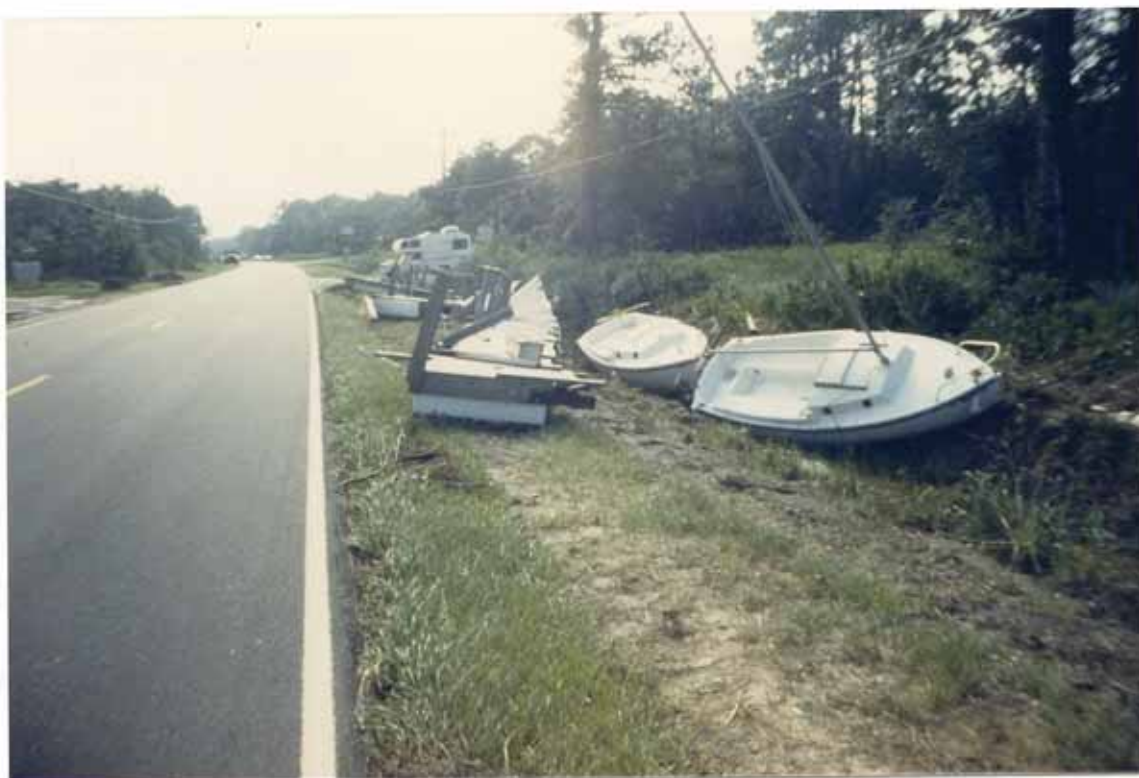
At the Lanark Marina, the storm tide and wave activity from Elena carried the floating docks and a few boats across the crown of U.S. Highway 98 and placed them in the ditch along the north right-of-way (Figure 23). The crown elevation of the road was measured at +7.487 feet NVGD by the survey team of the Bureau of Coastal Data Acquisition, Division of Beaches and Shores.

FIGURE 23. Elena's flooding at Lanark Marina, U.S. 98

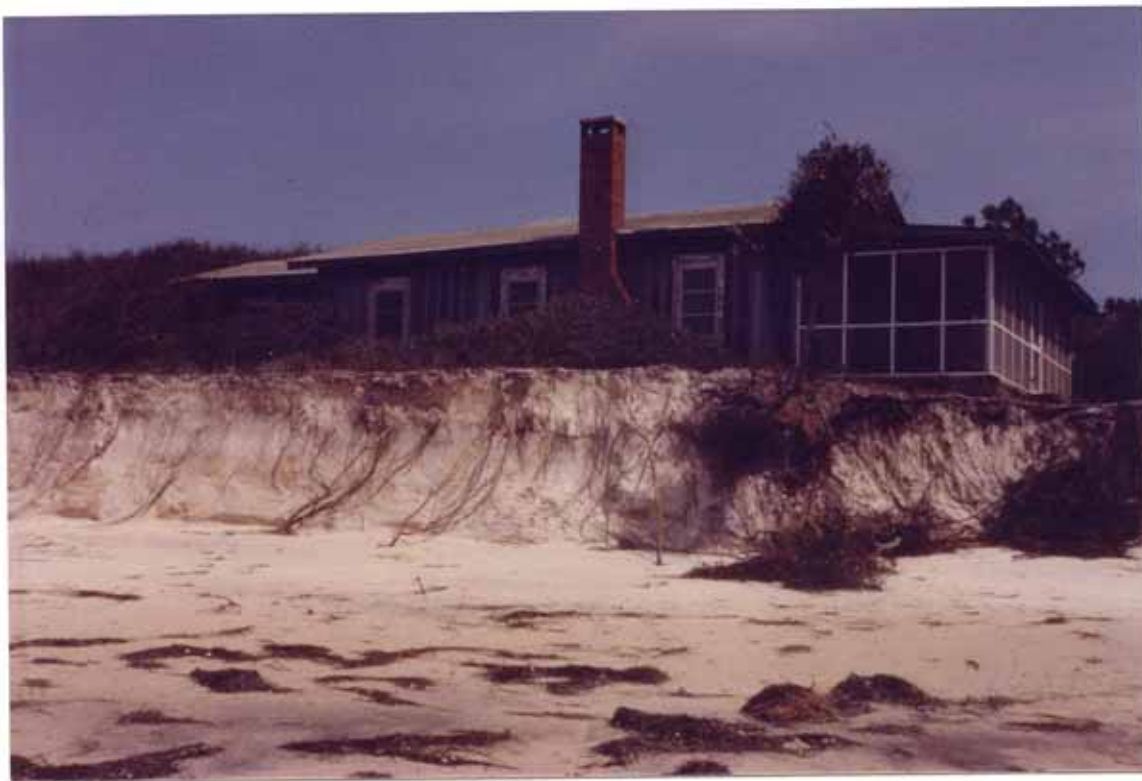
Along Chip Morrison Drive, a few dwellings immediately east of the Southwest Cape were placed in imminent danger and were in need of being relocated inland. Heavy dune erosion from Elena nearly reached these slab-on-grade structures (Figures 25 and 26). Between 500 and 800 feet east of the southwest Cape, a 300 foot long rock revetment was constructed to protect three dwellings after the "El Niño" extratropical storms inflicted heavy dune erosion in the spring of 1983. This stretch of revetment was authorized by the Department of Natural Resources and most of it was constructed to the Department's engineering recommendations. The eastern eighty feet and western eighty feet of this revetment was damaged primarily because of flanking around the ends of the structure which did not have sufficient returns into the upland. It had been anticipated that the revetment would continue both westward to stable shoreline conditions and eastward 200 feet to an existing rock revetment. The western end damage was also due to the low crest elevation and storm wave overtopping which caused substantial erosion losses behind the structure as well as around the end.

FIGURE 26. Southwest Cape dwelling threatened by Elena's erosion

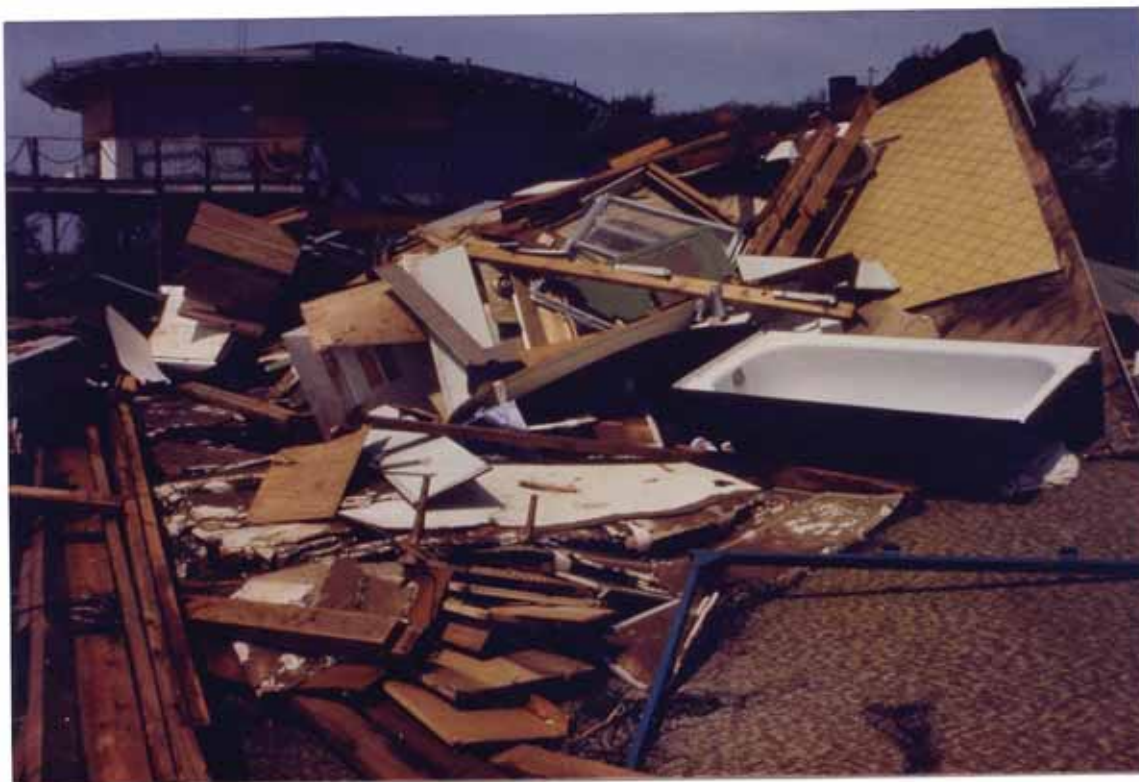
the structure leaving it in one compact heap of wood, furniture and fixtures (Figure 27). The next single-family dwelling to the east was left in imminent danger of collapse even though it remained standing after the storm. Additional piling supports are needed, regardless of whether a revetment is constructed at the site.

FIGURE 27. Southwest Cape dwelling destroyed by Elena

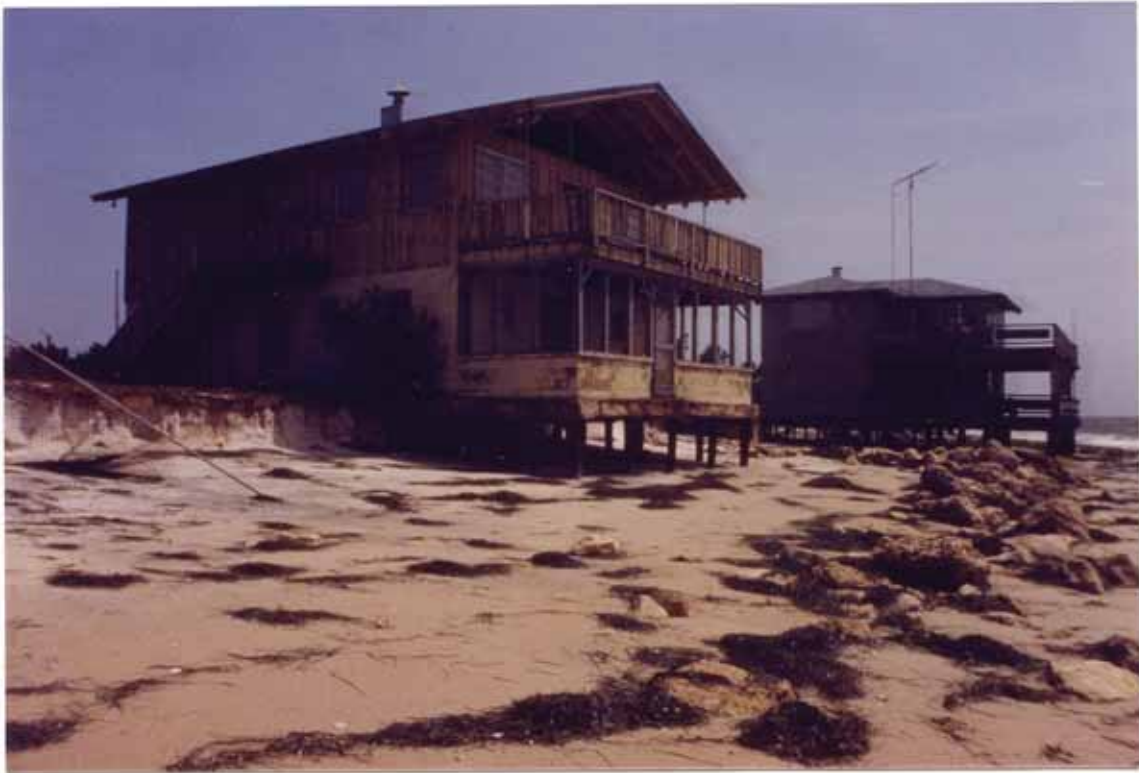
FIGURE 28. Southwest Cape revetment destroyed and dwelling undermined

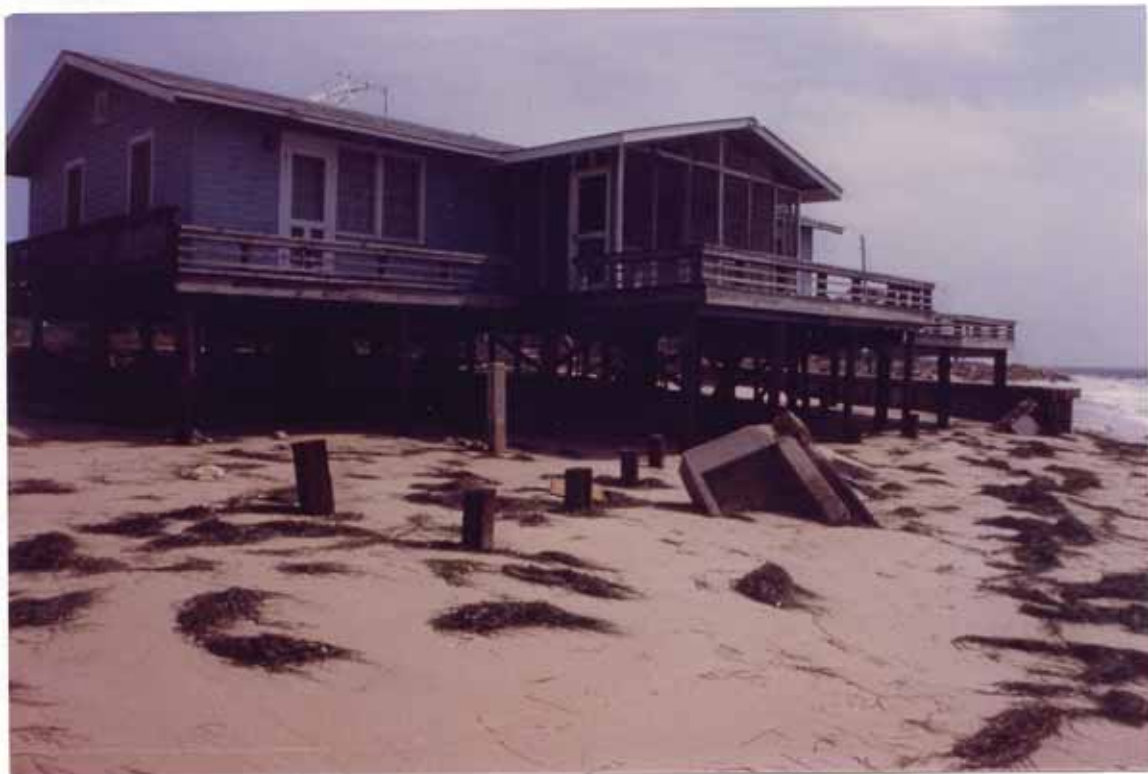
FIGURE 29. Southwest Cape bulkhead destroyed by Elena's waves

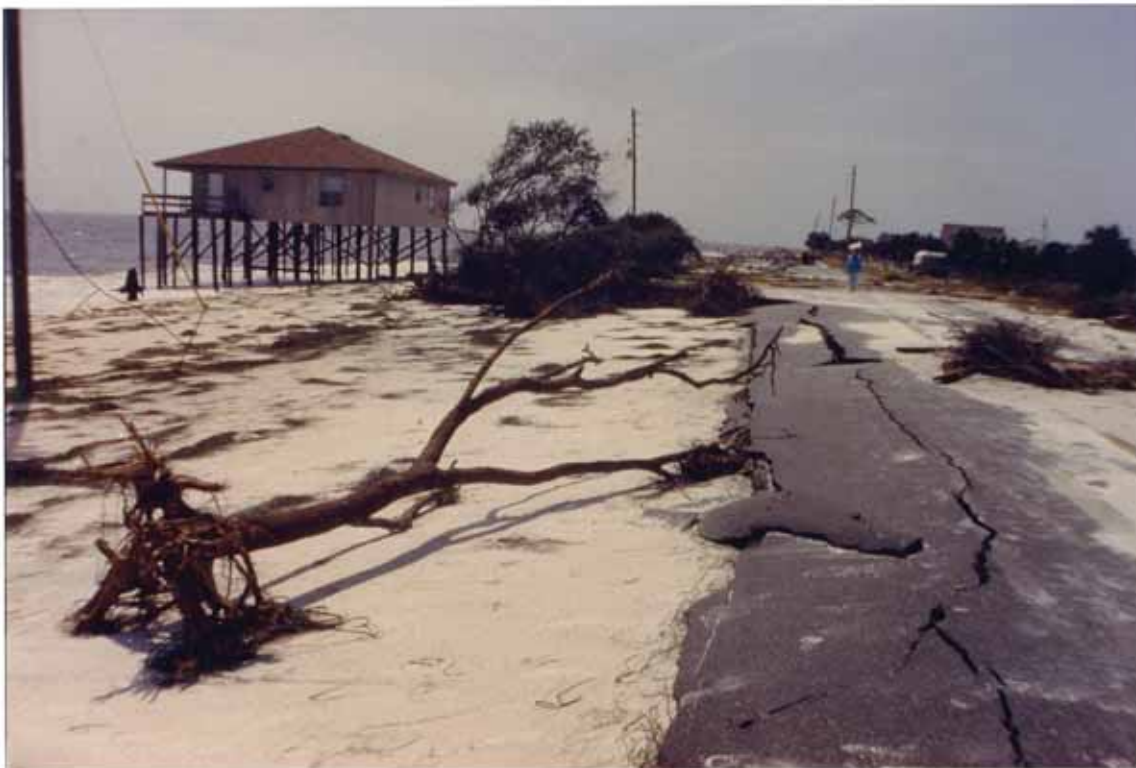
East of the KOA Campgrounds, four pile supported single-family dwellings sustained only light damages as their septic systems, stairways, and utilities were substantially damaged (Figures 32 and 33). One dwelling's fiberglass septic tank was transported approximately 250 feet westward before being deposited along the

FIGURE 33. Elena erosion and damage

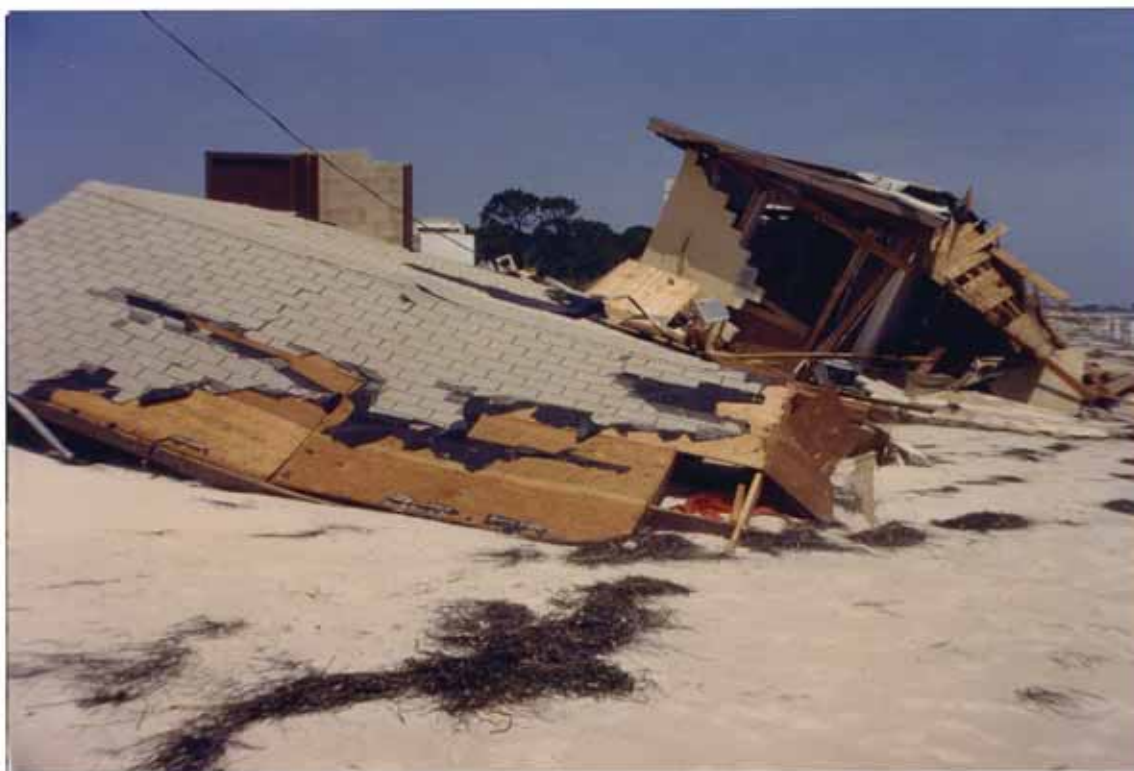
FIGURE 35. Same dwelling destroyed by Elena's erosion and waves on September 1

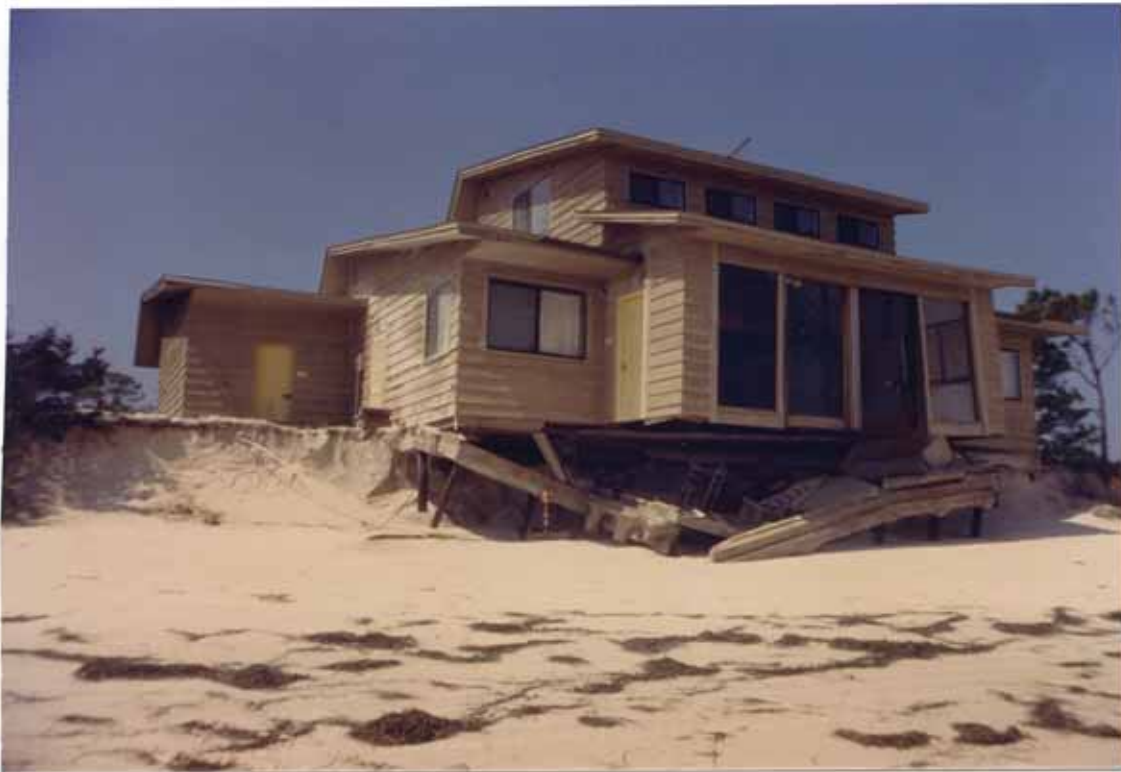
FIGURE 42. Lighthouse Point dwelling damaged by Elena's erosion

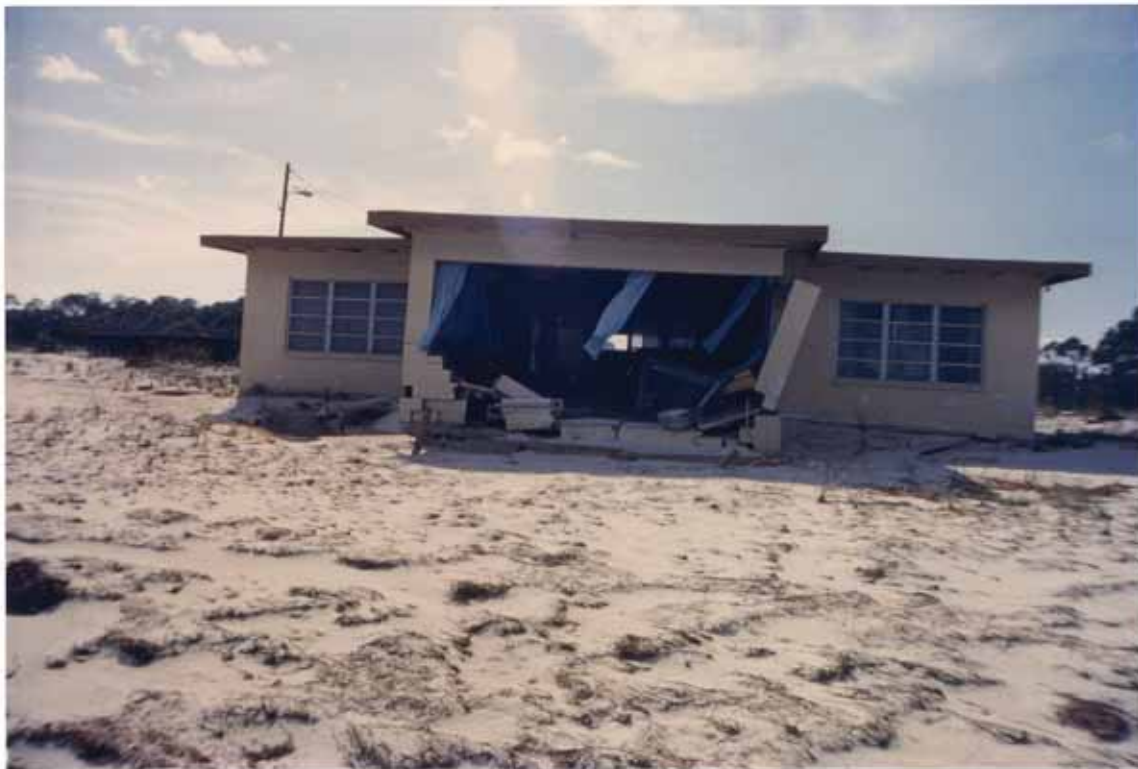
FIGURE 43. Elena's waves damaged dwelling near Bald Point

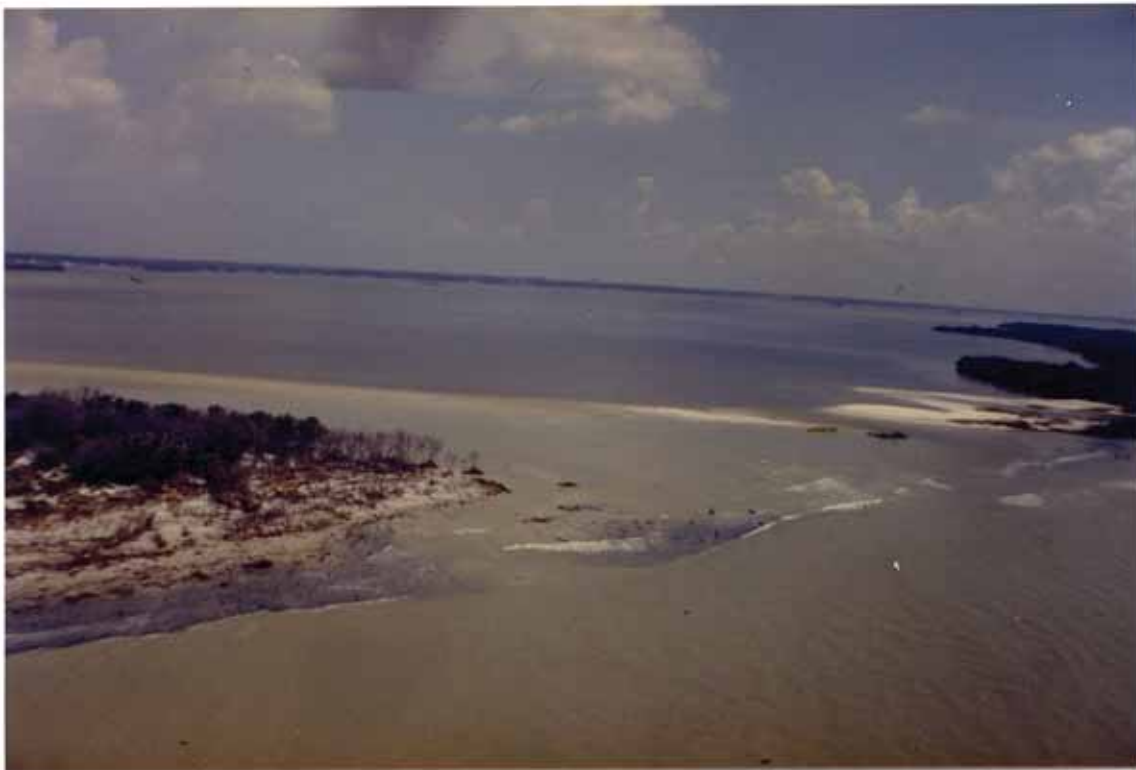
FIGURE 49. Major inlet breakthrough on Caladesi Island

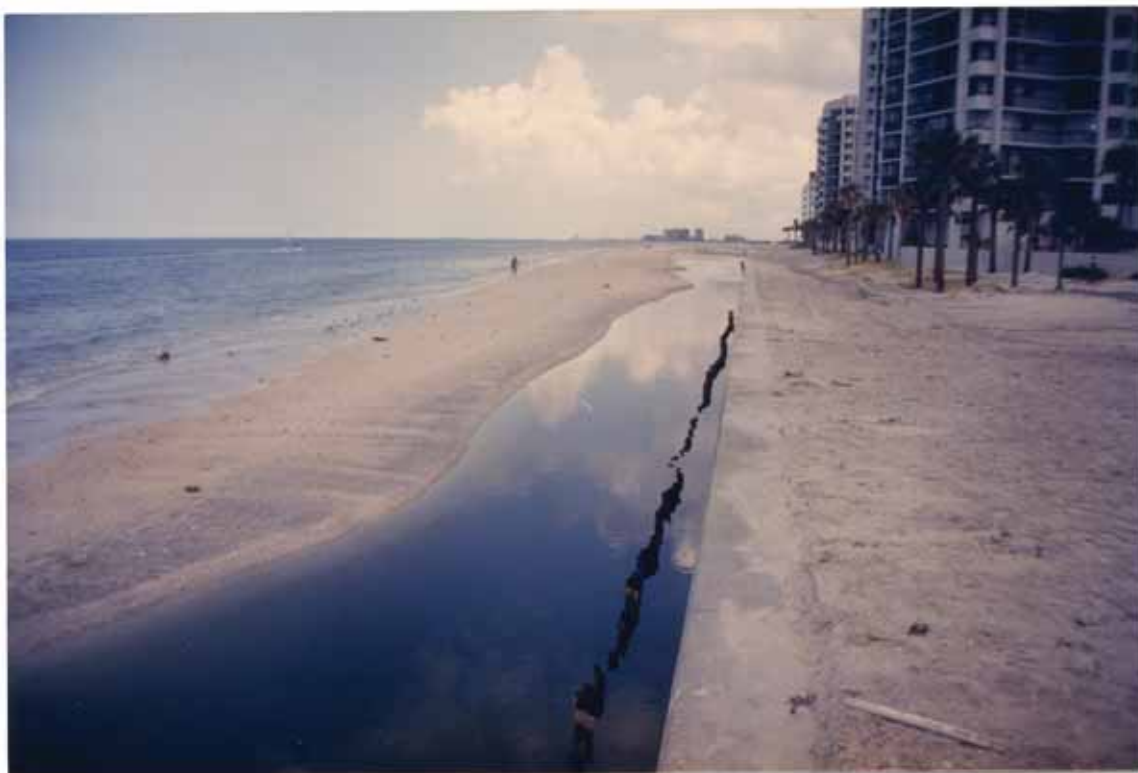
FIGURE 51. Scoured beach adjacent vertical bulkhead

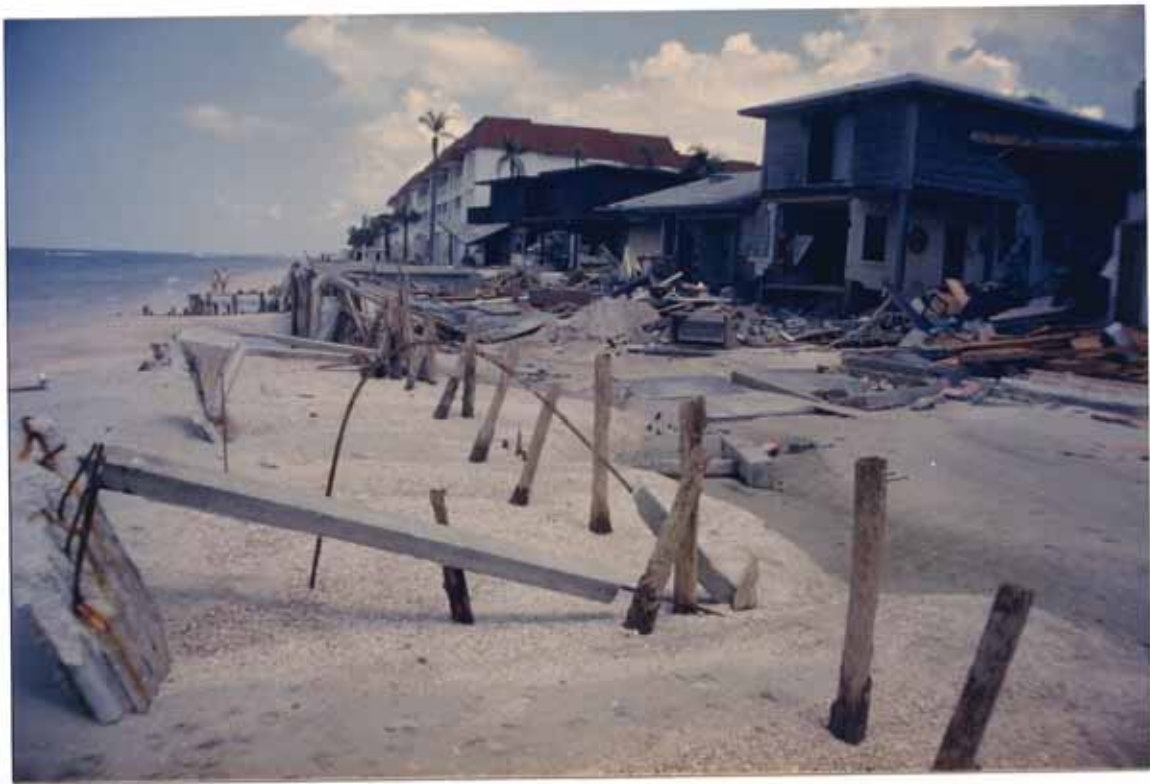
FIGURE 55. Concrete bulkhead destroyed by Elena, Belleair Beach

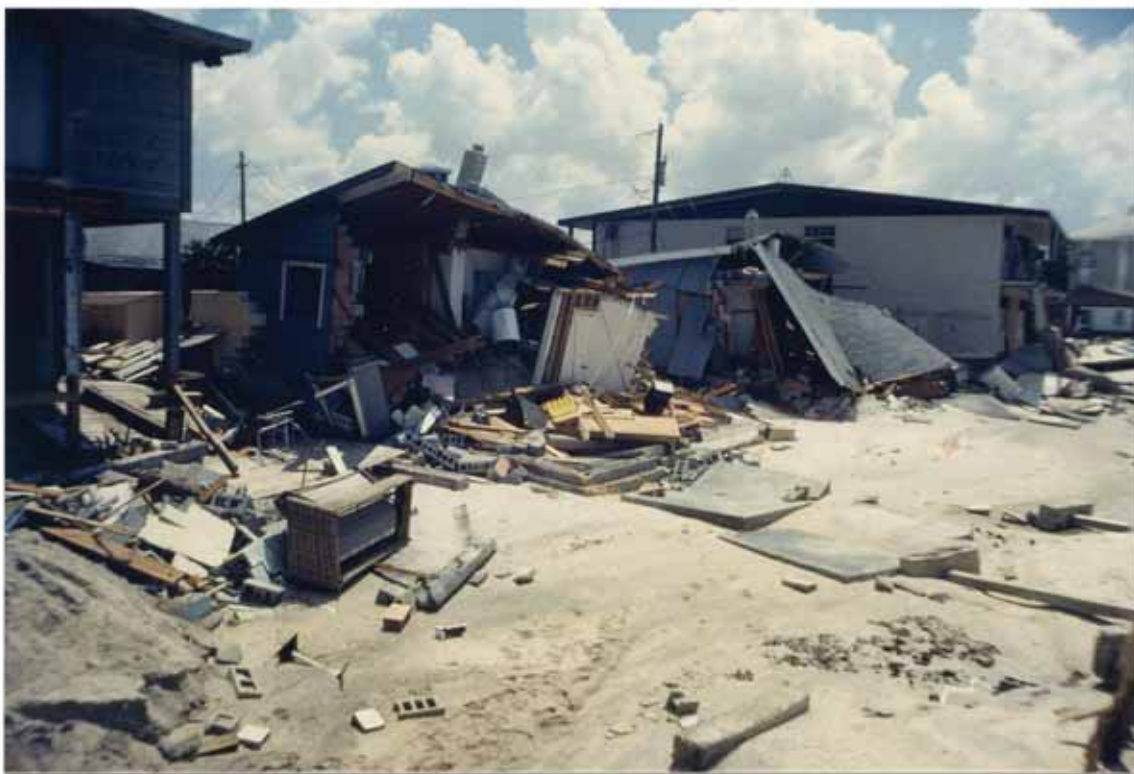
FIGURE 56. Belleair Beach dwellings destroyed by Elena
