# THE IMPACT OF HURRICANE ELENA AND TROPICAL STORM JUAN ON COASTAL CONSTRUCTION IN FLORIDA

Beaches and Shores Post-Storm Report No. 85-3

March, 1986

Bureau of Coastal Engineering and Regulation  
Division of Beaches and Shores  
FLORIDA DEPARTMENT OF NATURAL RESOURCES

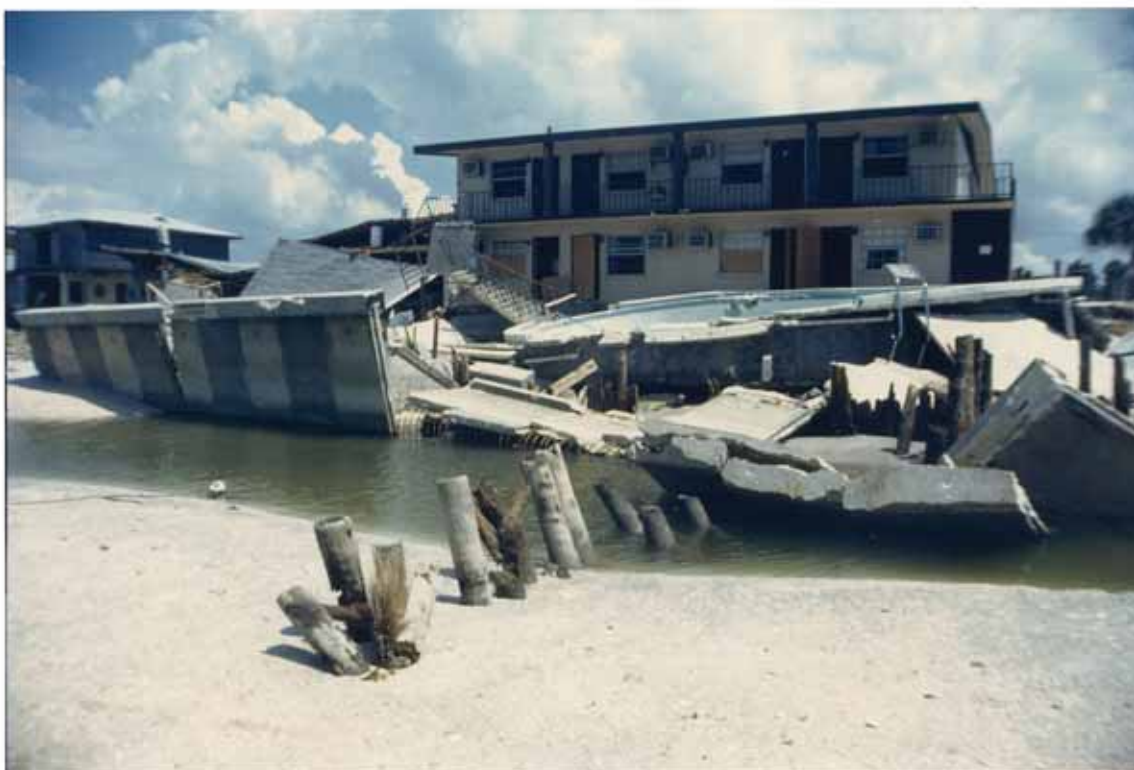
FIGURE 57. Bulkhead and swimming pool destroyed Chateau Motel, Belleair Beach

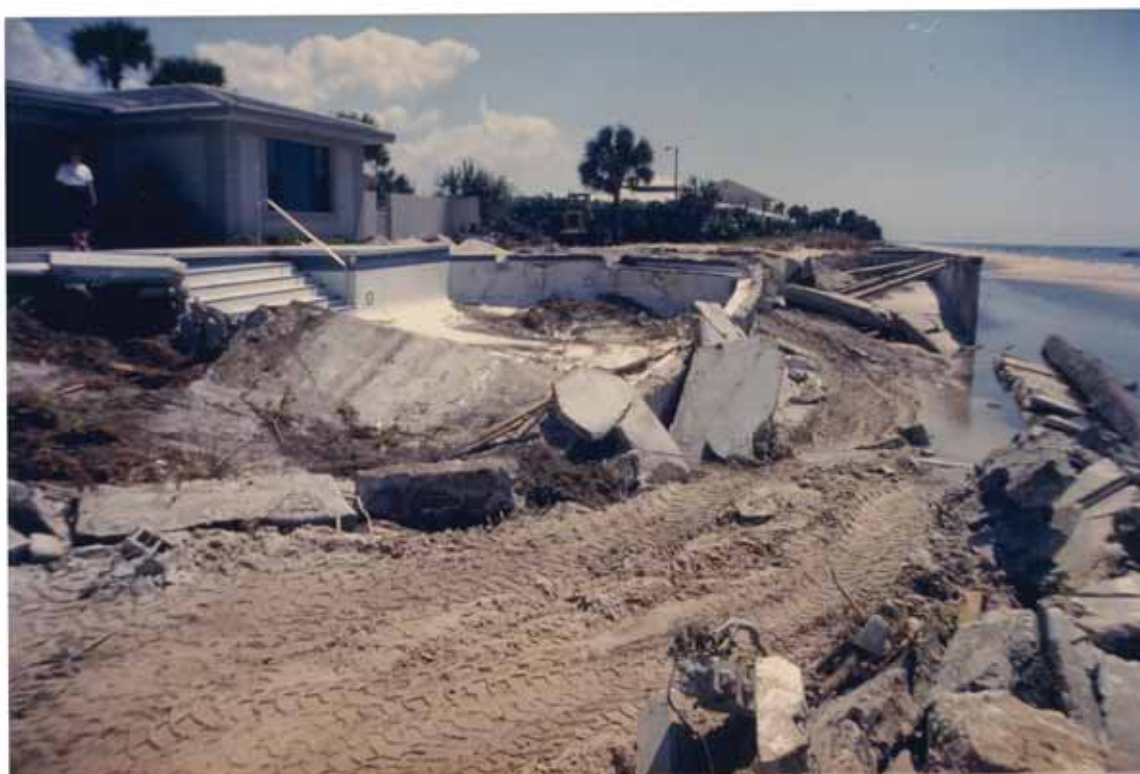
FIGURE 65. Wall and pool destroyed

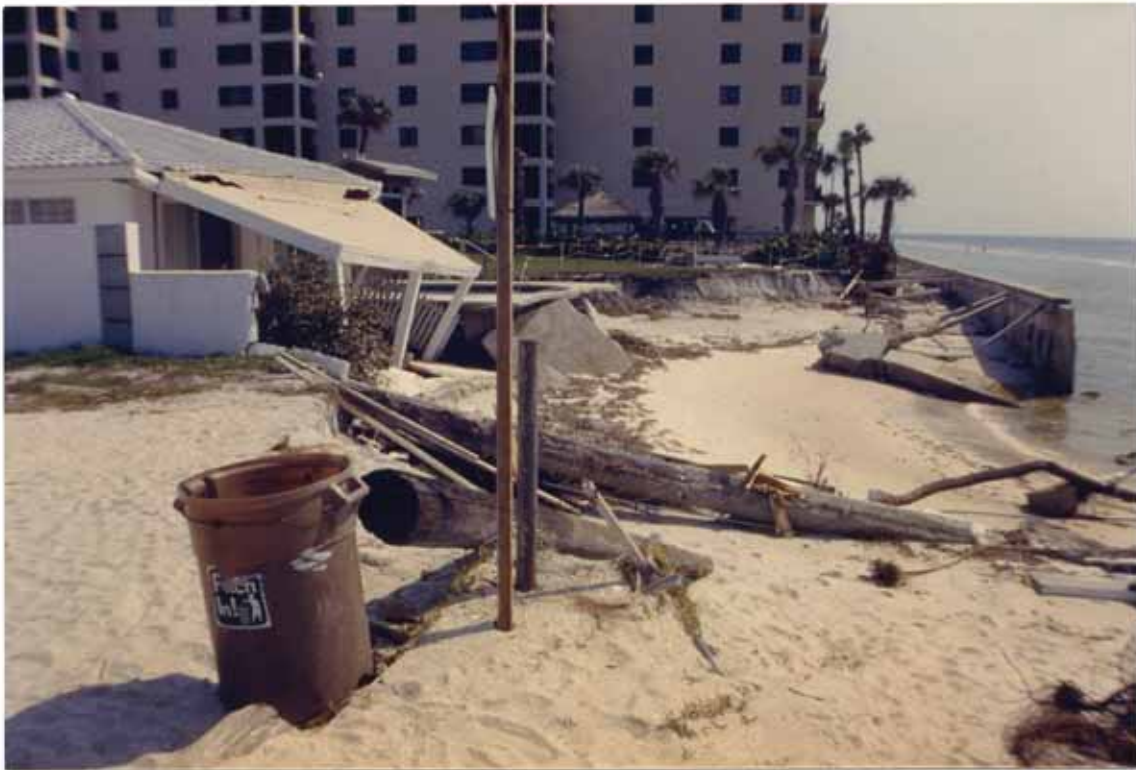
FIGURE 70. Damage at 25th Avenue, Indian Rocks Beach

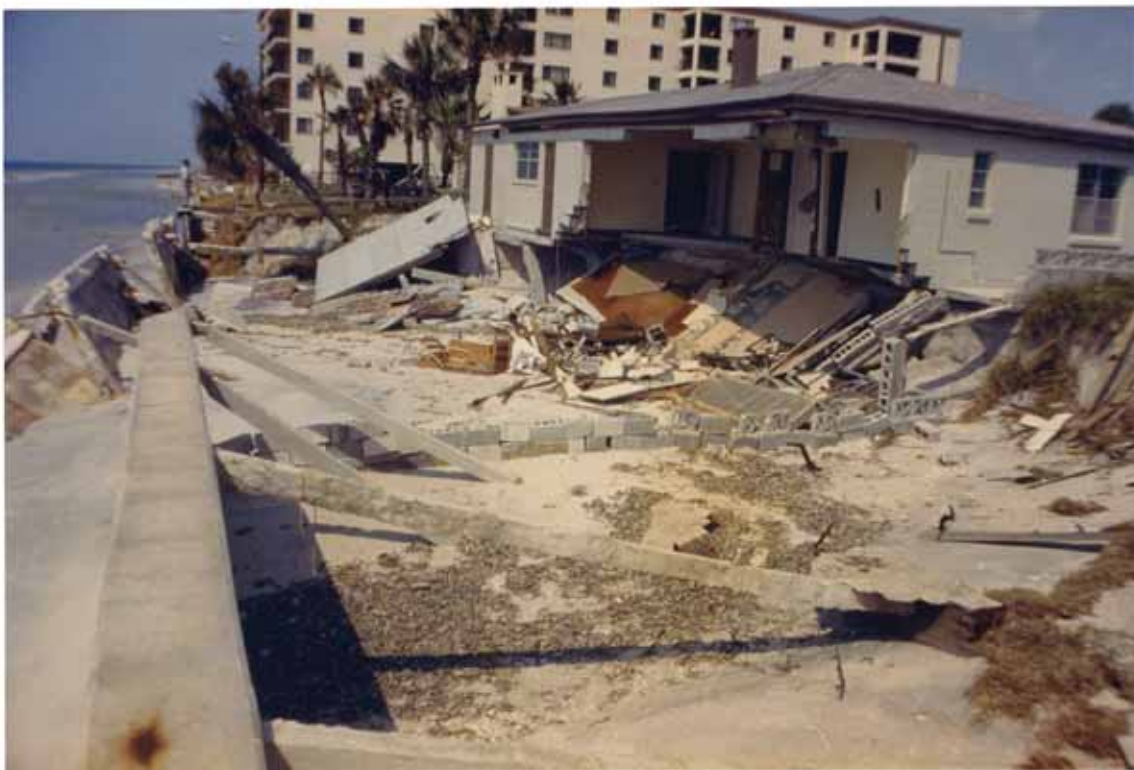
FIGURE 72. Dwelling damaged by Elena

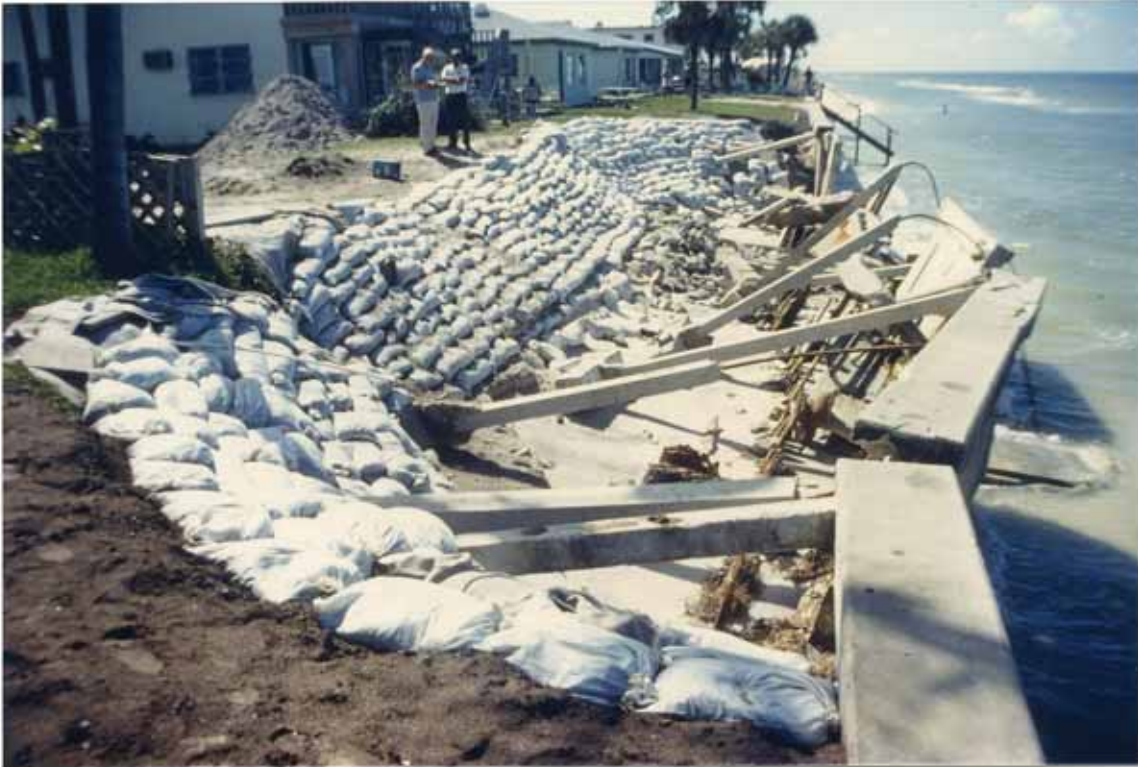
FIGURE 75. Post-Elena emergency protection, 23rd Avenue

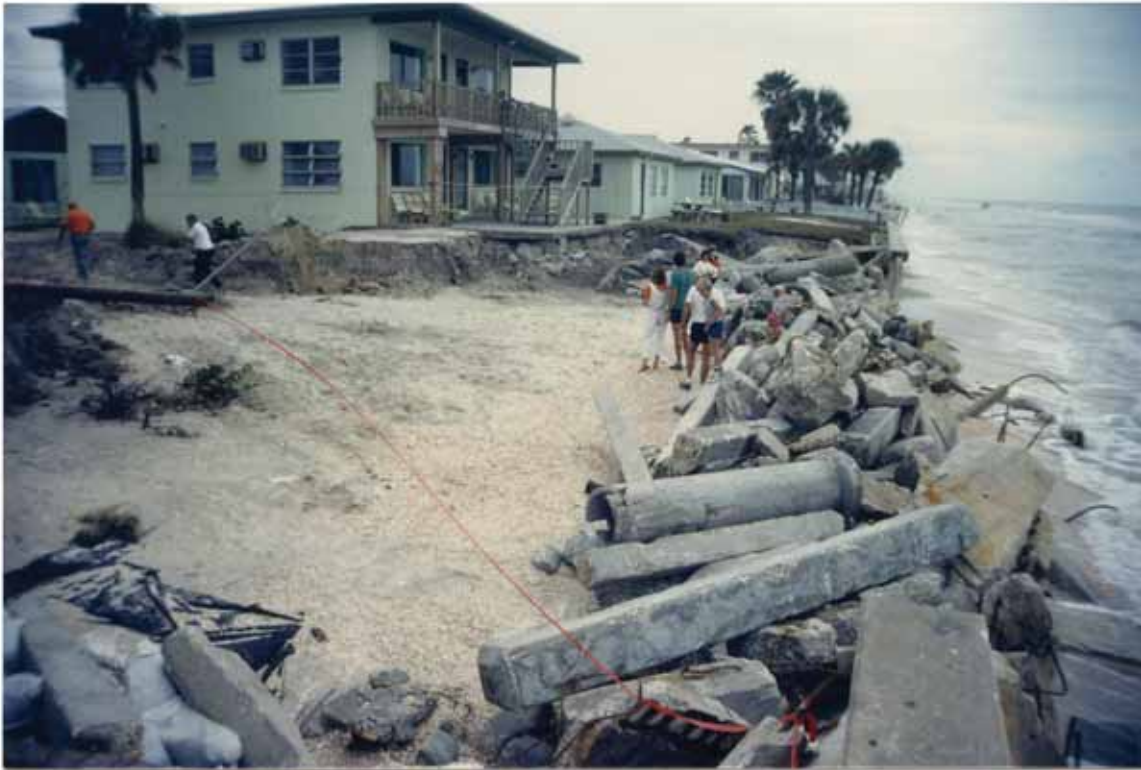
FIGURE 76. Juan destroyed 23rd Avenue

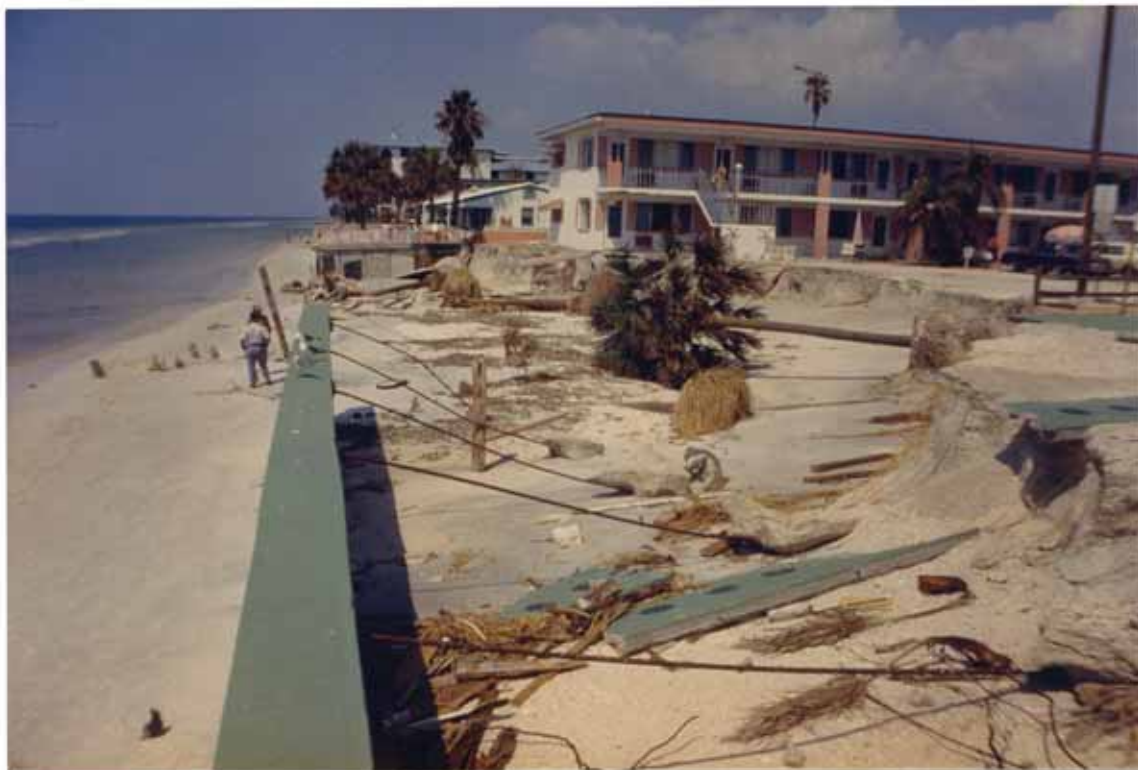
FIGURE 77. Elena destroyed 22nd Avenue

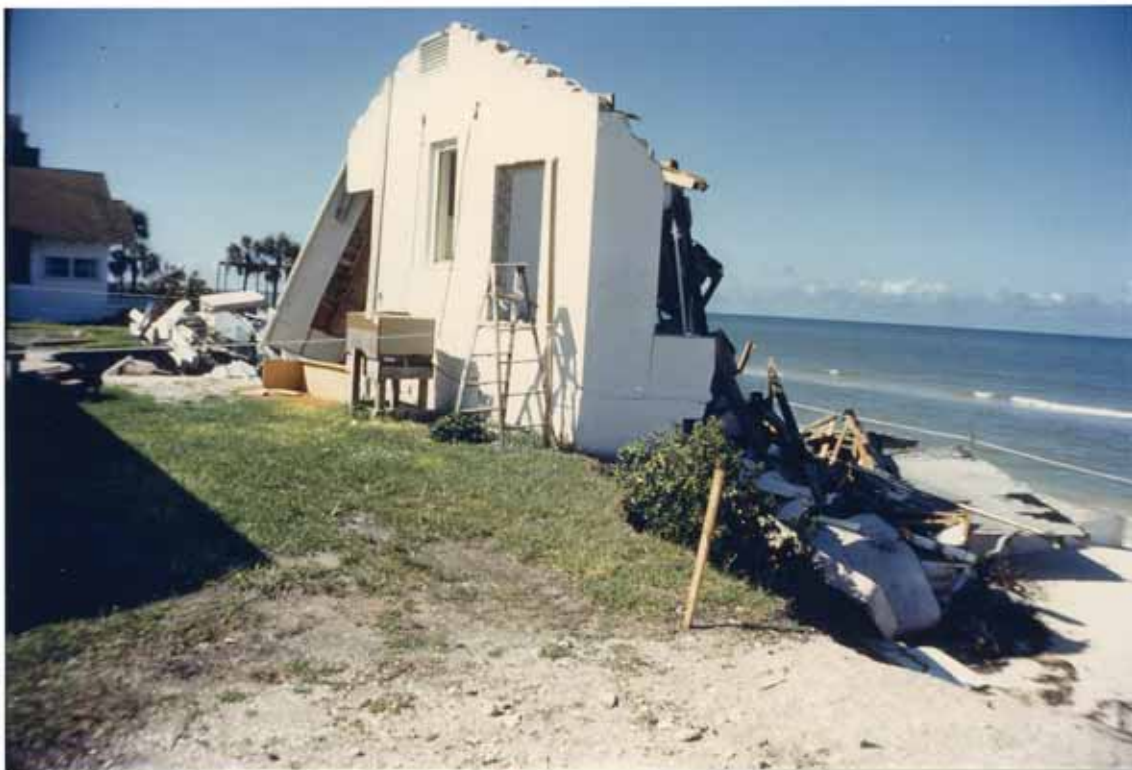
FIGURE 81. Dwellings destroyed at 17th Avenue

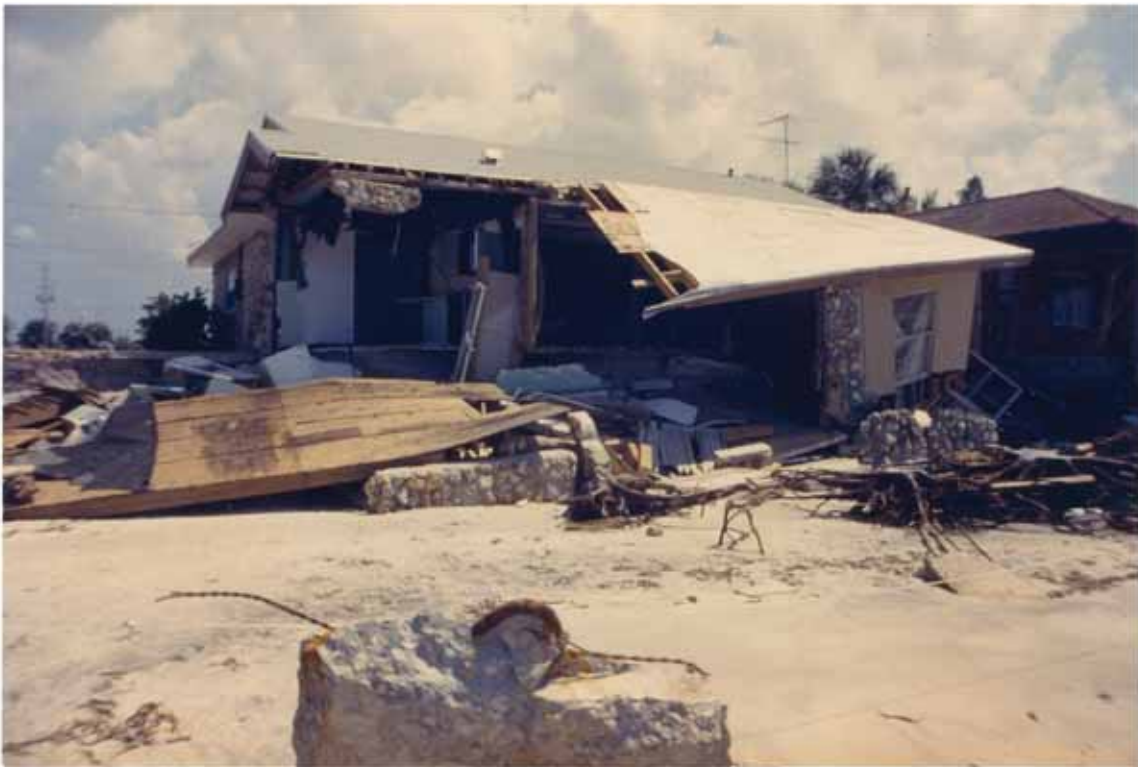
FIGURE 85. Dwelling damaged by Elena

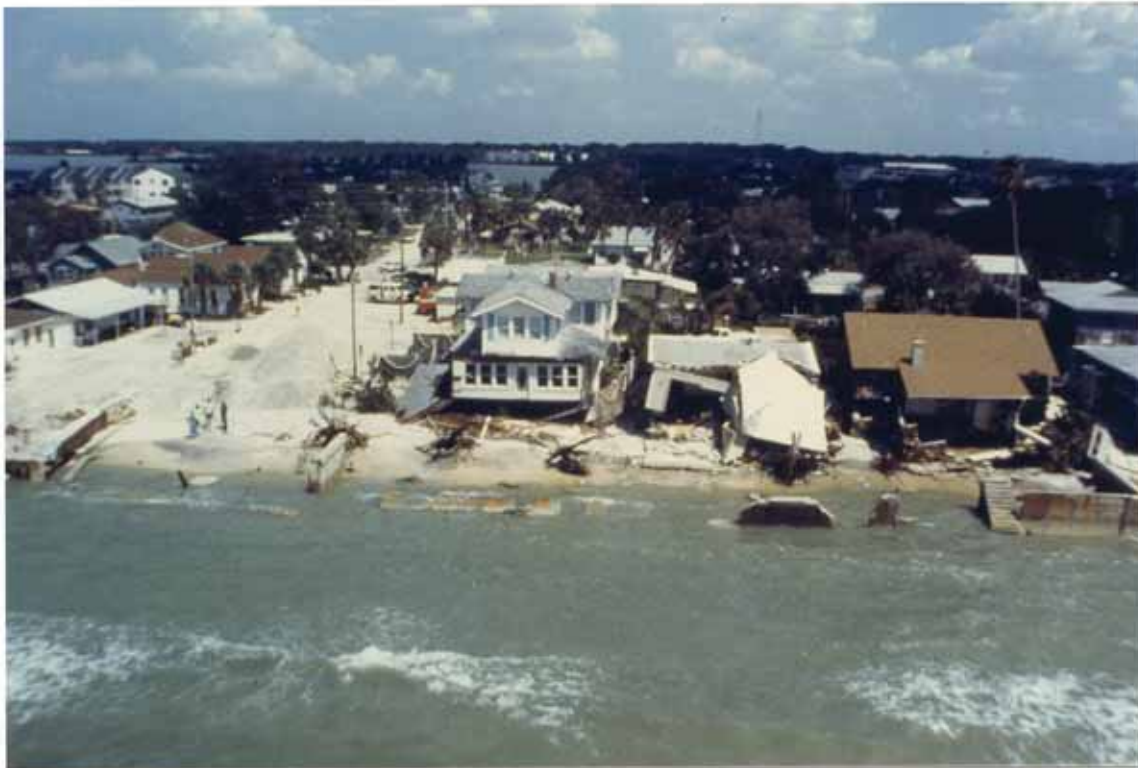
FIGURE 91. Bulkheads and dwellings destroyed and damaged

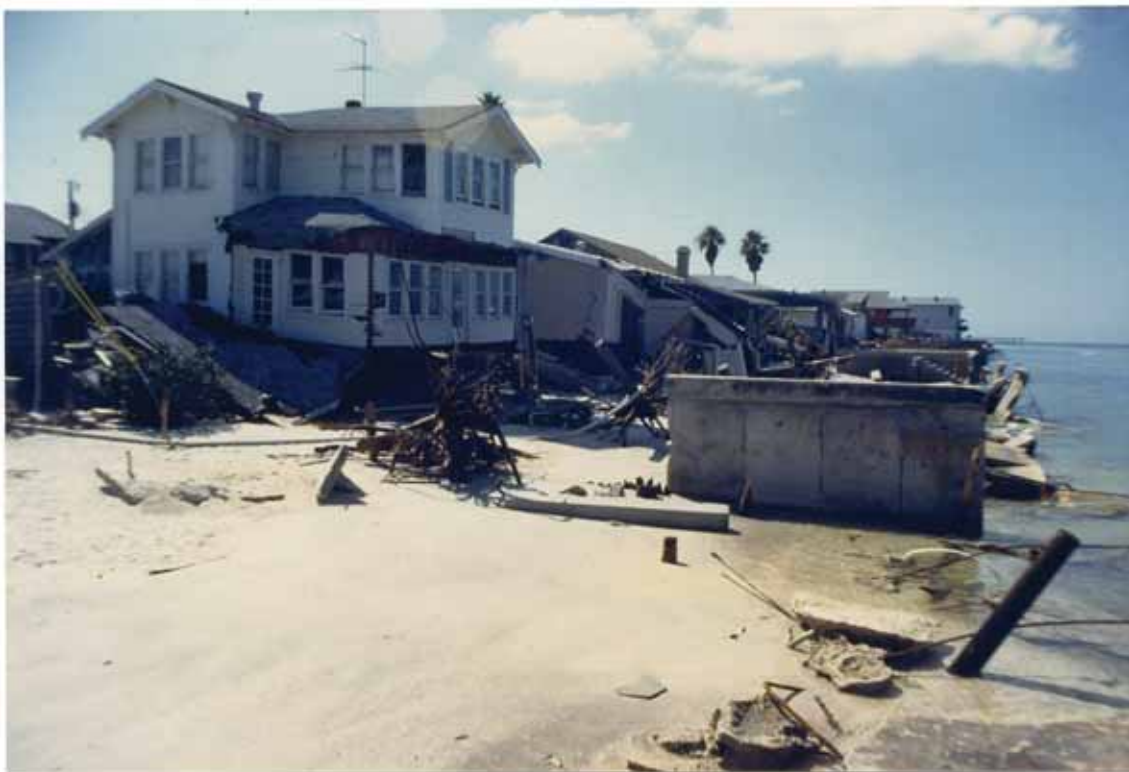
FIGURE 92. Elena destroyed 8th Avenue

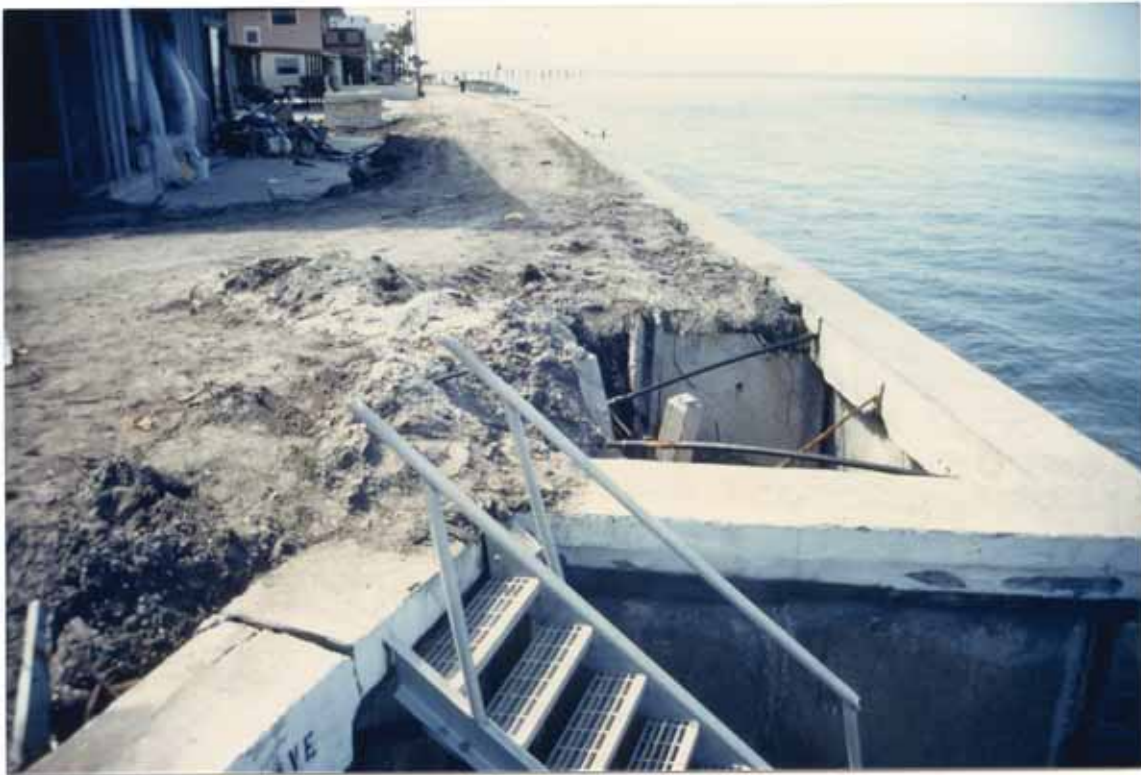
FIGURE 94. Post-Elena fill at 7th Avenue

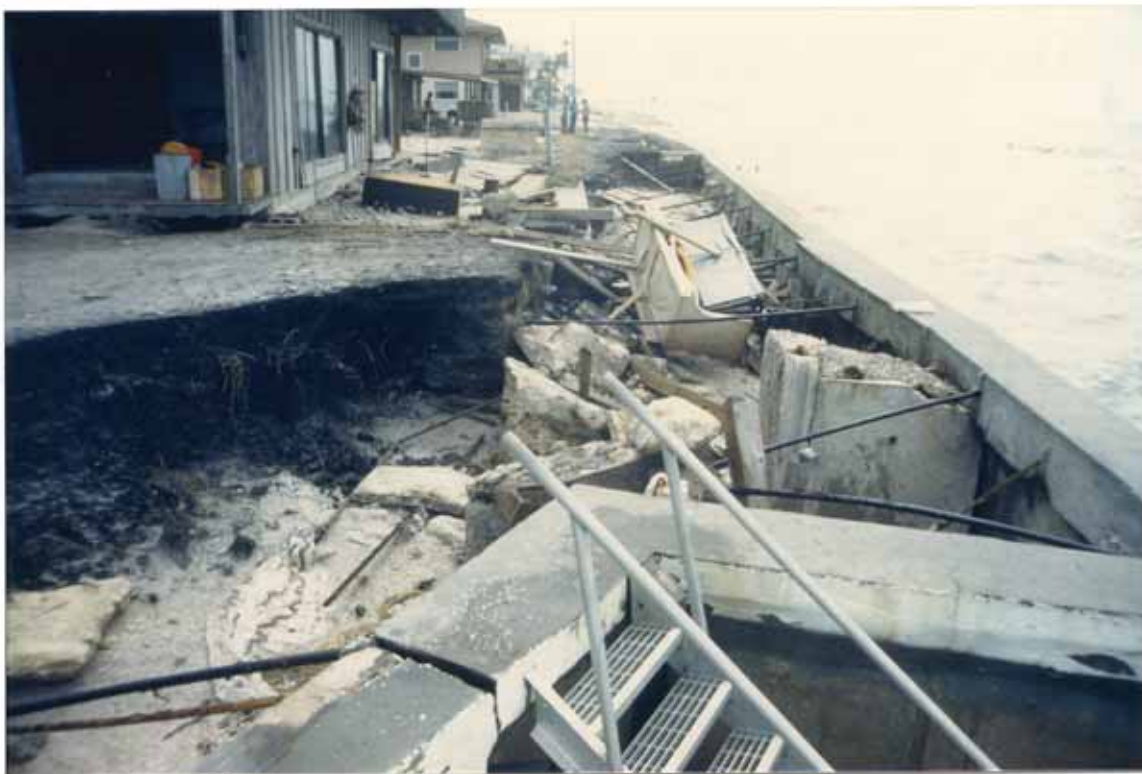
FIGURE 95. Juan eroded street-end fill, 7th Avenue

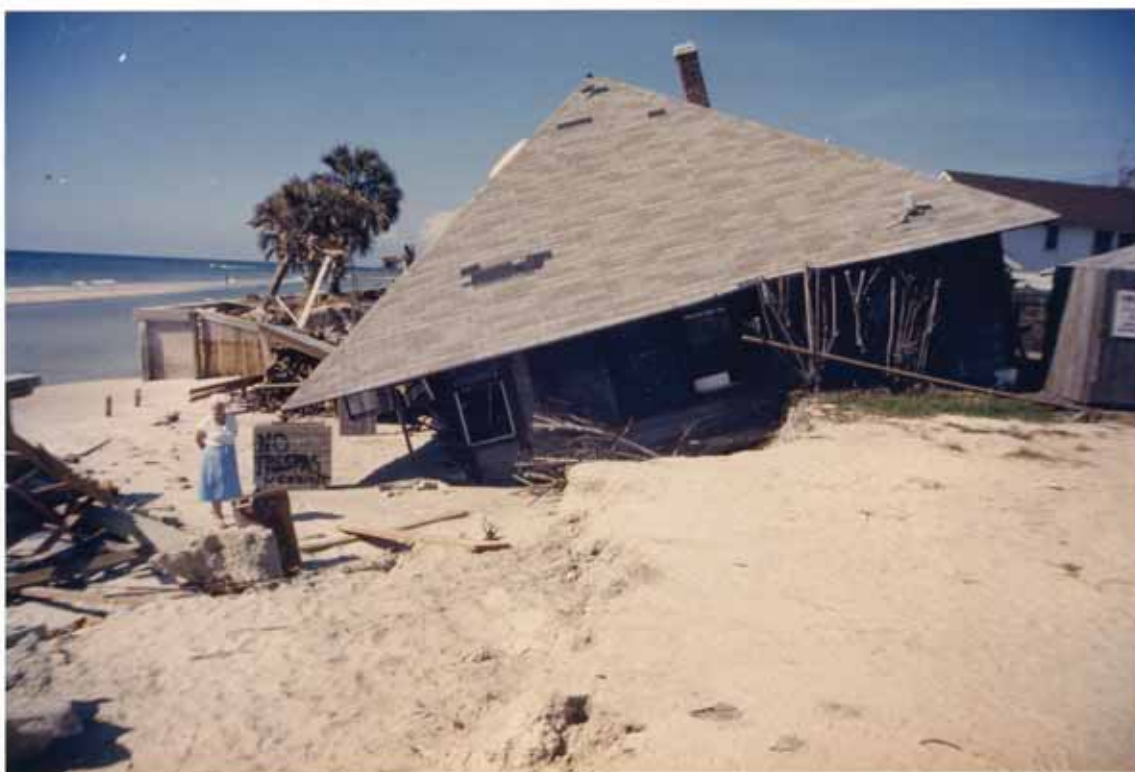
FIGURE 96. Dwelling destroyed by Elena, 2nd Avenue

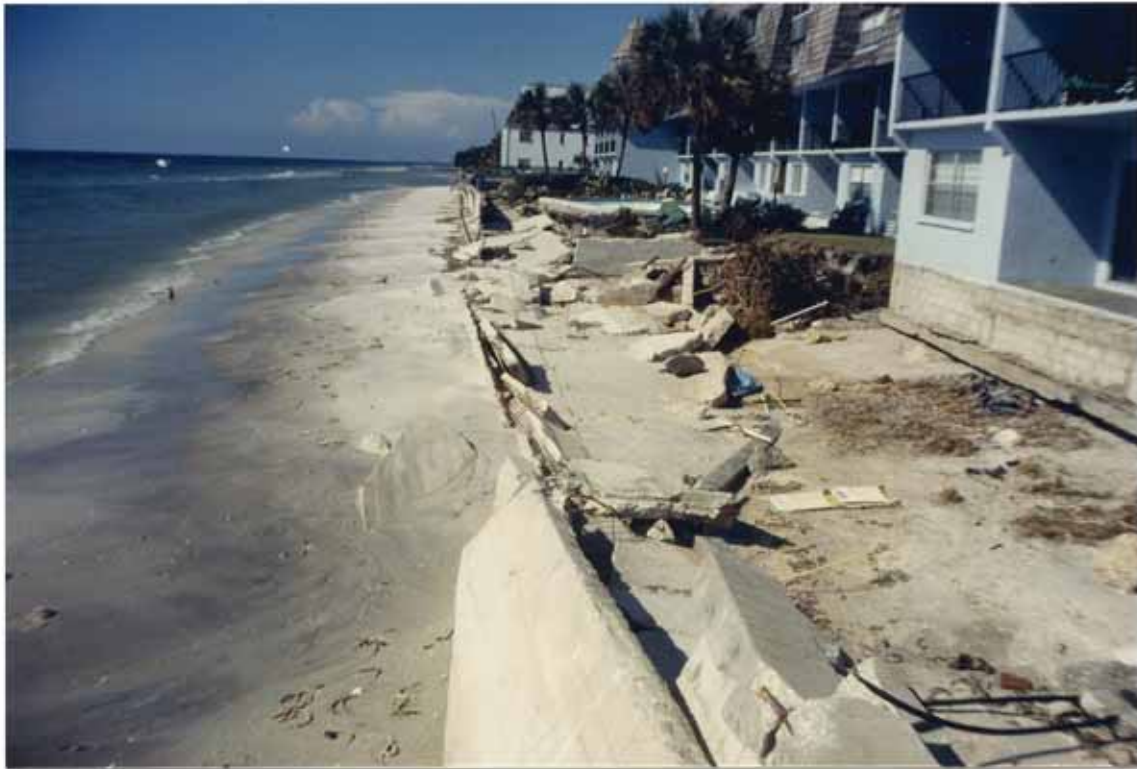
FIGURE 97. Happy Fiddler Condominium bulkhead after Elena

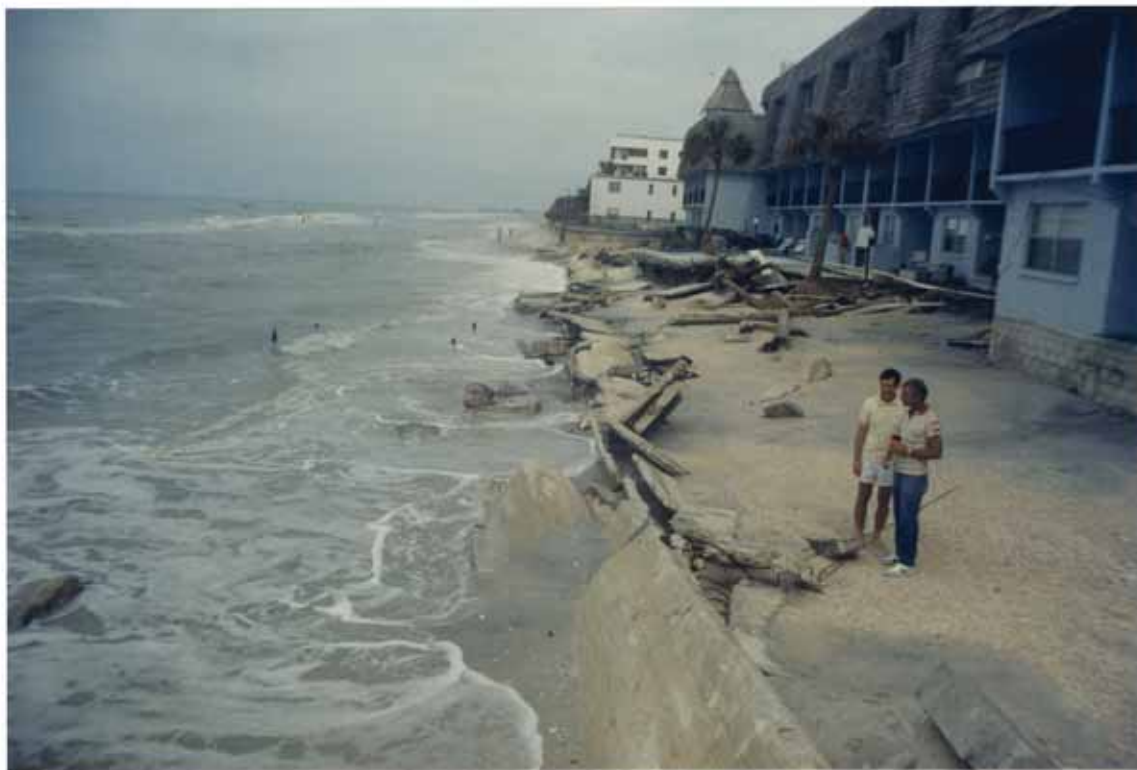
FIGURE 98. Happy Fiddler Condominium bulkhead after Juan

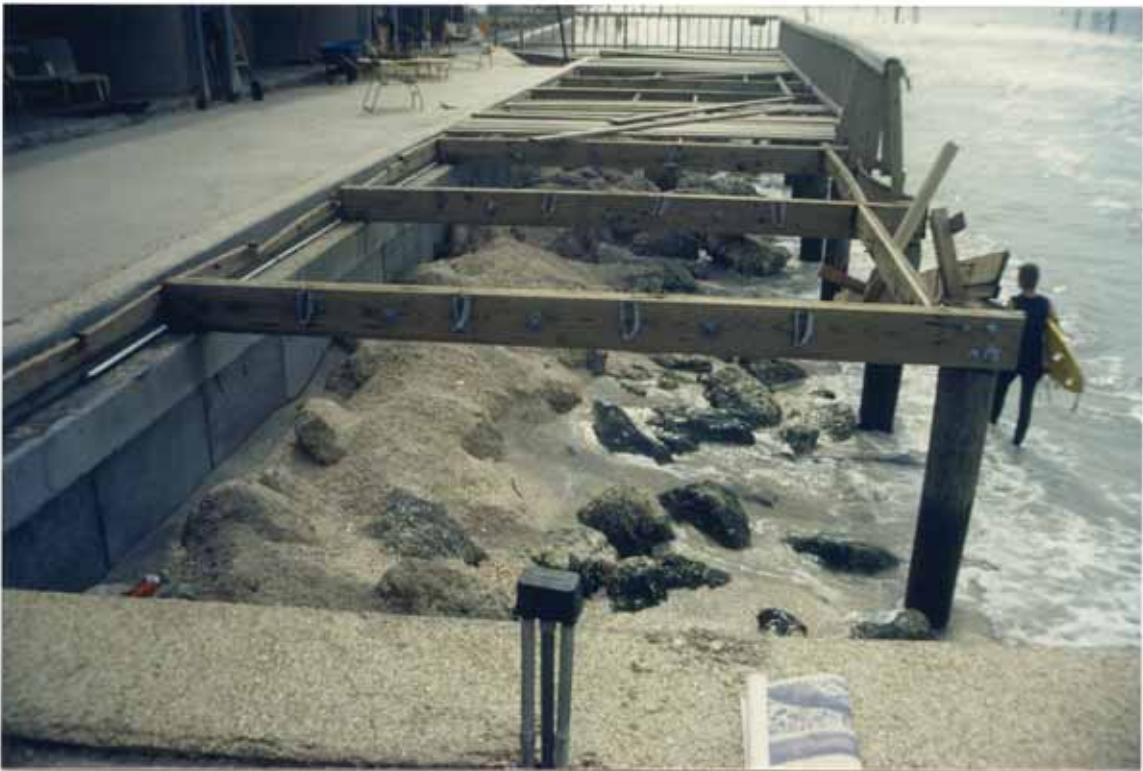
FIGURE 100. Toe-scour protection after Juan

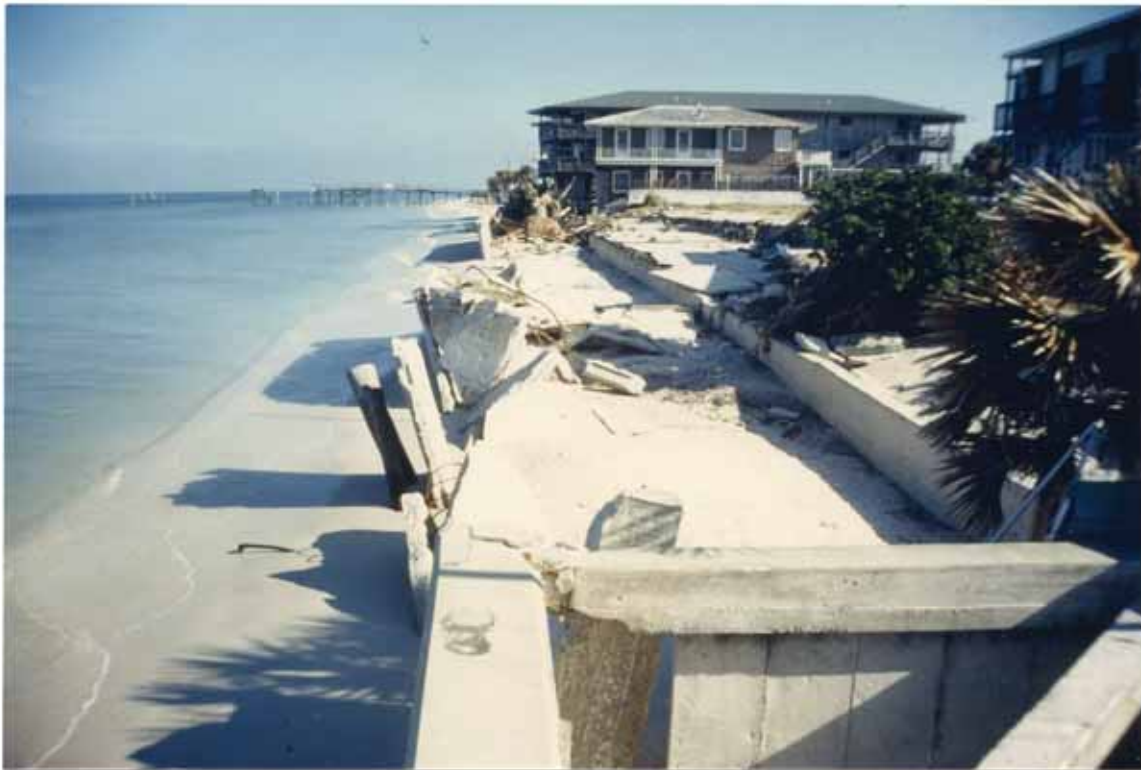
FIGURE 101. South Indian Rocks Beach after Elena

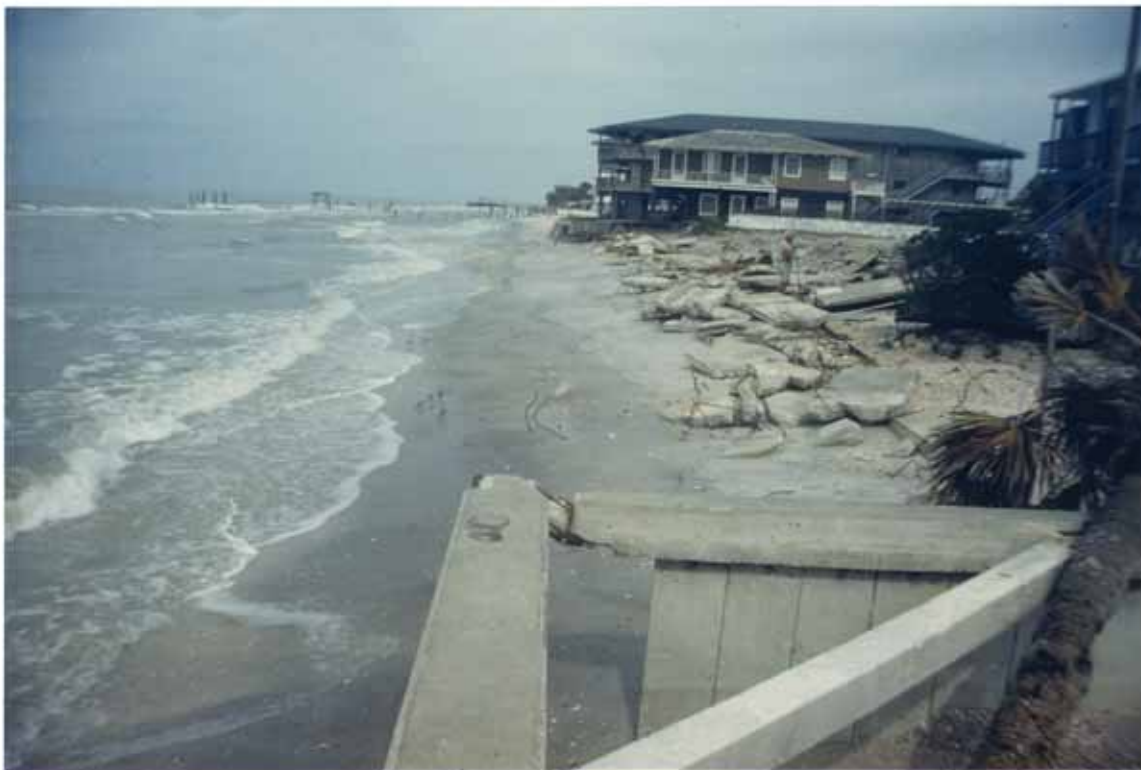
FIGURE 102. South Indian Rocks Beach after Juan

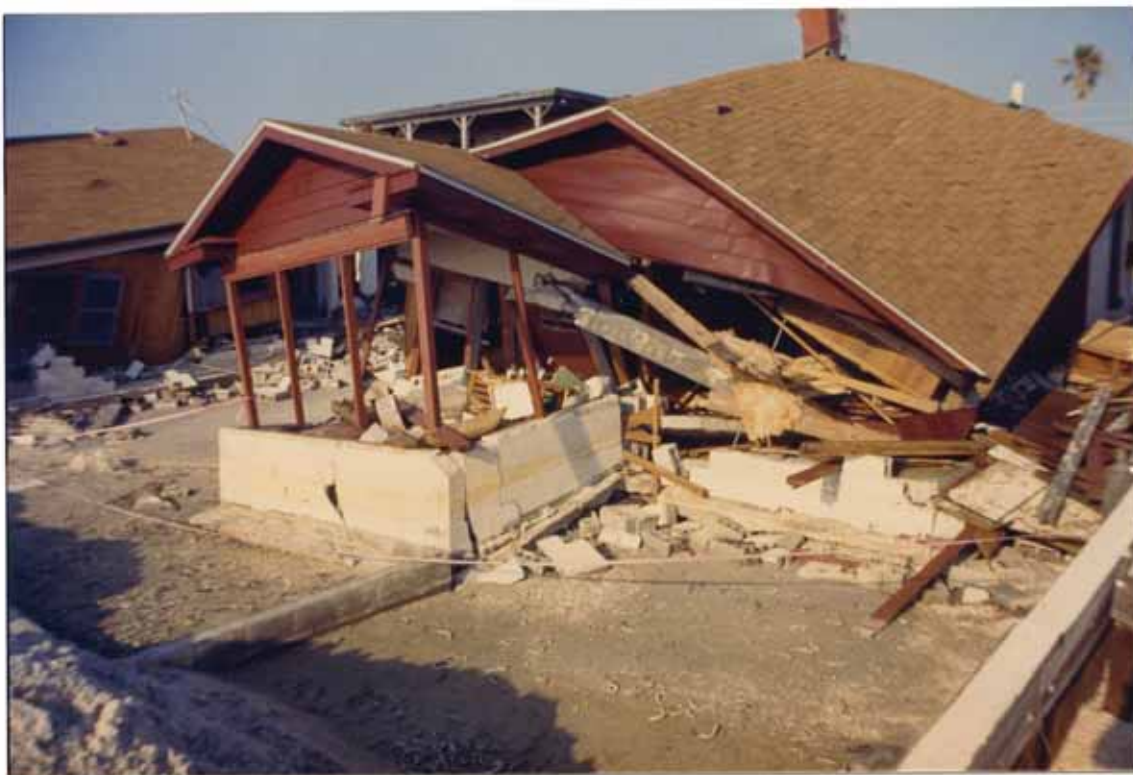
FIGURE 105. Dwelling destroyed by Elena

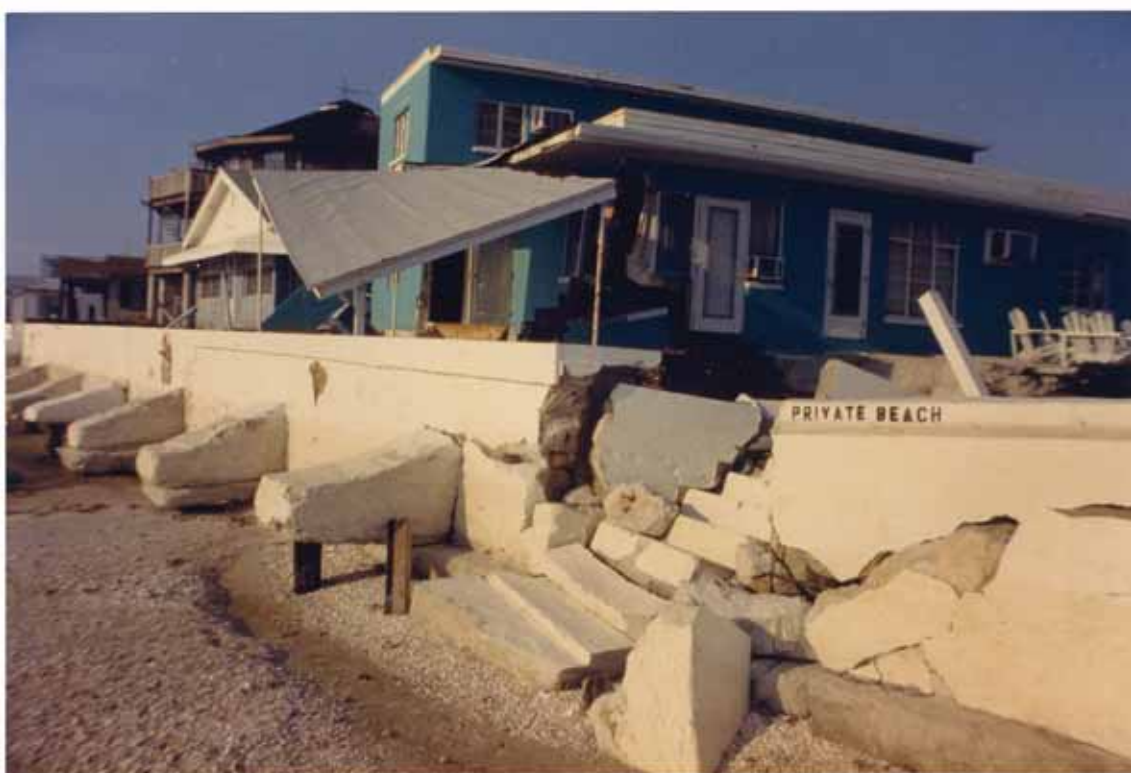
In the area of the Sand Castle Condominiums little damage was observed. Much of the beach lost to Elena returned during Juan. In the block to the south, three single-family dwellings were undermined and threatened by Elena. The beach was approximately 50 feet wide after the storms at 199th Avenue. South of 199th Avenue, 265 feet of wall and a single-family dwelling were destroyed and three townhouse structures and a single-family dwelling were undermined and threatened from any further erosion. Between 198th Avenue and 197th Avenue, seven single-family dwellings were destroyed or substantially damaged and the other dwellings were undermined and threatened from further erosion (Figure 105). A 160 foot wood bulkhead was destroyed by Elena and another 15 foot segment was destroyed by Juan. Three of the damaged dwellings were behind a 115 foot segment of concrete wall which was destroyed by Elena (Figures 106 and 107). South of

FIGURE 106. Wall damaged by wave impact loads

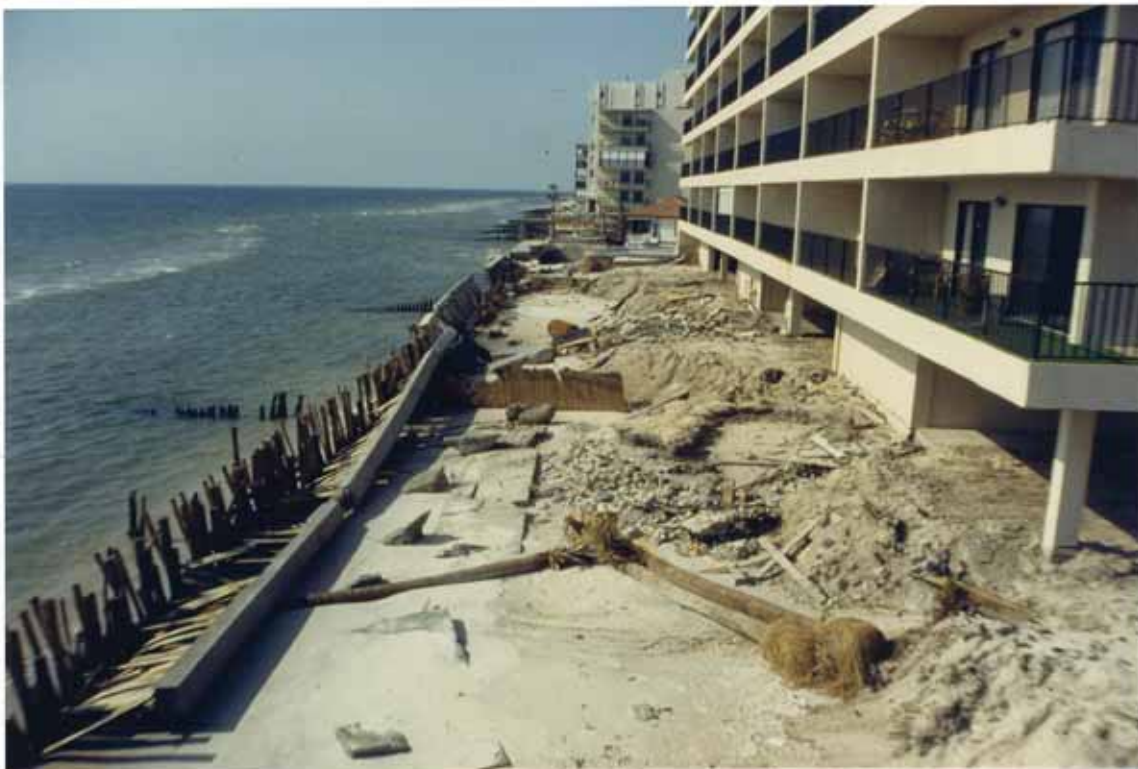
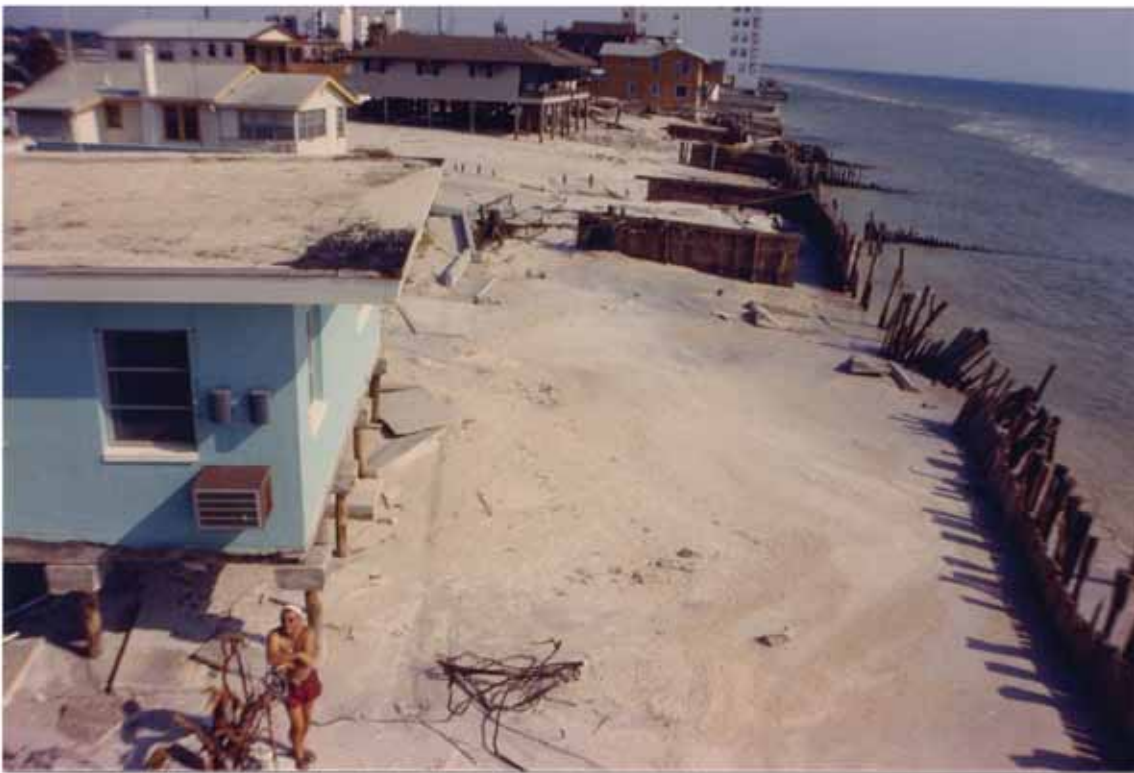
From 196th Avenue to the south, 400 feet of wood bulkhead was destroyed. Further south another 100 foot bulkhead segment was destroyed. To the north of the Indian Shores Town Hall, 820 feet of concrete and wood bulkheads were destroyed or substantially damaged (Figures 108 and 109). This area also had a swimming pool destroyed at the Sea Gate Condominium and a single-family dwelling and motel unit were damaged. Over 3,000 cubic yards of barrier dune sediment was eroded from behind this stretch of bulkhead.

FIGURE 108. Indian Shores bulkheads destroyed, 820 feet

FIGURE 109. Indian Shores bulkheads destroyed, 820 feet

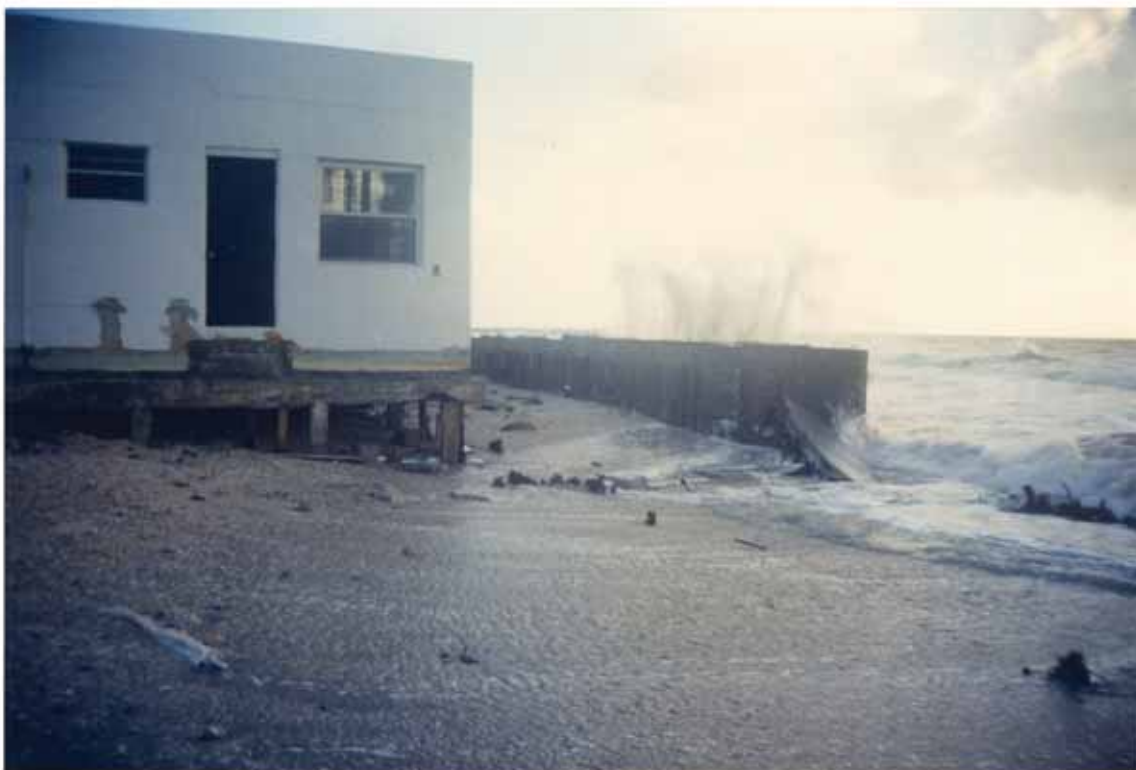
FIGURE 110. New bulkhead damaged without toe-scour protection

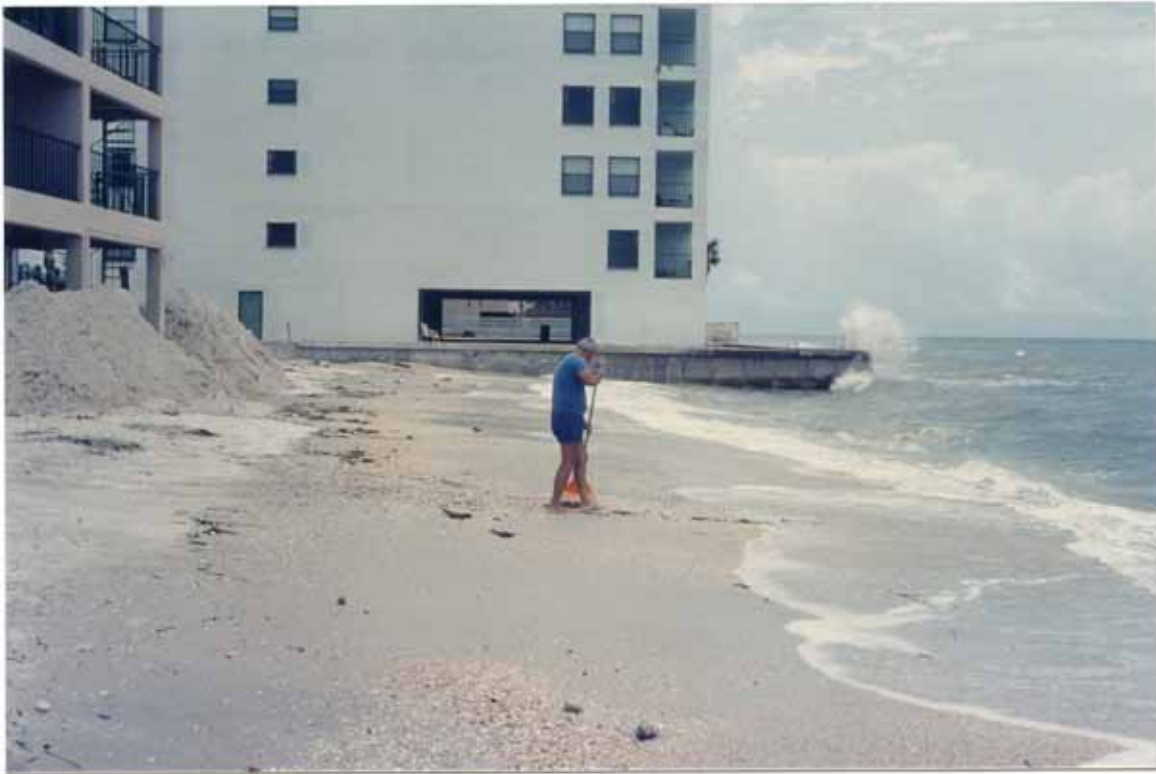
The recent changes of the area may be seen at 193rd Avenue where the gently sloping beach after the subtropical storm in June 1982 (Figure 111) was replaced with the armored shoreline shown after Elena in September 1985 (Figure 112). Upland erosion was reduced, but at the expense of any beach. This wall was damaged by Juan.

FIGURE 111. 193rd Avenue after the No Name Storm, 1982
