# THE IMPACT OF HURRICANE ELENA AND TROPICAL STORM JUAN ON COASTAL CONSTRUCTION IN FLORIDA

Beaches and Shores Post-Storm Report No. 85-3

March, 1986

Bureau of Coastal Engineering and Regulation  
Division of Beaches and Shores  
FLORIDA DEPARTMENT OF NATURAL RESOURCES

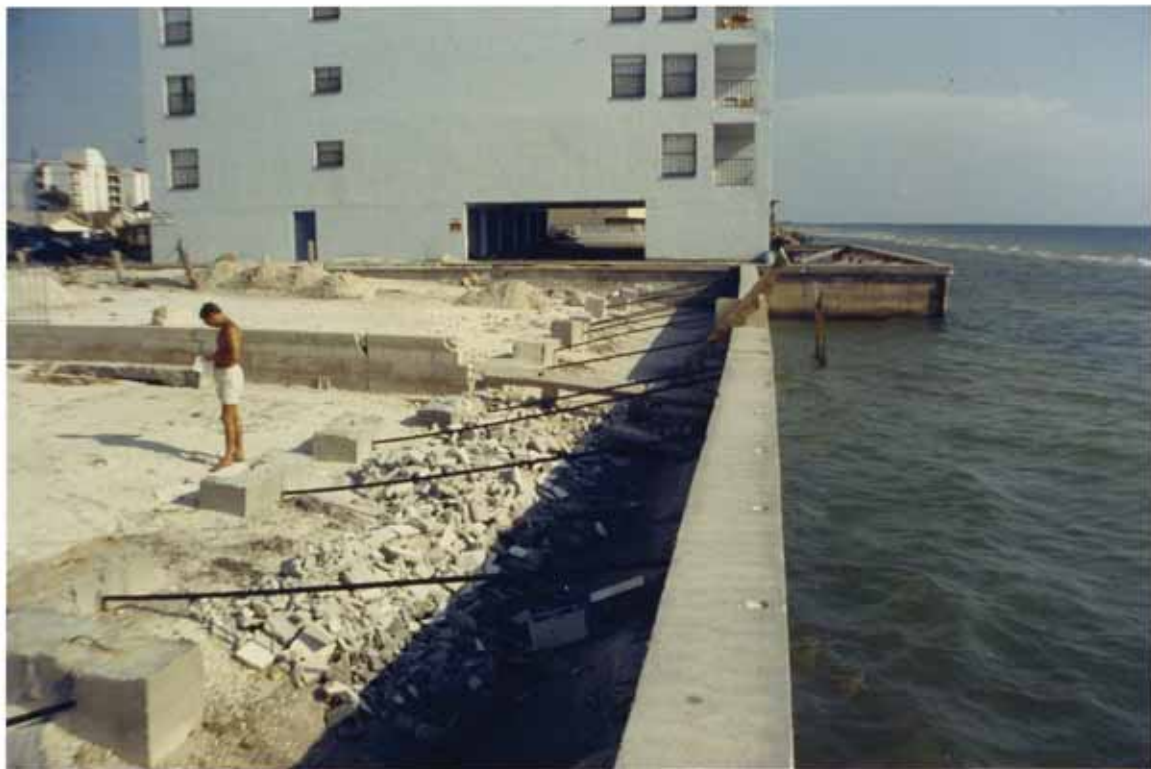
The recent changes of the area may be seen at 193rd Avenue where the gently sloping beach after the subtropical storm in June 1982 (Figure 111) was replaced with the armored shoreline shown after Elena in September 1985 (Figure 112). Upland erosion was reduced, but at the expense of any beach. This wall was damaged by Juan.

FIGURE 112. No beach at 193rd Avenue after Elena

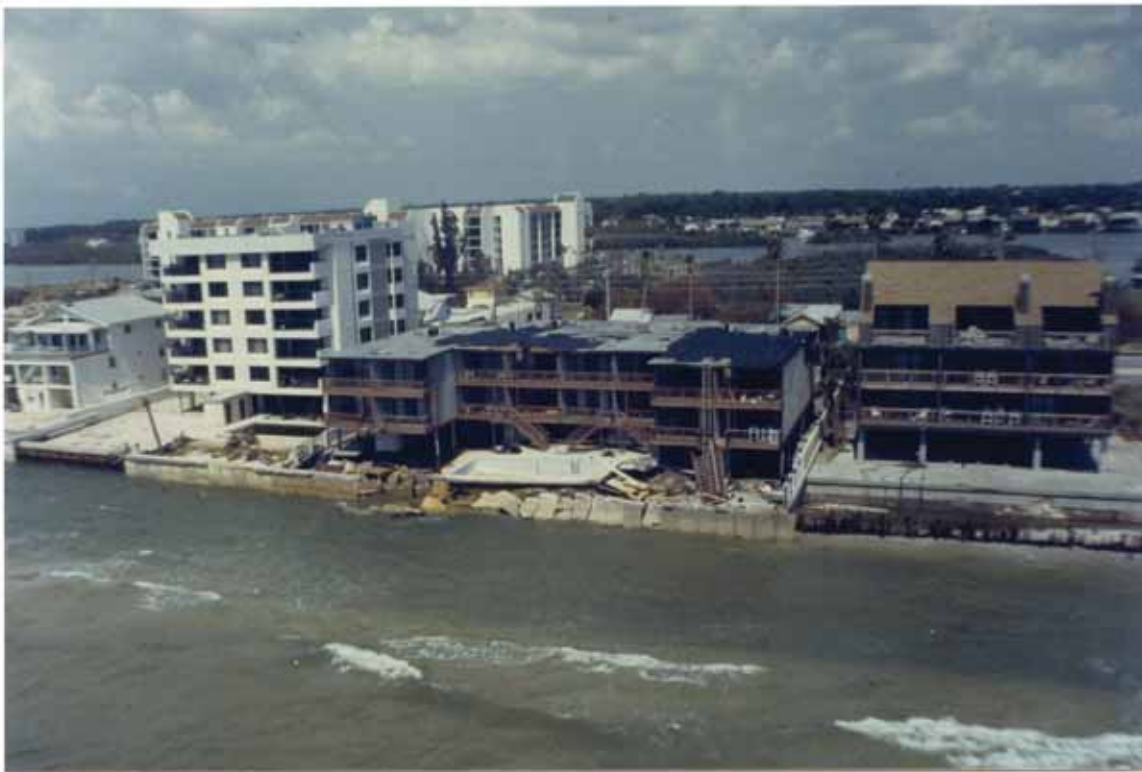
South of 190th Avenue, 100 feet of concrete bulkhead and 100 feet of wood bulkhead was destroyed by Elena (Figure 113). The concrete bulkhead was completely leveled and the swimming pool

FIGURE 113. Bulkhead destroyed by Elena

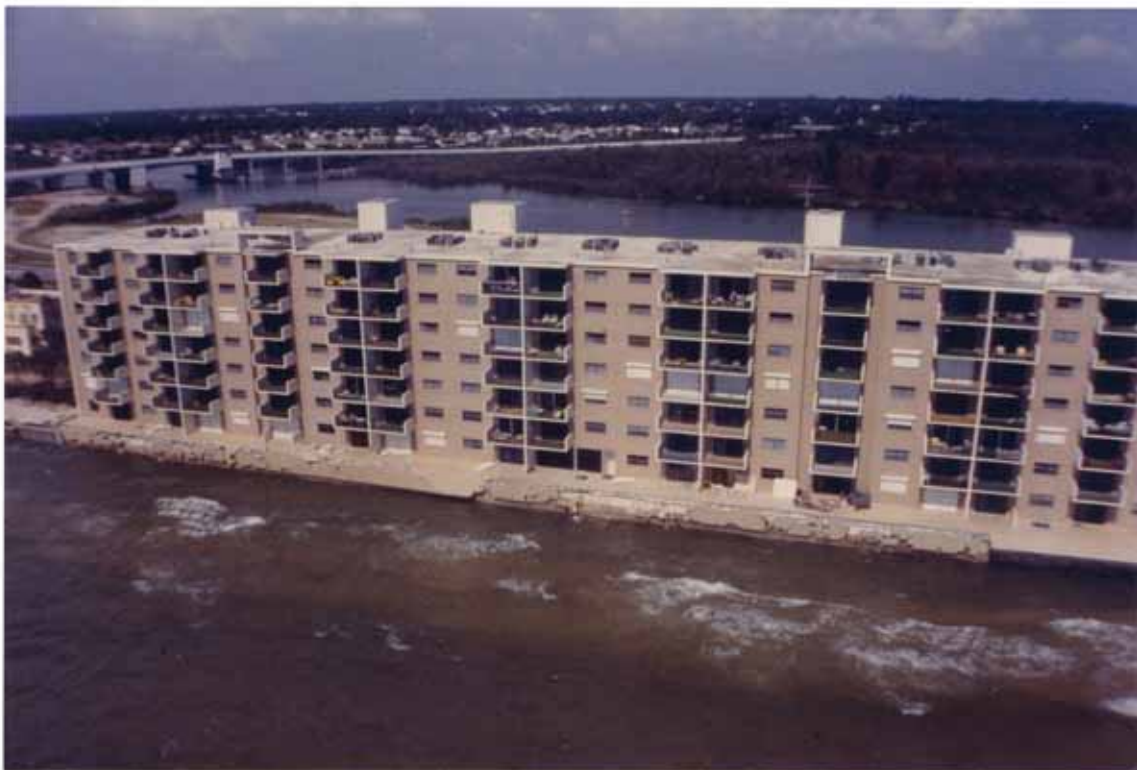
destroyed by Juan. There was no major wall damage between 189th Avenue and 186th Avenue. At the Gulf Shores Condominium which characterizes the worst of coastal planning and development in Florida, no beach remains after the storms. An inappropriately designed cantilevered concrete deck was destroyed by the uplift forces of Elena's storm waves (Figure 114).

FIGURE 114. Gulf Shores Condominium after Elena

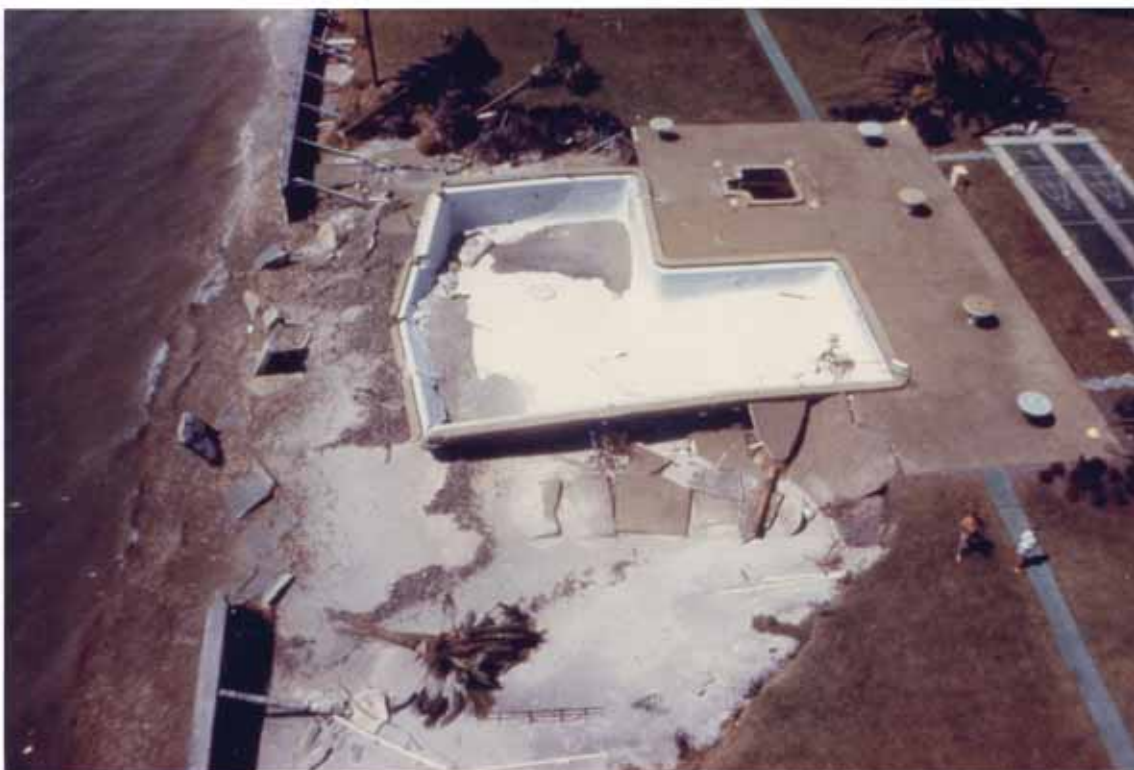
At the Shore Mariner Condominium, Elena destroyed 150 feet of concrete bulkhead and a large swimming pool (Figure 115). Additional segments of the wall, although standing, were damaged. An additional segment of wall was destroyed by Juan; however, the property owners had taken emergency measures with temporary revetment construction and prevented any building damage (Figure 116). South of the Shore Mariner a 70 foot segment of concrete wall was destroyed by Elena.

FIGURE 115. Wall and pool destroyed, Shore Mariner Condominium

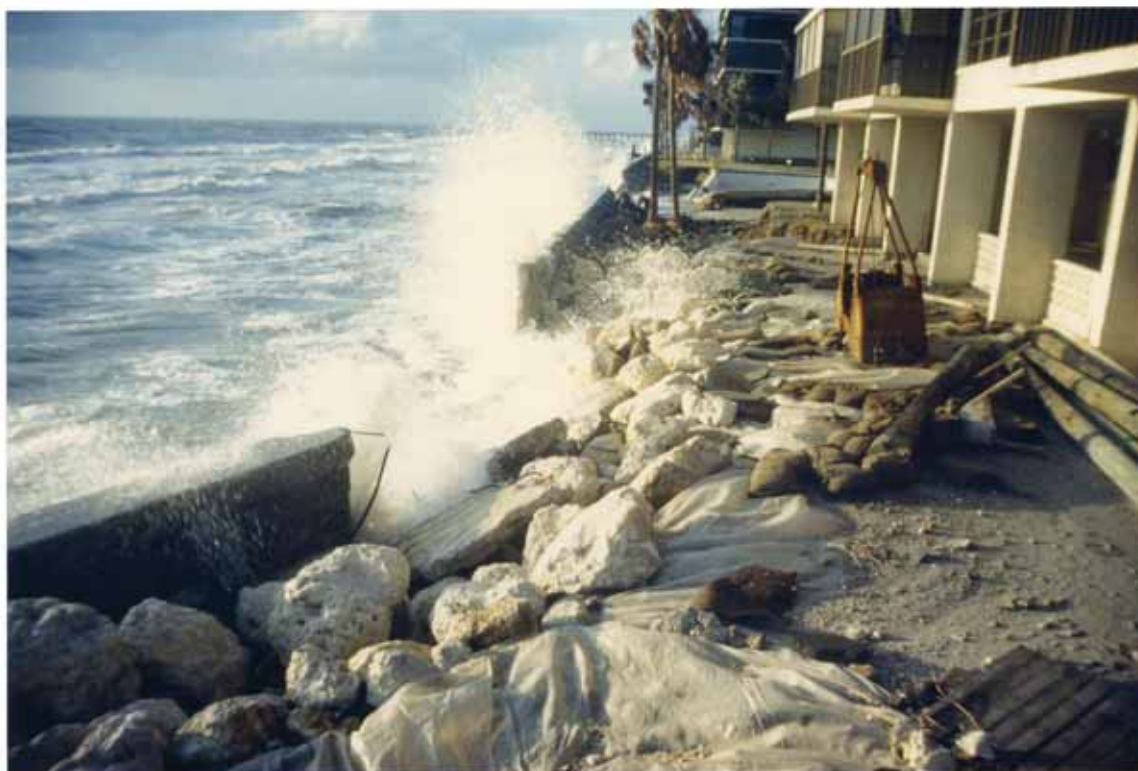
FIGURE 116. Emergency revetment protection from Juan

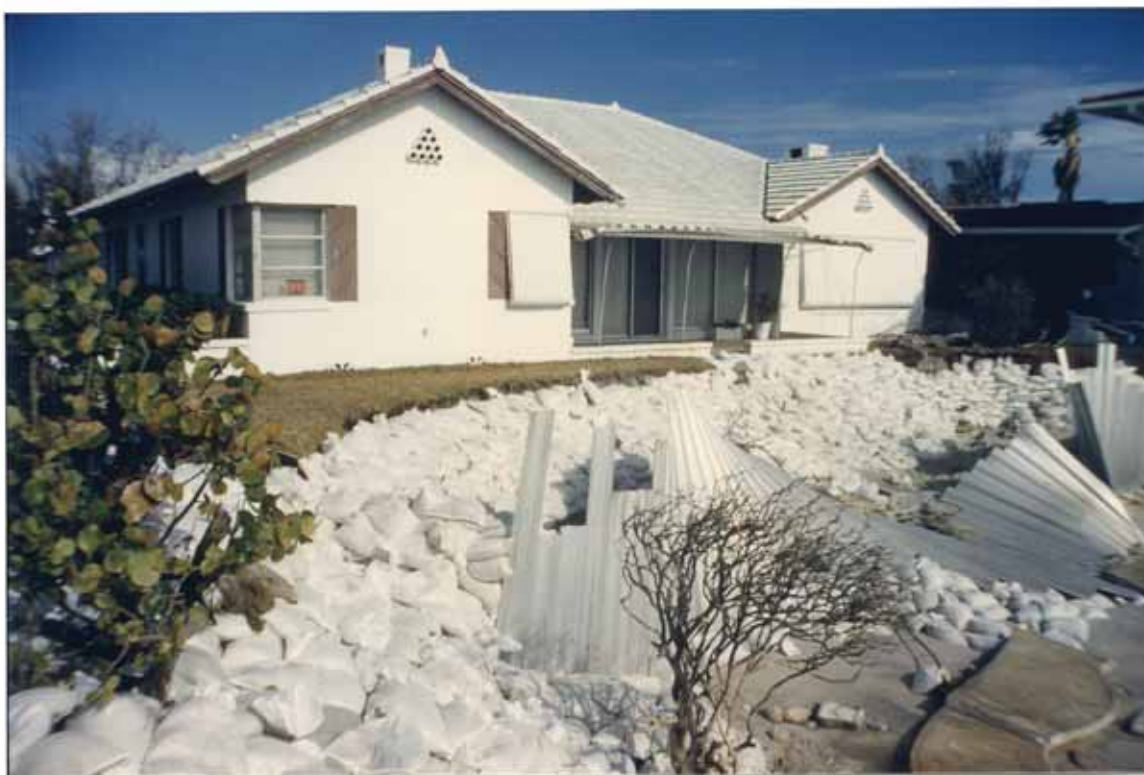
FIGURE 118. Emergency protection after Juan

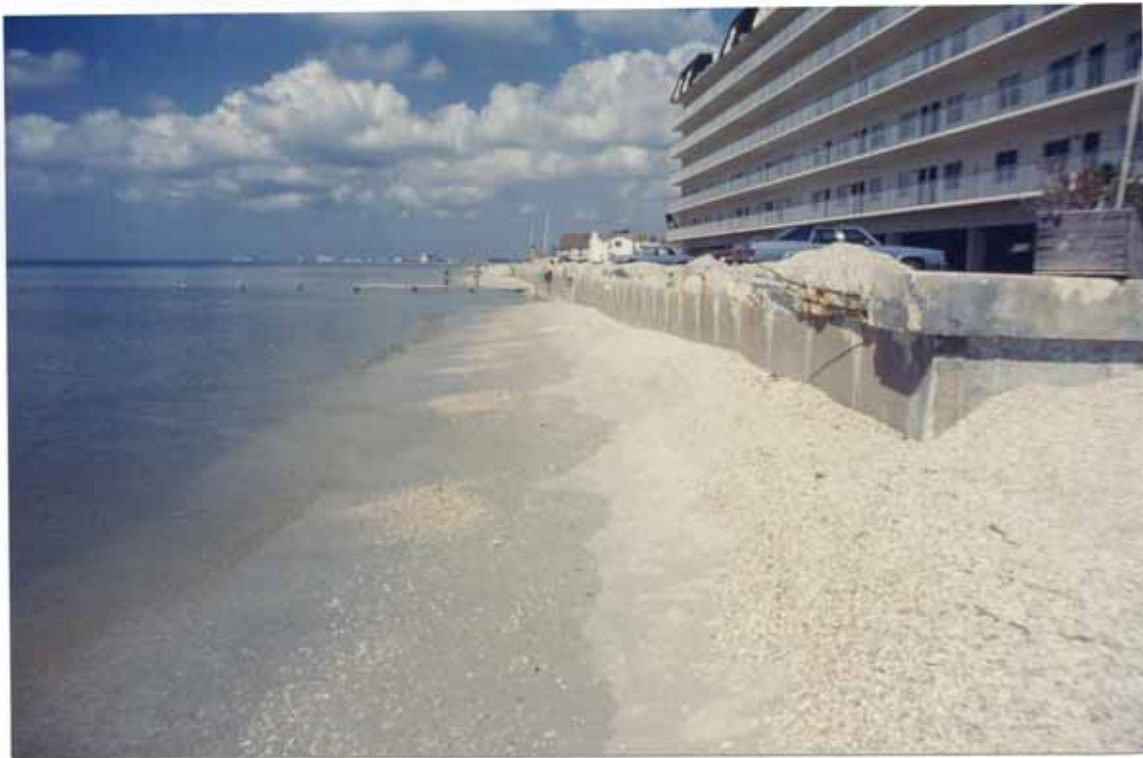
FIGURE 123. Juan damaged Sunset Chateau Condominium's bulkhead, Treasure Island

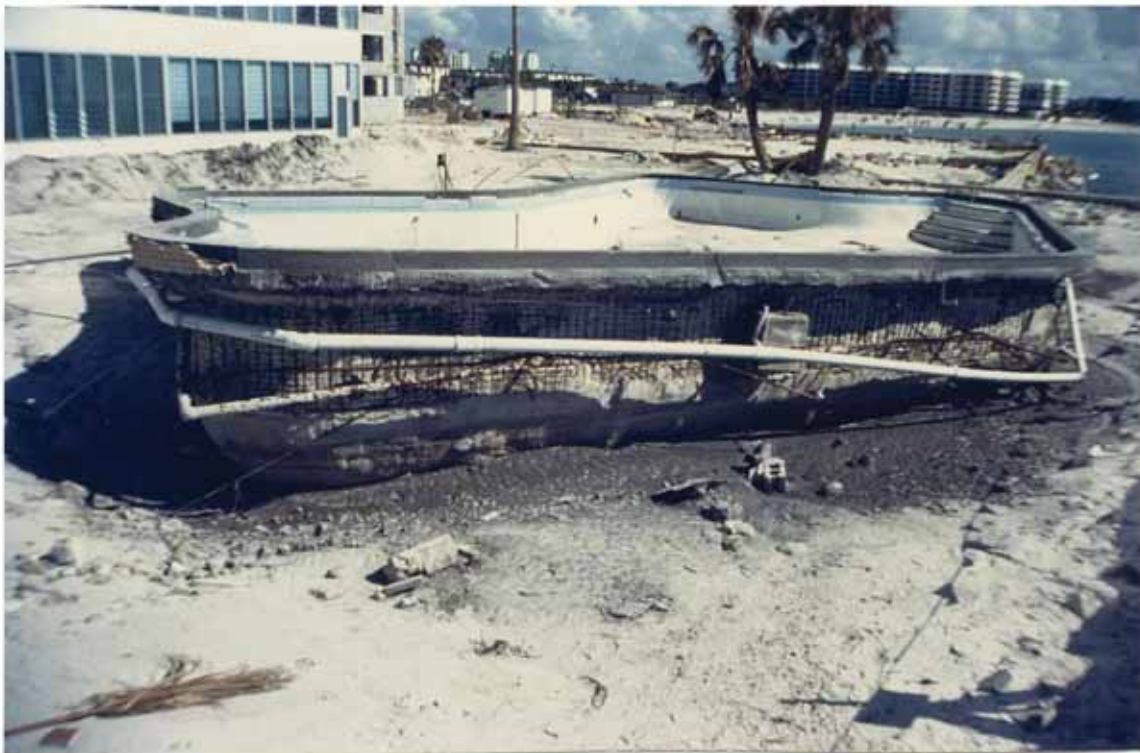
FIGURE 124. Pool at Starlight Tower Condominium floated above grade during Juan's flooding, St. Petersburg Beach

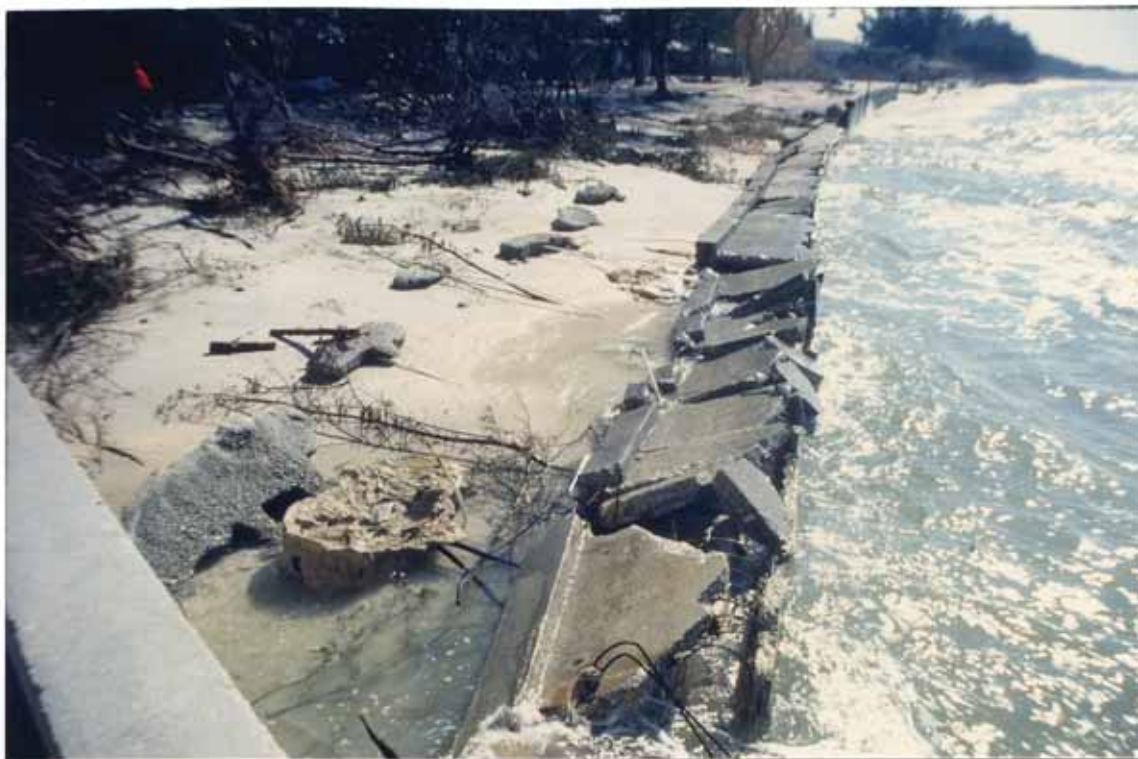
FIGURE 127. Elena and Juan destroyed 920 feet of bulkhead

Lack of fill containment was also a problem in Manatee County where there was substantial wall damage from Elena and Juan (Figure 127). In most cases boulder-mounds and revetments provided adequate protection; however, a few such structures

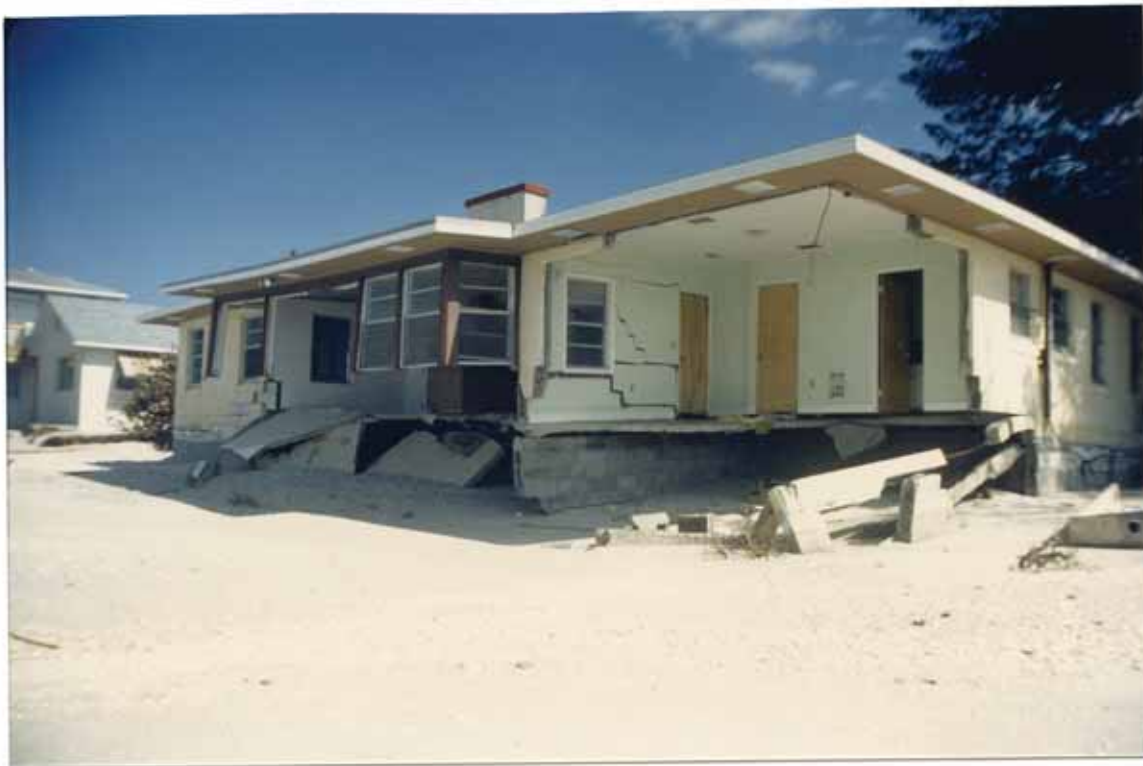
FIGURE 129. Juan's beach accretion at damaged dwelling

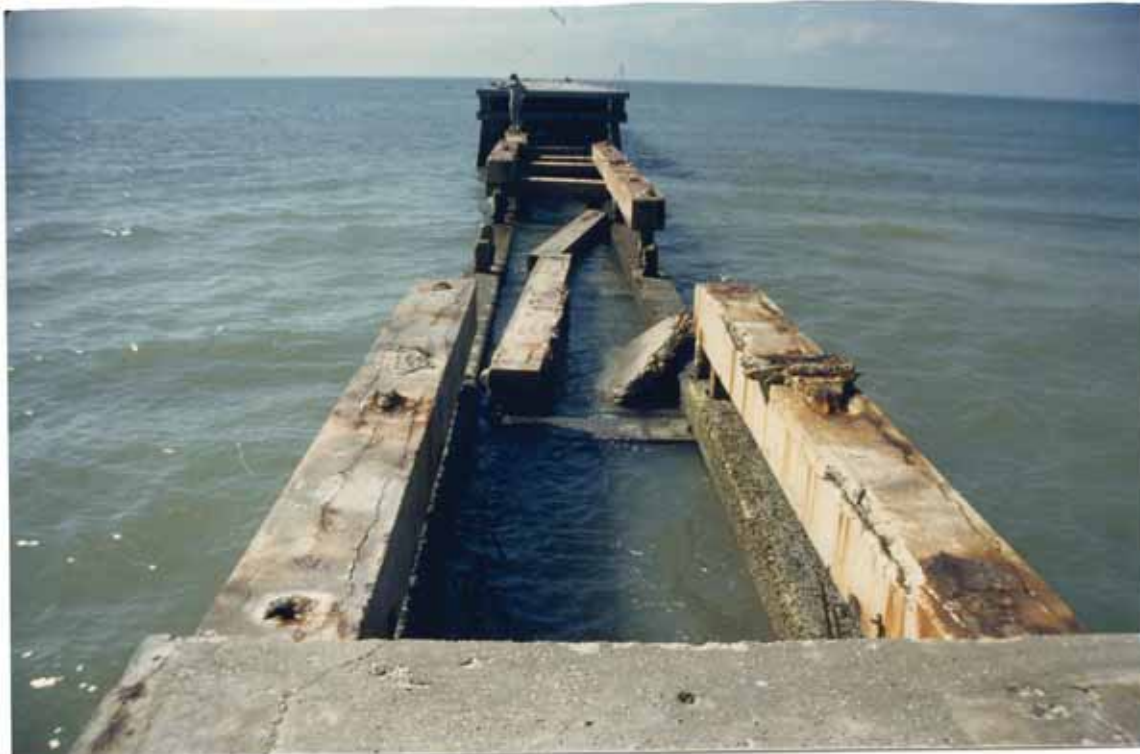
FIGURE 130. Juan damaged pier-groin at County park

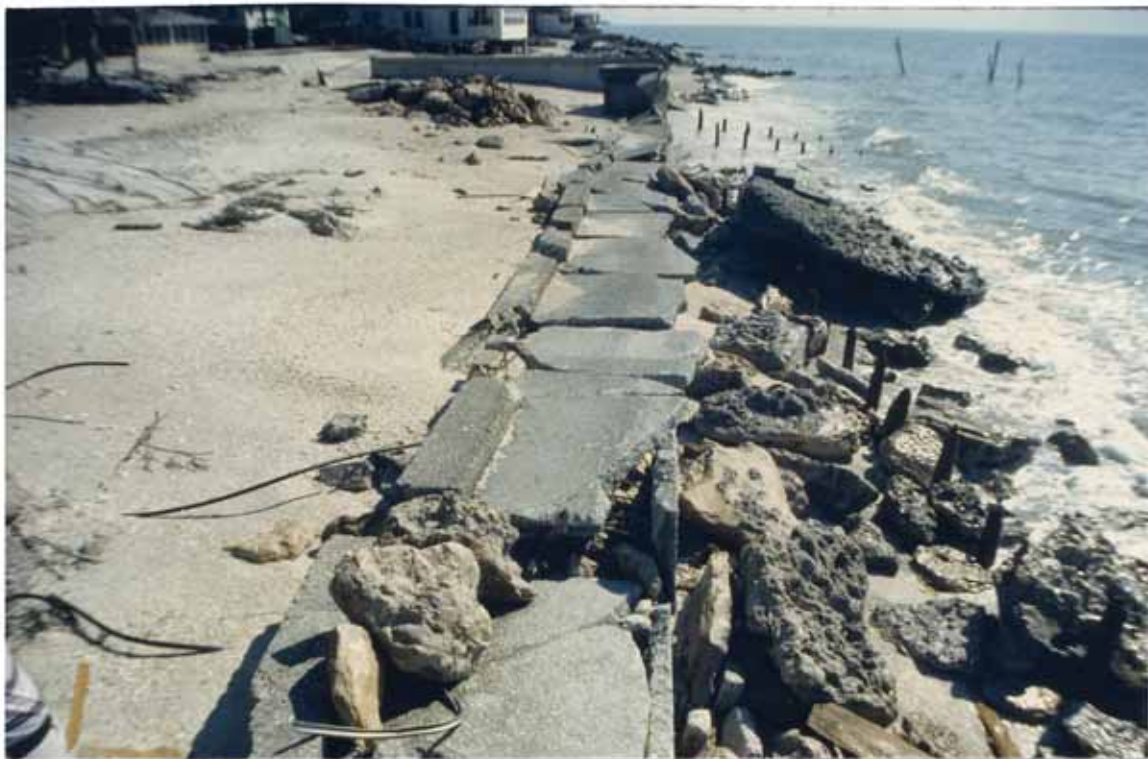
FIGURE 132. Bulkhead destroyed by wave impact loads

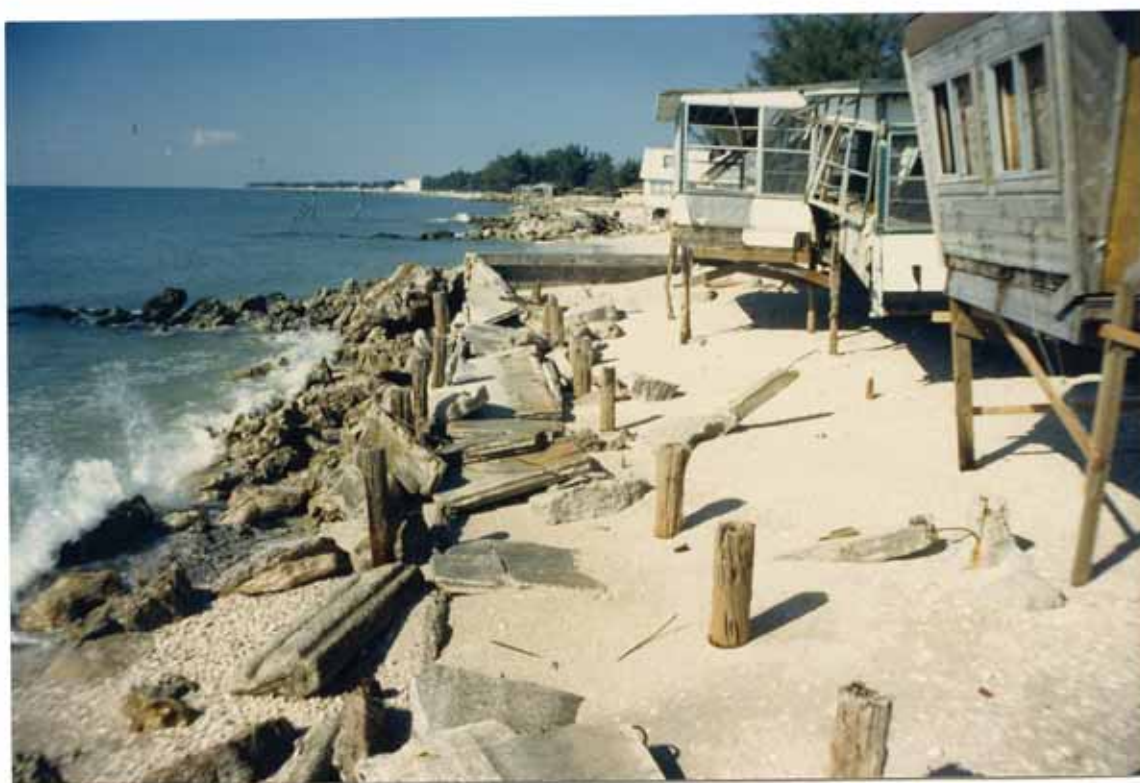
FIGURE 134. Bulkhead with toe-scour protection destroyed

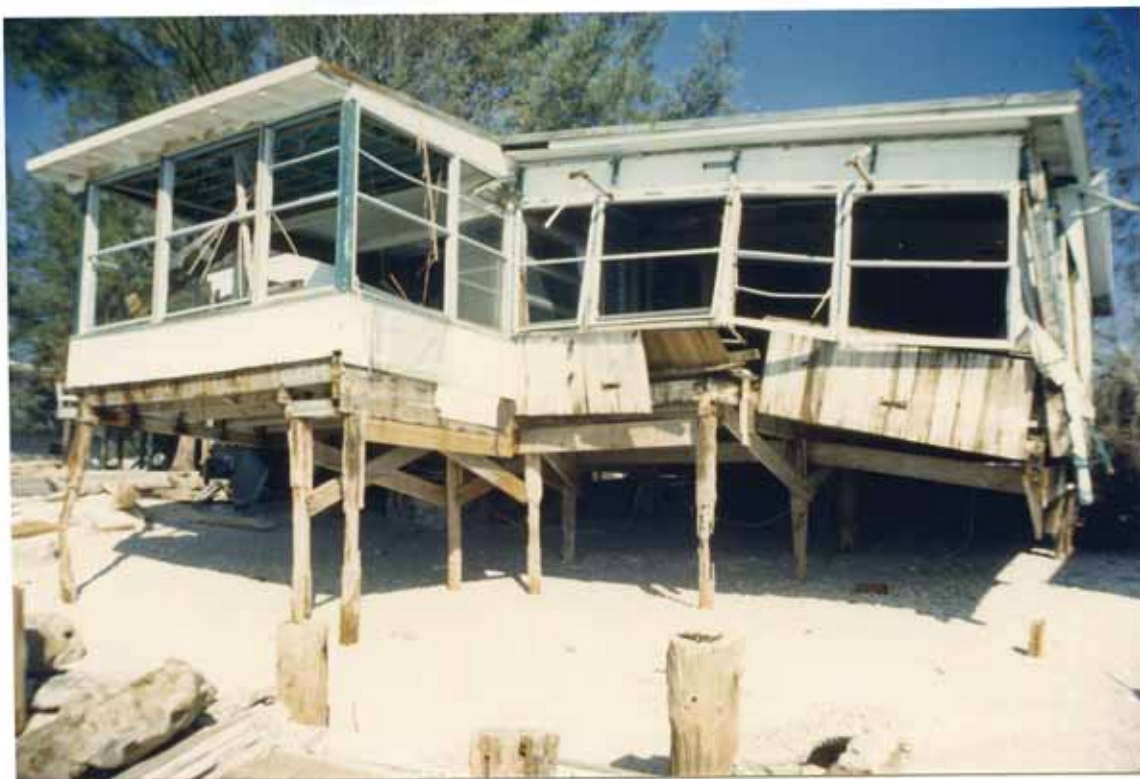
FIGURE 135. Holmes Beach dwelling destroyed by Elena

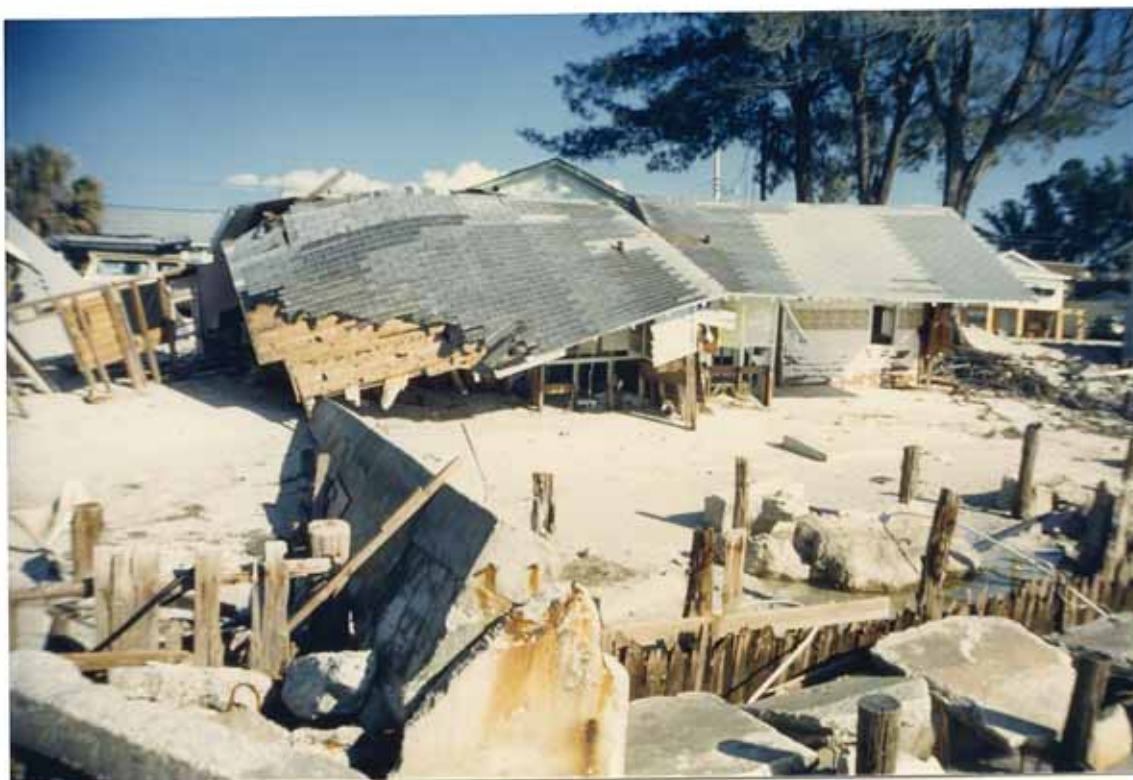
FIGURE 136. Bradenton Beach dwelling destroyed by Elena

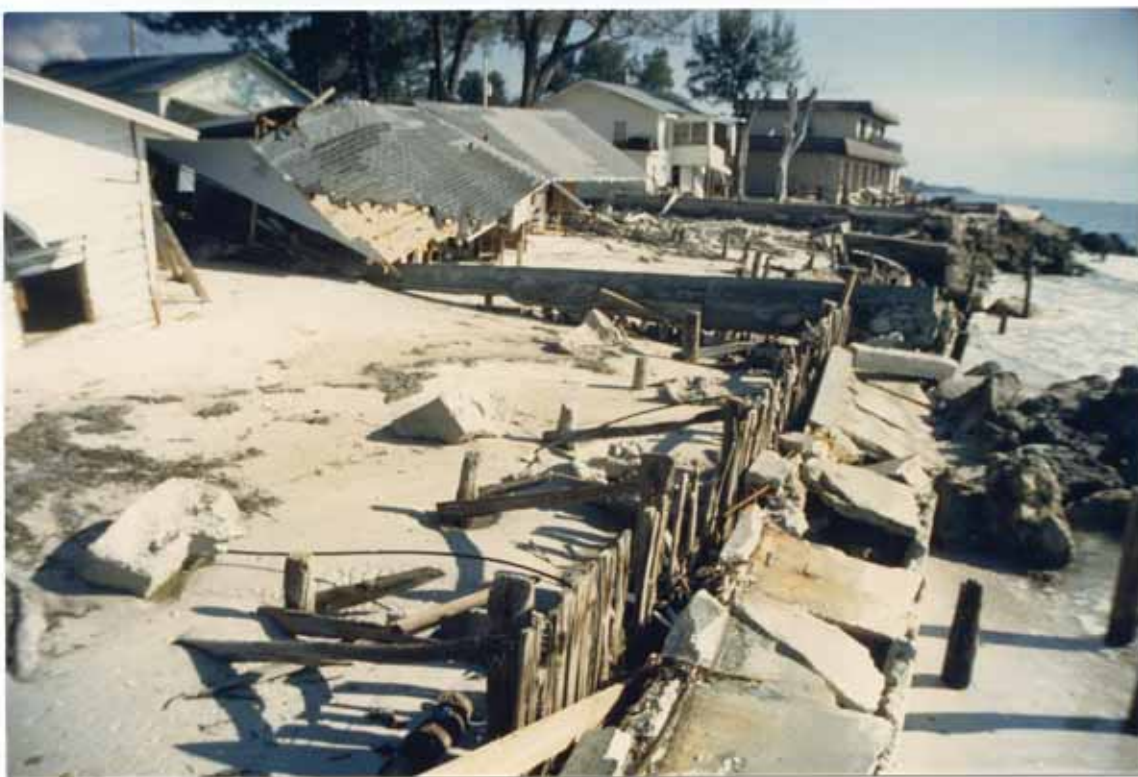
FIGURE 139. Bulkheads destroyed by wave loads

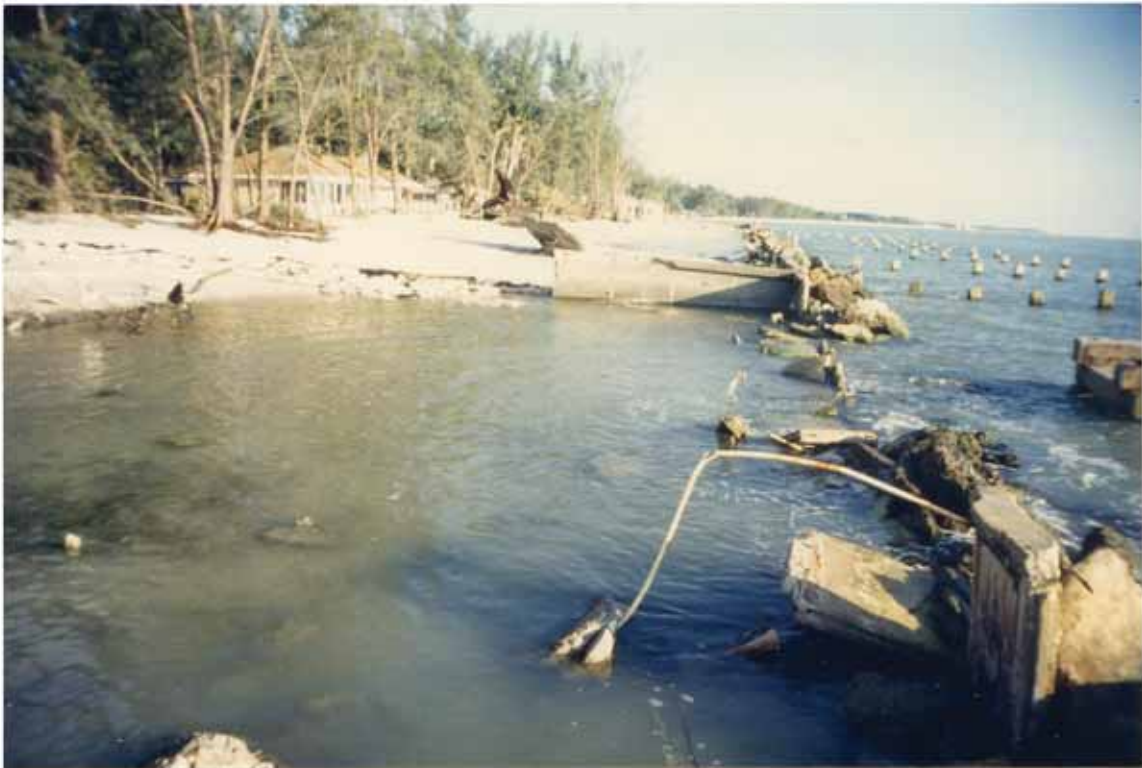
Further south a continuous 700 foot stretch of concrete bulkhead was destroyed by Juan (Figure 142). Considerable erosion took place landward of the bulkhead resulting in a number of large Australian pine trees being toppled (Figures 145 and 146). Notwithstanding the two beach profile computations at DNR reference monument numbers 51 and 54 as reported in Post-Storm Report Number 85-2, moderate to heavy beach erosion took place along the two mile stretch south of this area of heavy structural damage. This area experienced wave overtopping and one swimming pool was damaged by Juan beyond repair.

FIGURE 142. Juan destroyed 700 feet of bulkheads

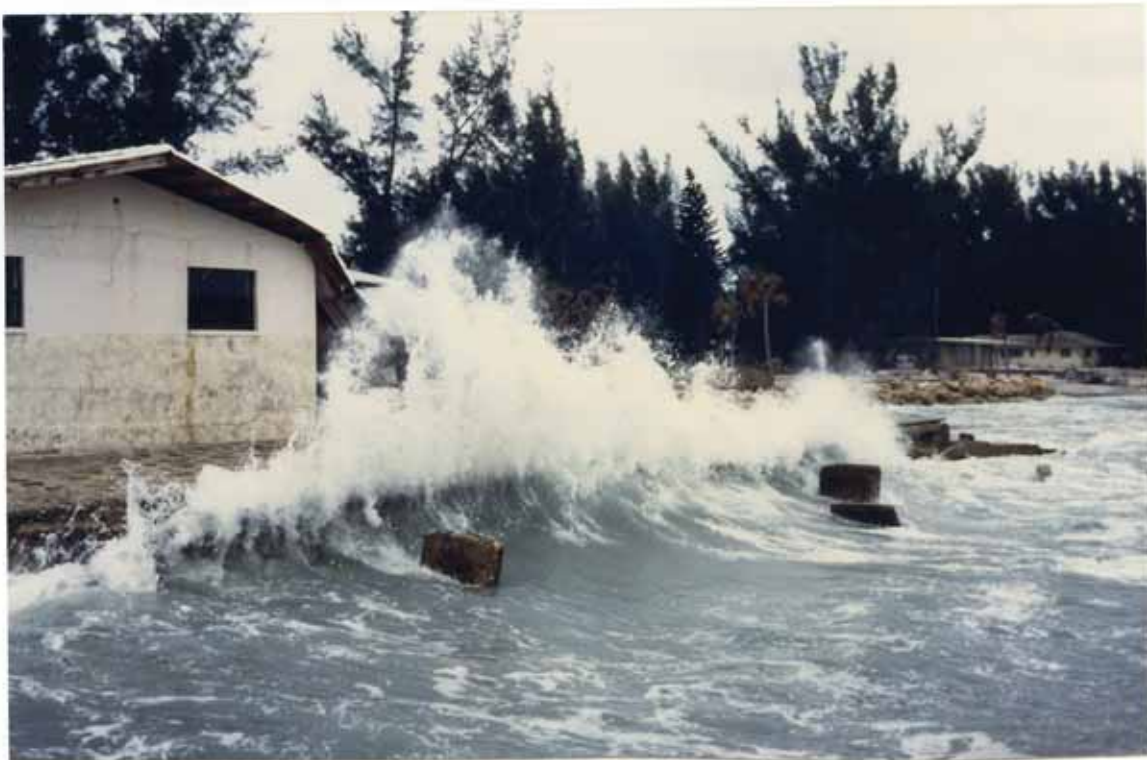
FIGURE 143. Longboat Key dwelling under wave attack  
(S. West)

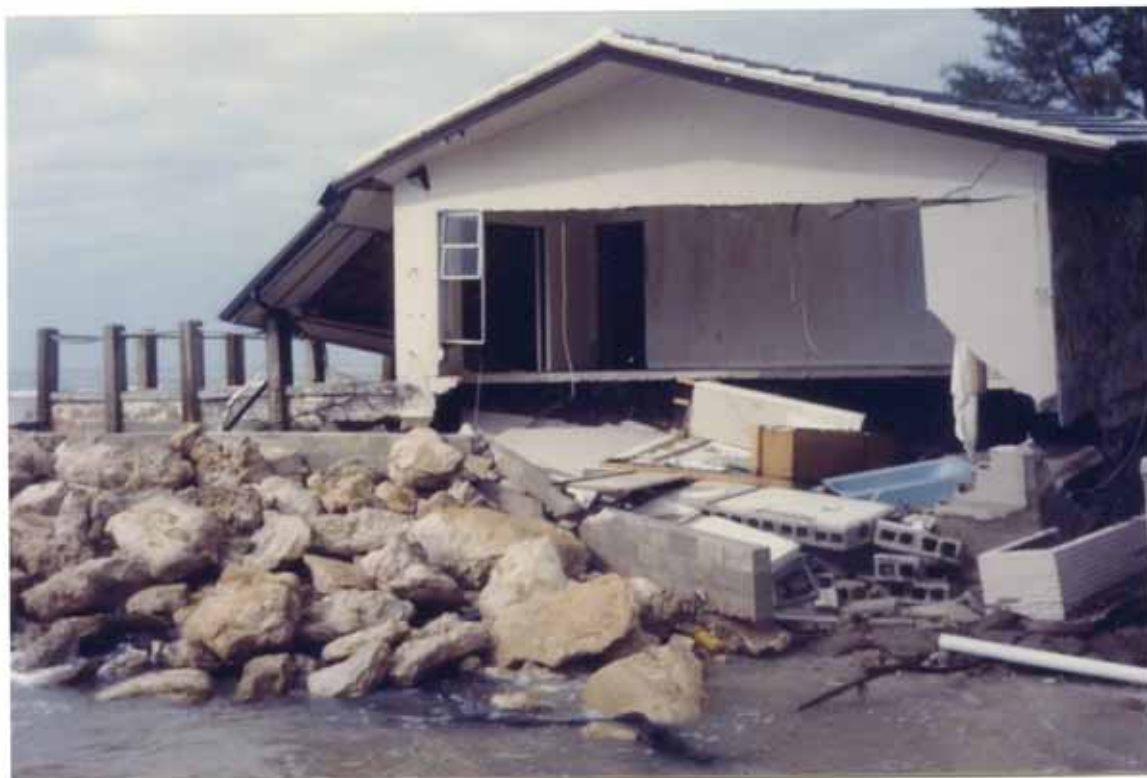
Approximately one mile south of Longboat Pass considerable structural damage occurred along Gulfside Drive. At one property, 100 feet of concrete bulkhead was destroyed, 40 feet by Elena and 60 feet by Juan, and the front deck and decorative wall seaward of the dwelling were destroyed by Juan. At the dwellings immediately to the south a patio and a deck and spa were destroyed by Juan. Further south, two single-family dwellings and a groin sustained major damage by Elena and Juan. One dwelling sustained wave damage to its lower floor (Figure 141). The other dwelling experienced roof collapse from the constant impact of Juan's storm waves (Figure 143). This dwelling was also substantially damaged from flanking wave attack around its south side (Figure 144).

FIGURE 144. Same dwelling destroyed by wave flanking  
(M. Joity)

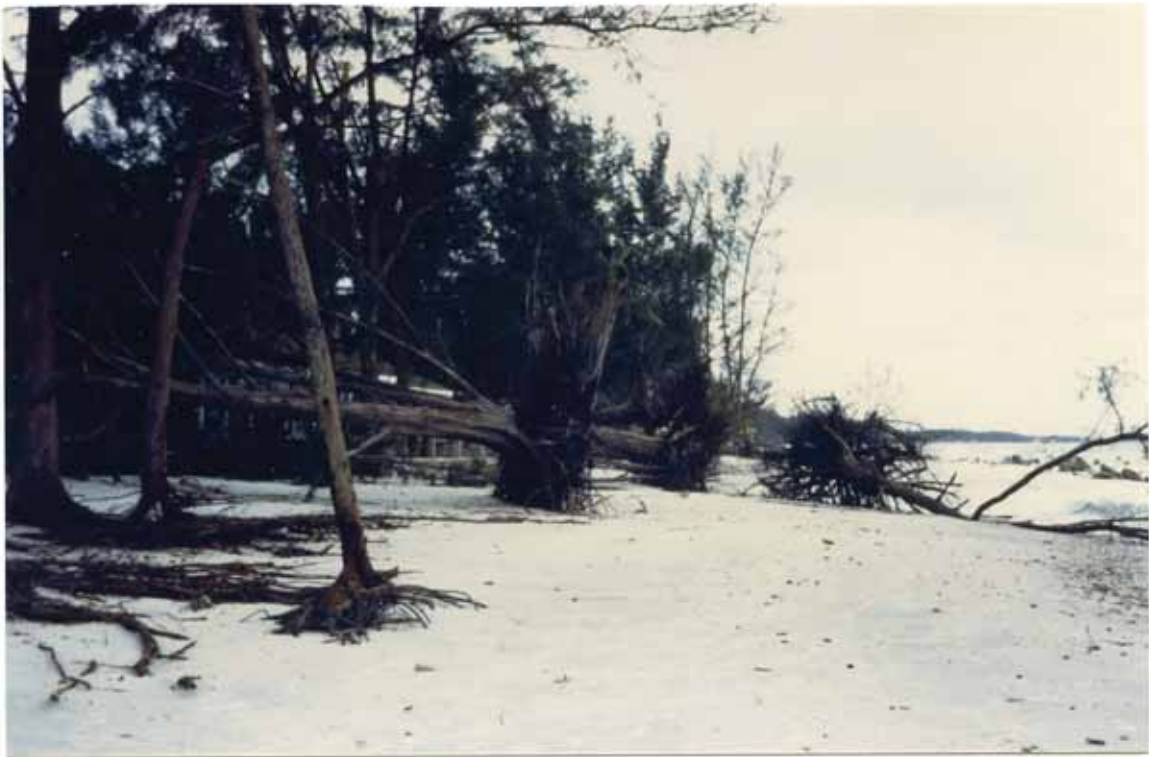
FIGURE 145. Severe erosion on Longboat Key (S. West)

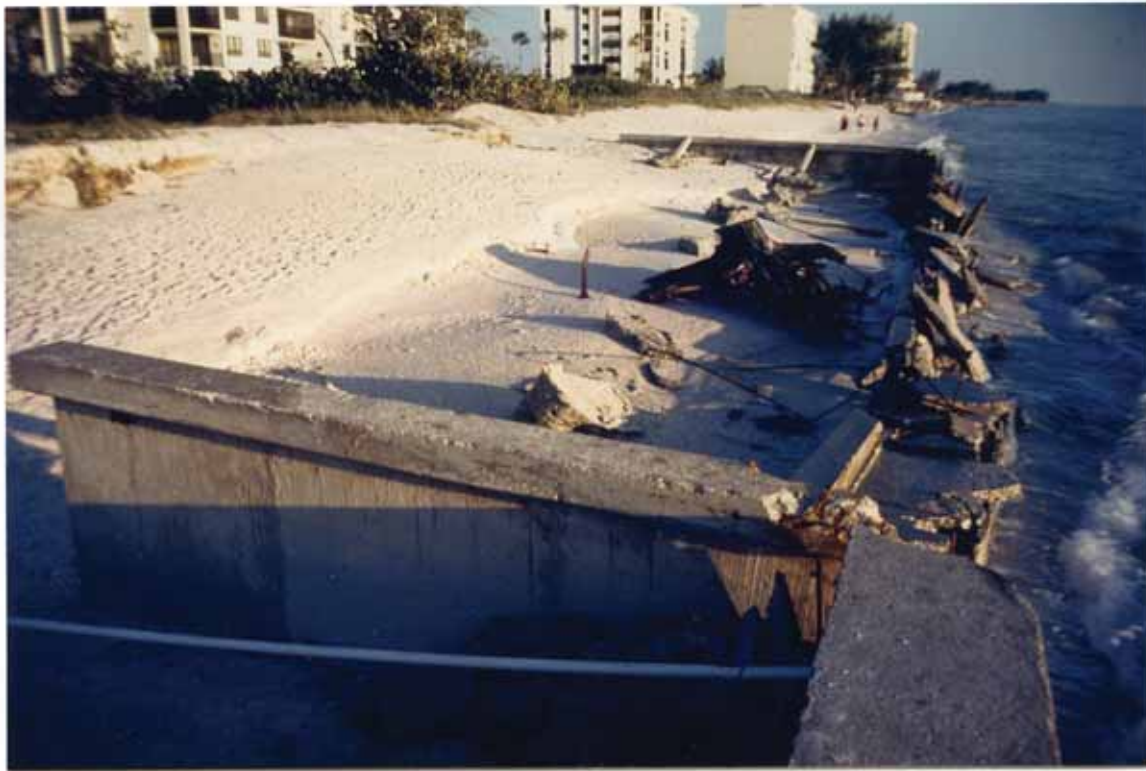
Near the south end of Manatee County, a 100 foot concrete bulkhead was destroyed by Juan adjacent a dwelling south of the Casa del Mar Condominiums (Figure 147). The Longboat Harbor Towers lost 90 feet of concrete bulkhead during Elena and an additional 120 feet of wall and the swimming pool during Juan (Figure 148).

FIGURE 147. Juan destroyed concrete bulkhead

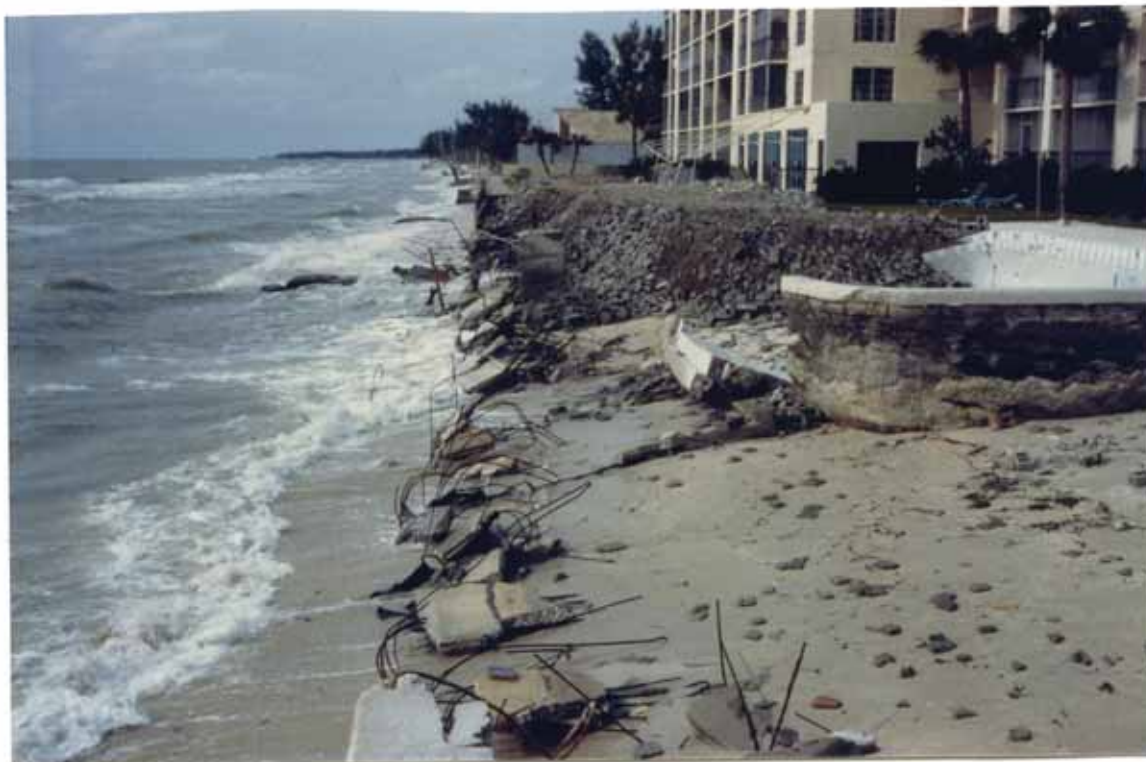
FIGURE 148. Juan destroyed pool and bulkhead, Longboat Harbor Towers (S. West)

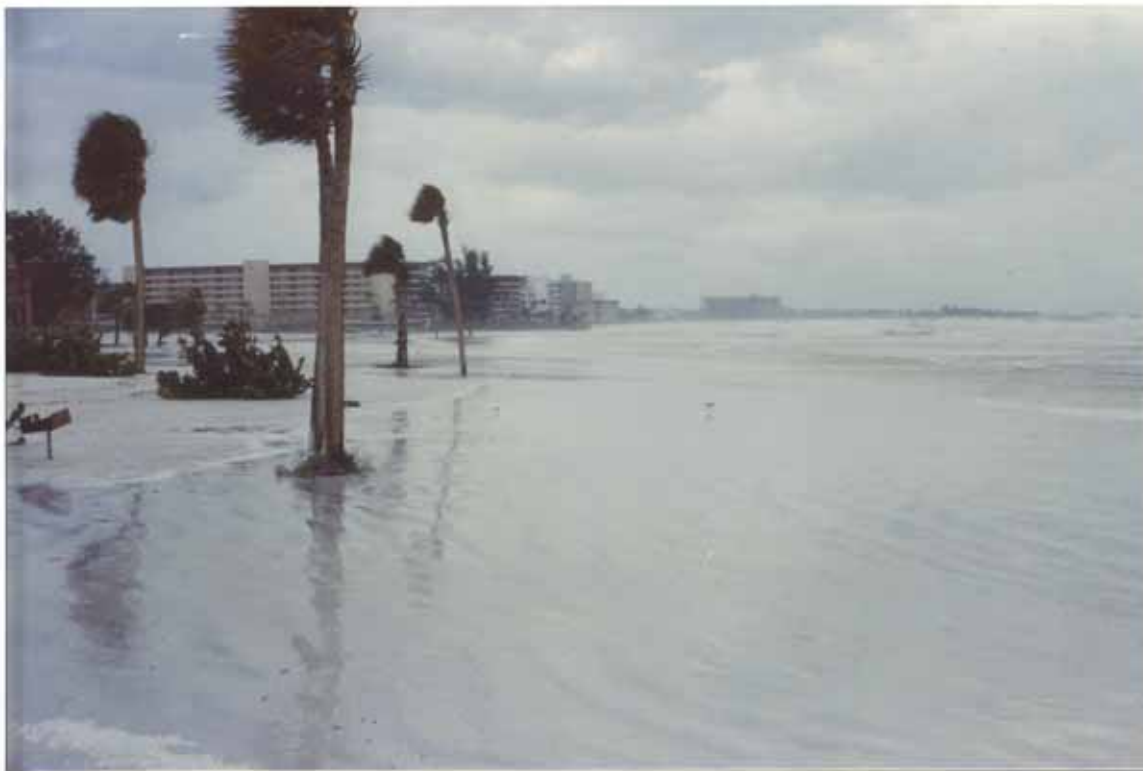
FIGURE 152. Siesta Key flooding during Elena (S. West)
