LEACHATE TREATMENT
and
RECLAMATION
FACILITY TANK ASSESSMENT

HILLSBOROUGH COUNTY
SOUTHEAST COUNTY LANDFILL

**TANK ASSESSMENT INSPECTION REPORT
LEACHATE TREATMENT AND RECLAMATION FACILITY
SOUTHEAST COUNTY LANDFILL
HILLSBOROUGH COUNTY, FLORIDA**

TANK ASSESSMENT INSPECTION REPORT

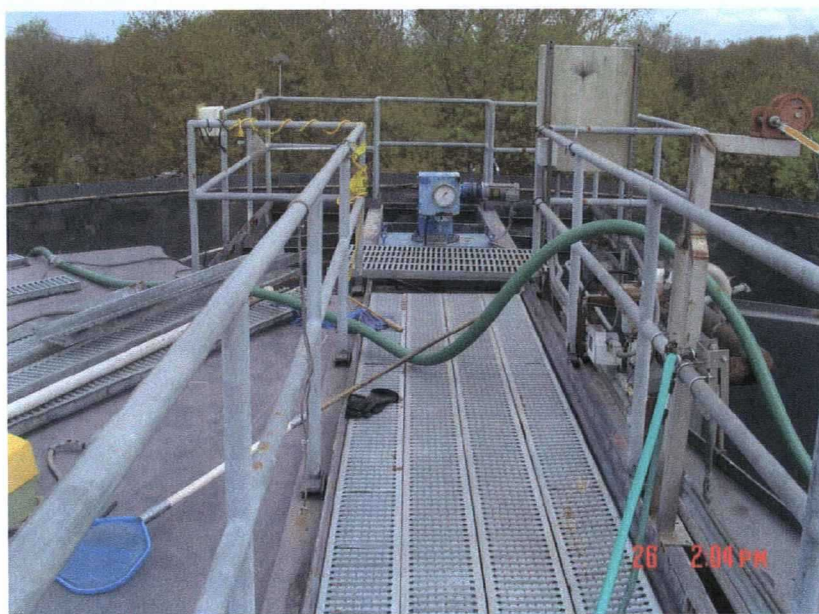
7. Catwalk top.

Visual inspection of the tank surfaces and accessories (manways, nozzles, walkways, and stairways) were conducted to examine the metal surfaces for evidence of general corrosion, localized/pitting corrosion, coating conditions, and serviceability. The five shell manways (24 inch-diameter bolted lids) were in very good condition. The tank system access stairs and overhead walkways were in good condition. Minor paint peeling and surface corrosion were noted on the walkway frame.

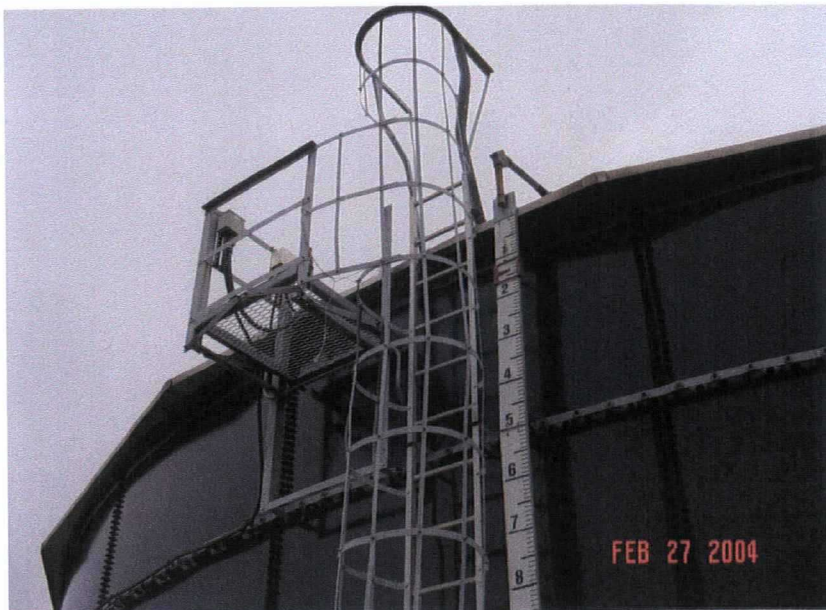
5. Exterior ladder top.

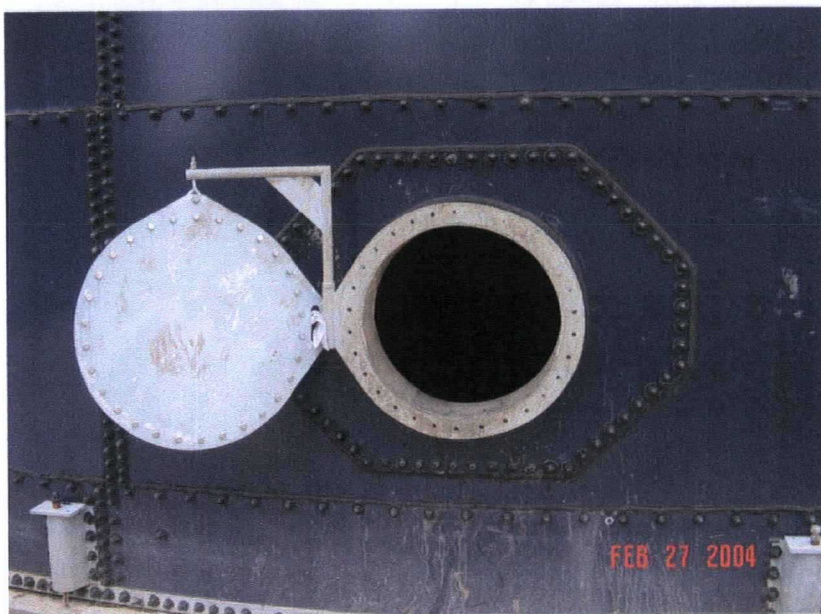
7. Manway Exterior.

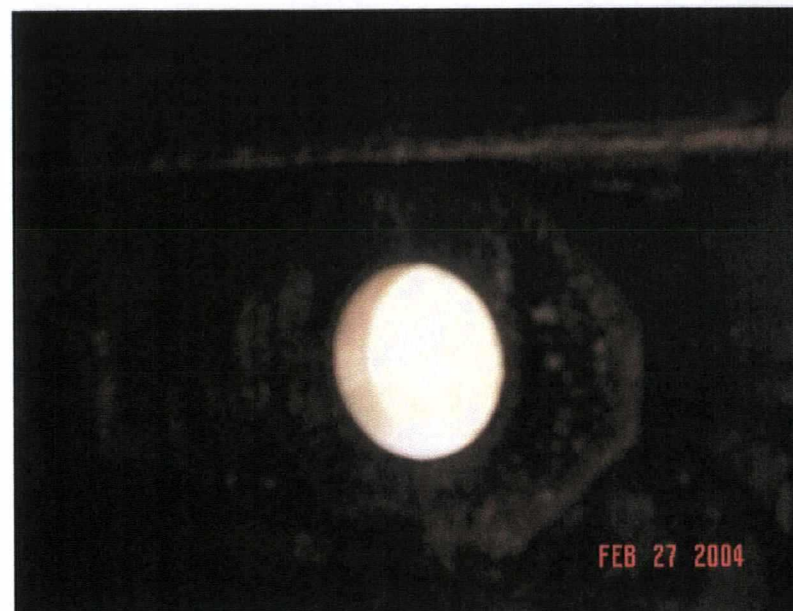
8. Manway interior.

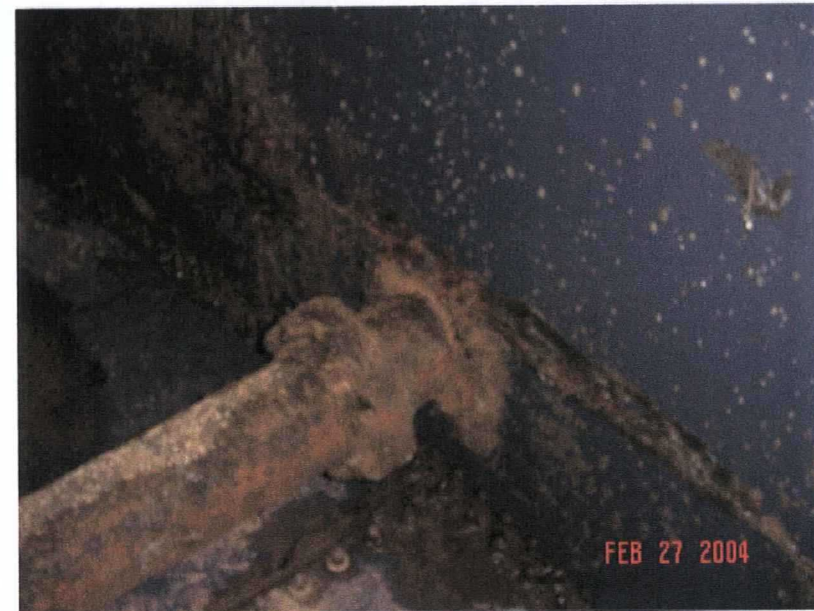
12. Lower nozzle interior.

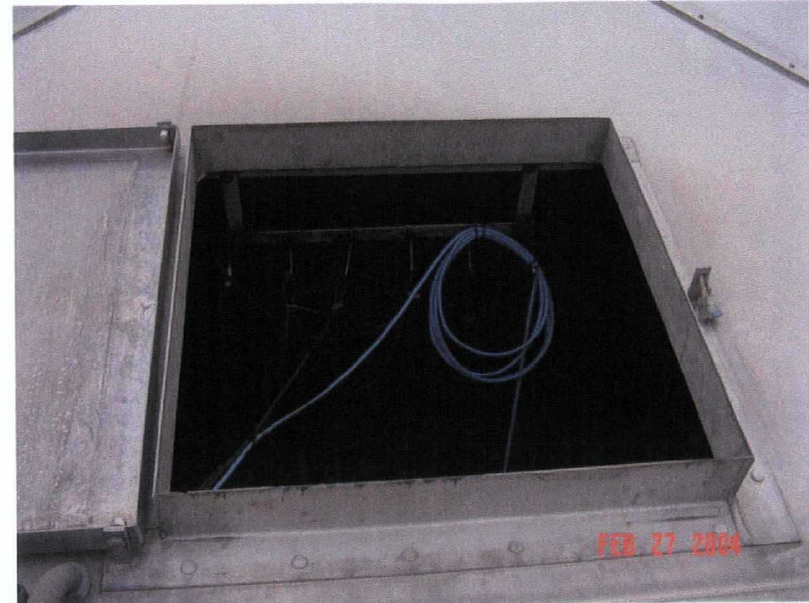
14. Roof hatch.

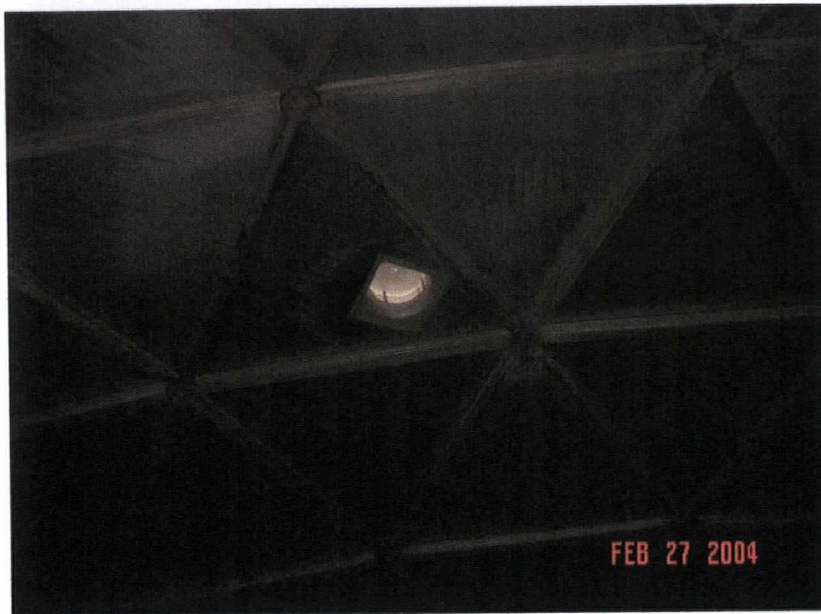
15. Roof interior.

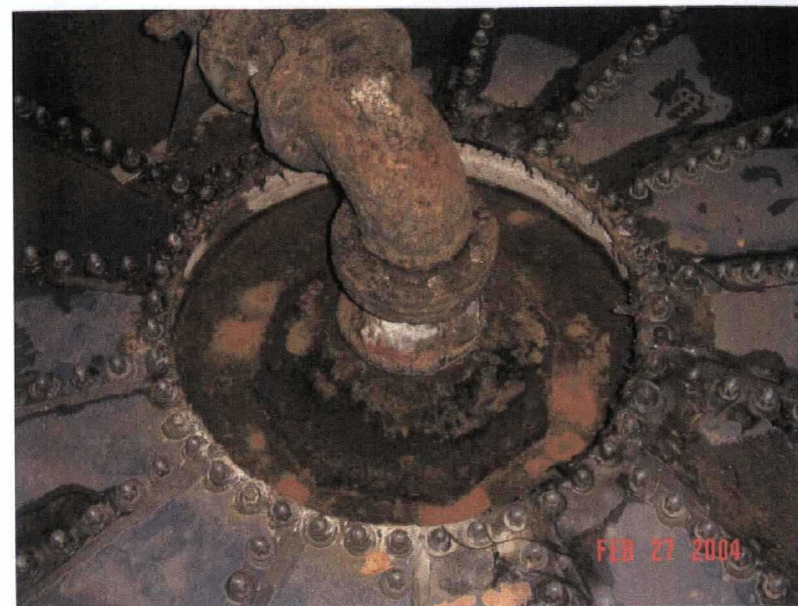
18. Center sump

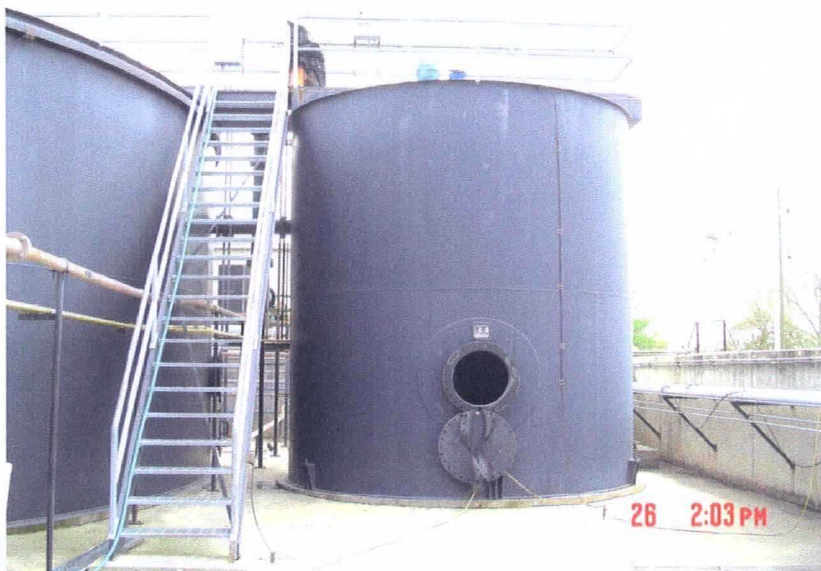
1. Tank overall..

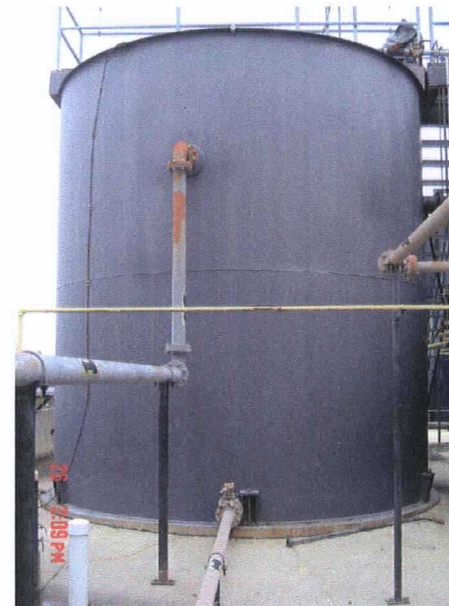
2. Tank overall.

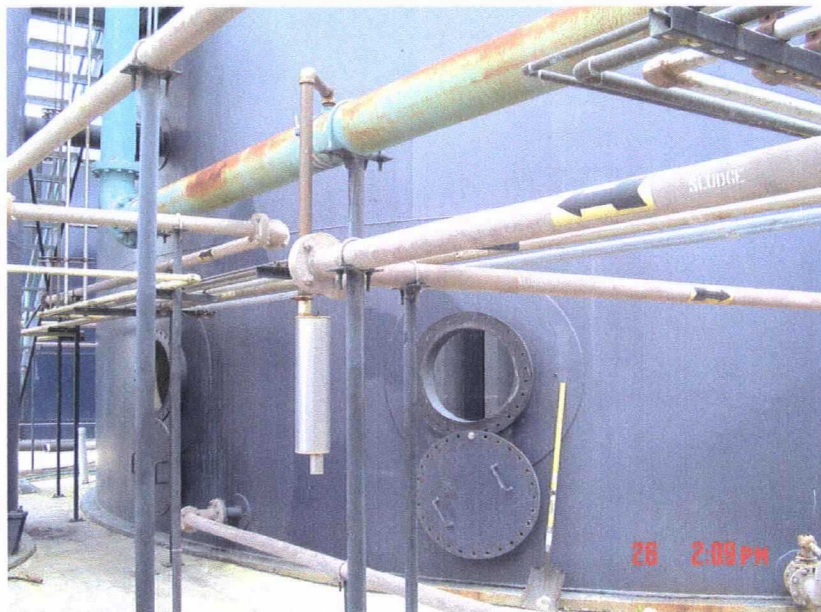
1. **Manway:** Access into the tank is provided by a 24" diameter shell manway. The manway was found to be in very good condition.
2. **Stairway:** A steel stairway provides access to an overhead walkway, which connects the Clarifier Tank and the adjacent PACT Facility. The stairway and walkway were found in very good condition.

3. Tank Manway.

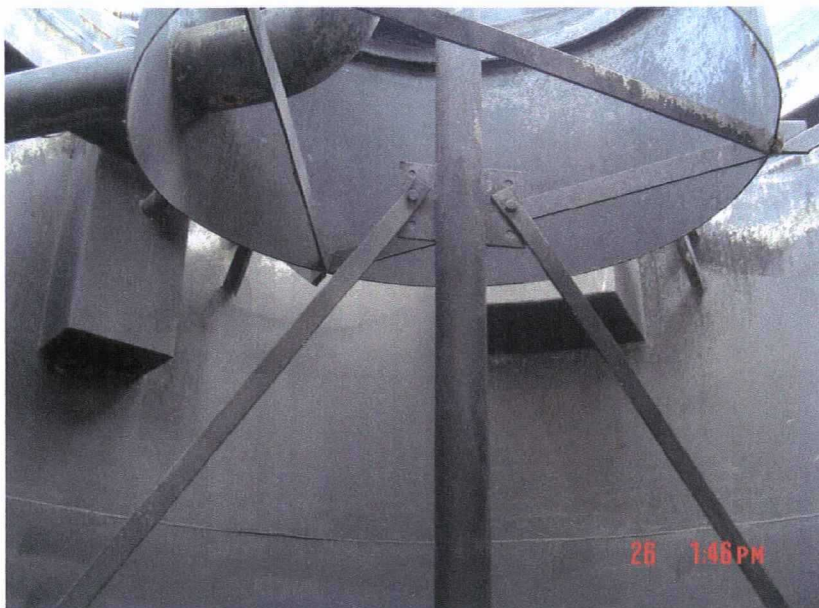
5. Center structure.

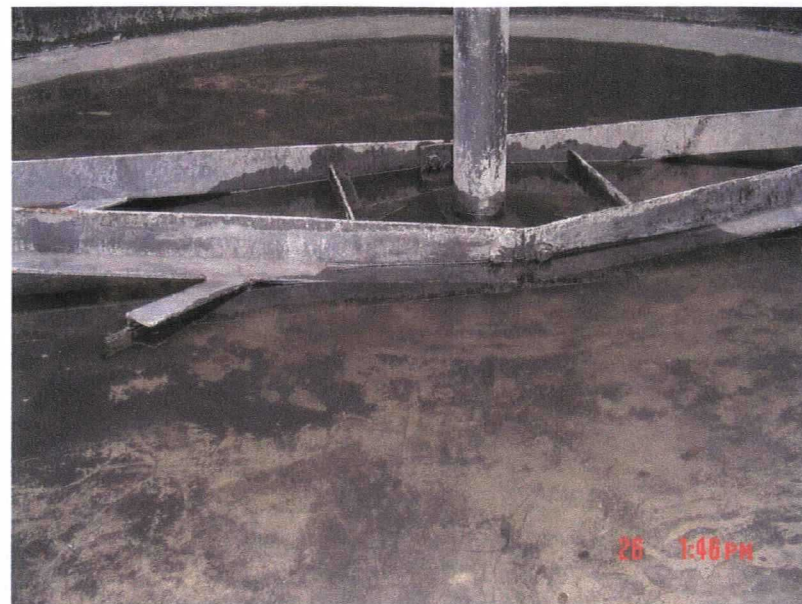
6. Mixer center.

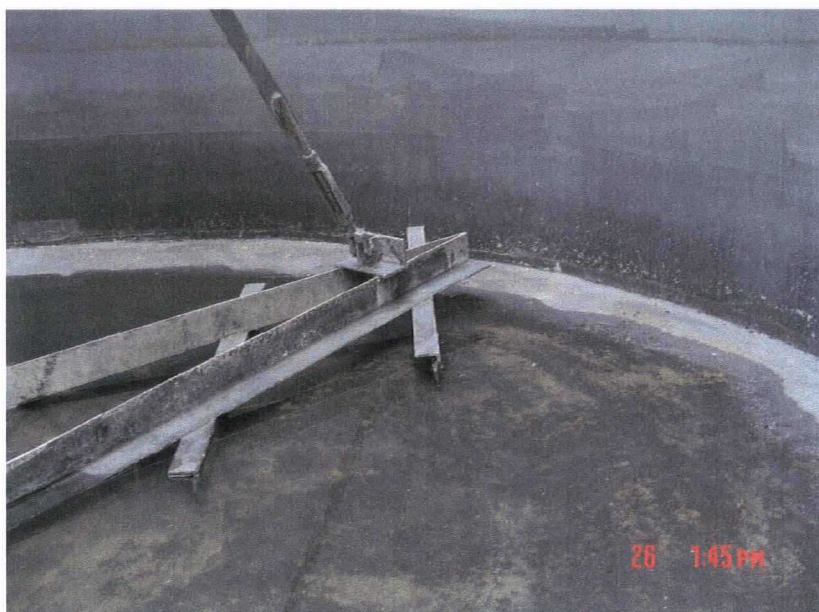
7. Mixer end.
